MIAMI-DADE COUNTY INTERNAL SERVICES DEPARTMENT

La Quinta Inn Physical Condition Assessment

10821 Caribbean Blvd, Miami, FL 33189

ISD PROJECT No. W220057

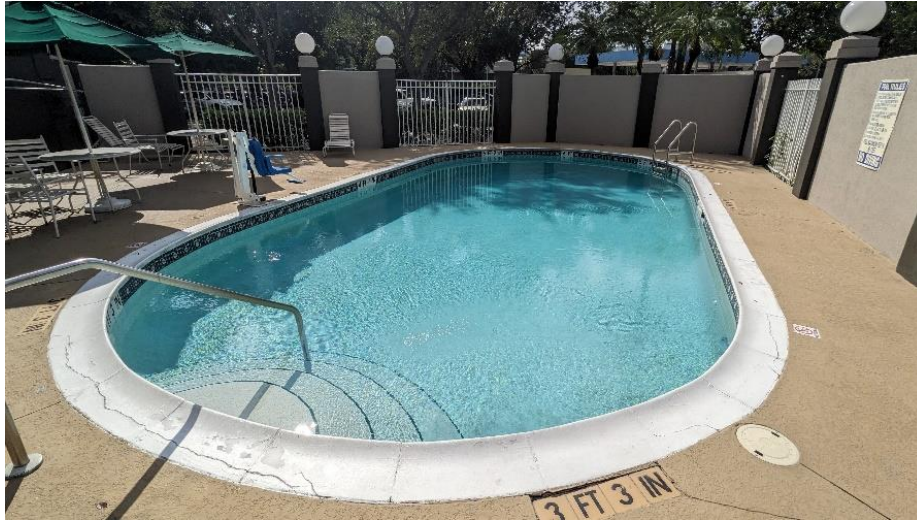
- The pool deck contains cracks/fractures that partially run throughout the perimeter of the pool deck, closer to the pool. The cracks/fractures are commonly caused by stress in the concrete due to settlement, or thermal expansion with insufficient control joints.

- While the cracks generally do not seem to present a tripping hazard, they should be sealed in with exterior-grade, high-performance, high-movement, durable, flexible sealant. Furthermore, the deck should be resurfaced with a non-slip pool deck overlay.

- Should the pool not be used or needed, it is recommended for the pool to be filled in and topped with turf or sod to minimize risks and avoid occupants from accidentally falling into the pool in the future.
- This pool and pool deck area may further receive some awnings with further tables and benches, to be transformed into a secured exterior barbecue area or small playground. The existing surrounding block walls and fence include light fixtures that provide illumination and safety for future occupants and families.

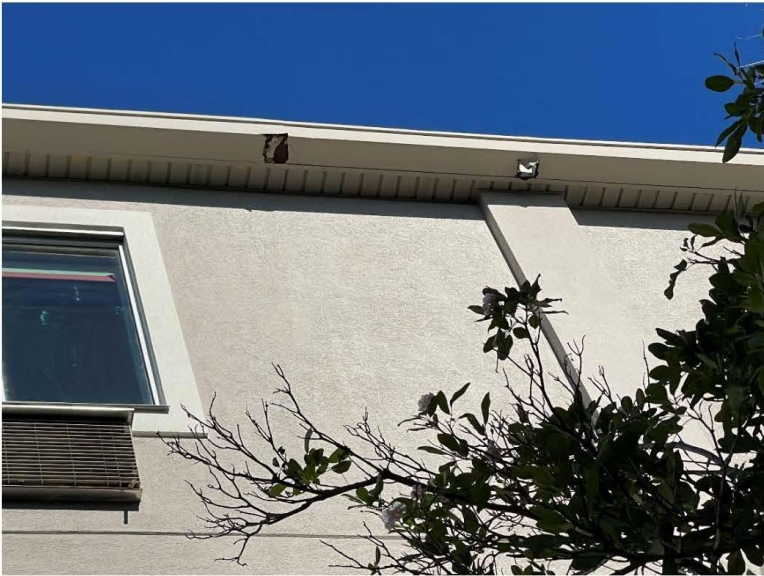
PHOTOGRAPHIC LOG		BEA architects
Site Progress Report		
Client: Miami Dade County - ISD Consultant: BEA Architects, Inc.		Site Location: La Quinta Inn 10821 Caribbean Blvd, Miami, FL 33189
Project: 21-9007 / W220057		
Photo No. 9	Date: 10/19/23

Direction Photo Taken: Southeast		
Description: Missing downspout and damaged and rusted roof gutter.		
Photo No. 10	Date: 10/19/23

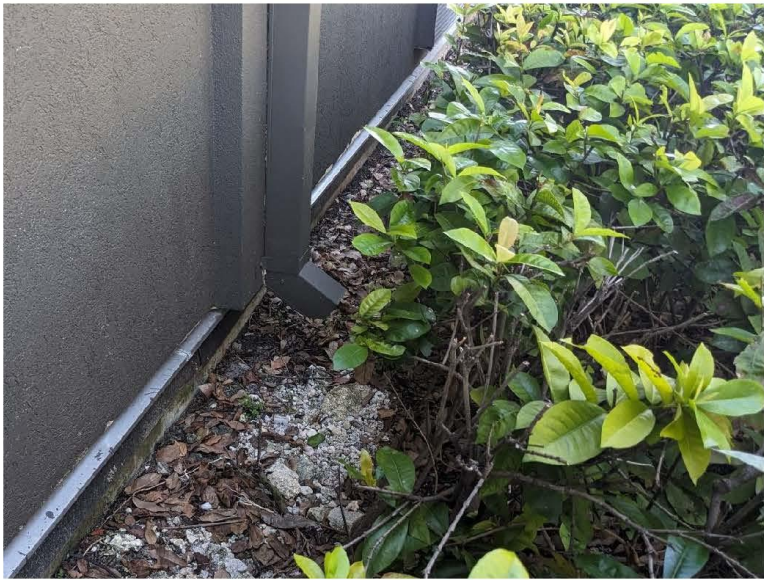
Direction Photo Taken: Northeast		
Description: Downspout missing splash block.

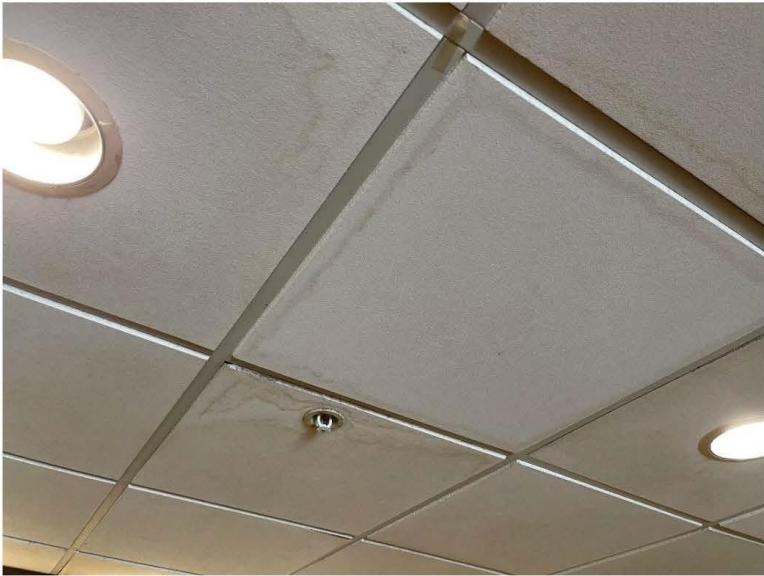
Client: Miami Dade County - ISD Consultant: BEA Architects, Inc.		Site Location: La Quinta Inn 10821 Caribbean Blvd, Miami, FL 33189
Project: 21-9007 / W220057		
Photo No. 15	Date: 10/19/23

Direction Photo Taken: Toward Ceiling		
Description: Stained acoustic ceiling tiles with dried water damage in dining area.		
Photo No. 16	Date: 10/19/23

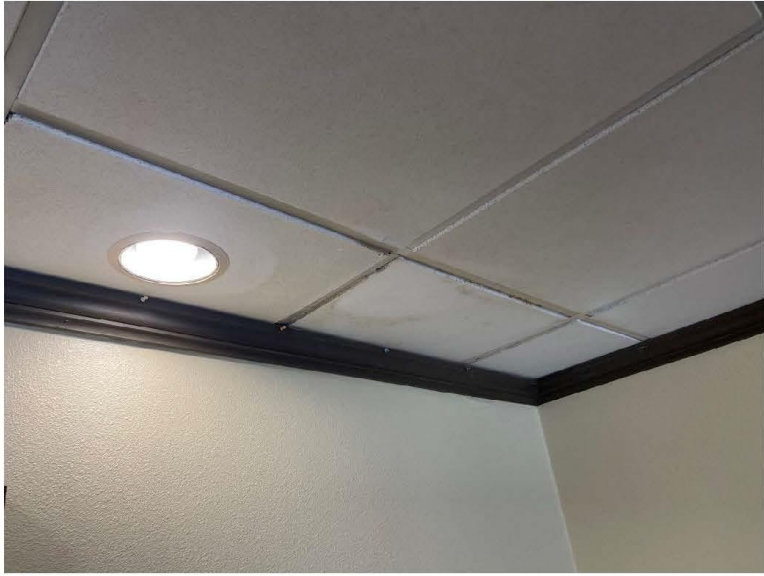
Direction Photo Taken: Toward Ceiling		
Description: Stained acoustic ceiling tiles with dried water damage in dining area and dining preparation area.

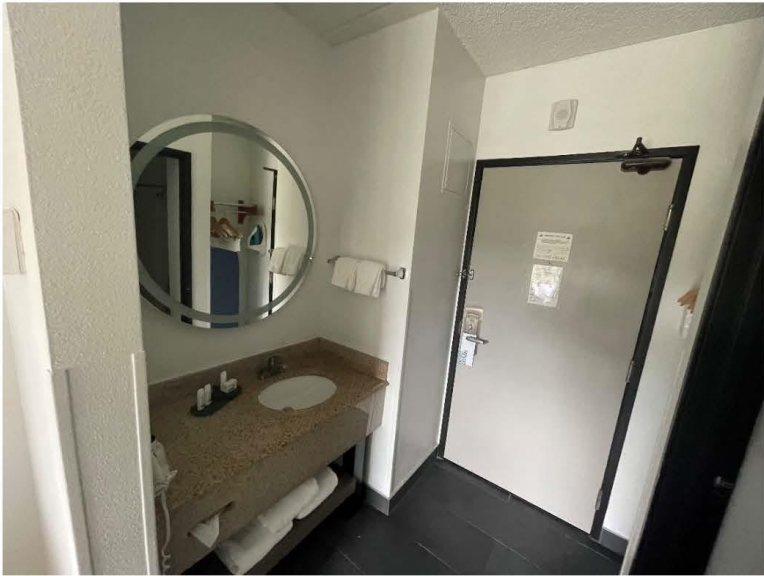
PHOTOGRAPHIC LOG		BEA architects
Site Progress Report		
Client: Miami Dade County - ISD Consultant: BEA Architects, Inc.		Site Location: La Quinta Inn 10821 Caribbean Blvd, Miami, FL 33189
Project: 21-9007 / W220057		
Photo No. 63	Date: 10/24/23

Direction Photo Taken: Northwest		
Description: Entrance to Dwelling Units. Existing Doors equip with Door Closers. Bathroom hand sink and reduced counterspace found in 16 units due to chase for ductwork, in each floor.		
Photo No. 64	Date: 10/24/23

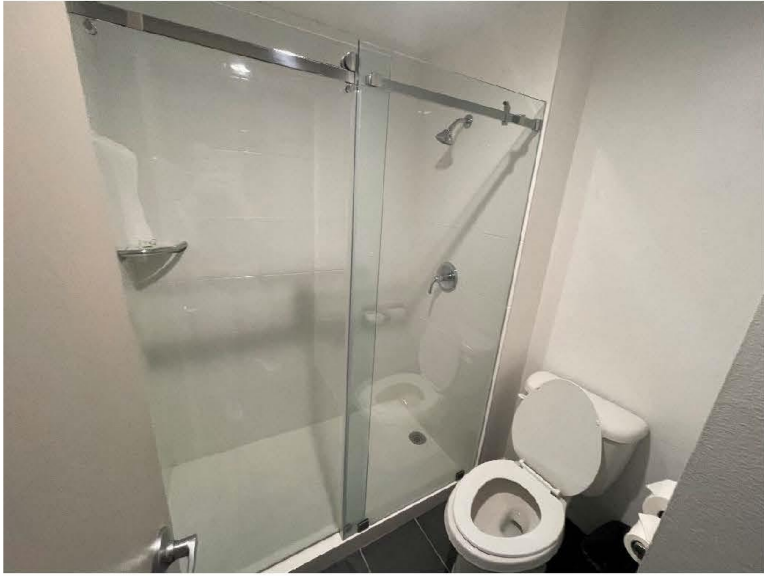
Direction Photo Taken: N/A		
Description: Bathroom in dwelling units with shower found in # units.

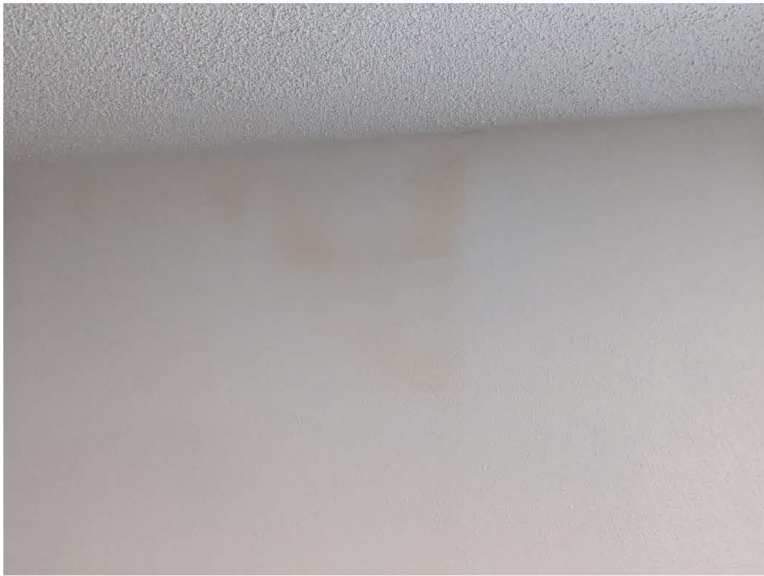
PHOTOGRAPHIC LOG		BEA architects
Site Progress Report		
Client: Miami Dade County - ISD Consultant: BEA Architects, Inc.		Site Location: La Quinta Inn 10821 Caribbean Blvd, Miami, FL 33189
Project: 21-9007 / W220057		
Photo No. 75	Date: 10/24/23

Direction Photo Taken: N/A		
Description: Dried staining of interior of exterior wall. No existing liquid damage of any kind found.		
Photo No. 76	Date: 10/24/23

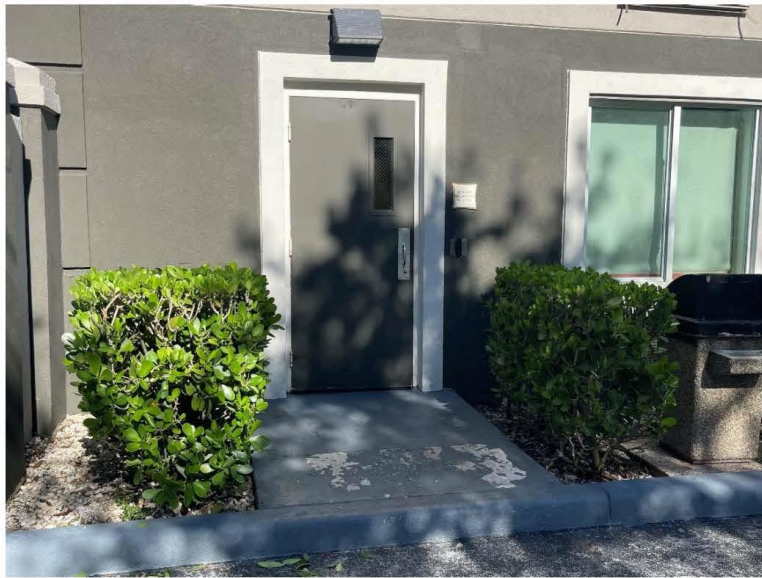
Photo No.
94

Fire Egress Door in Southwest Elevation, damage on concrete slab.

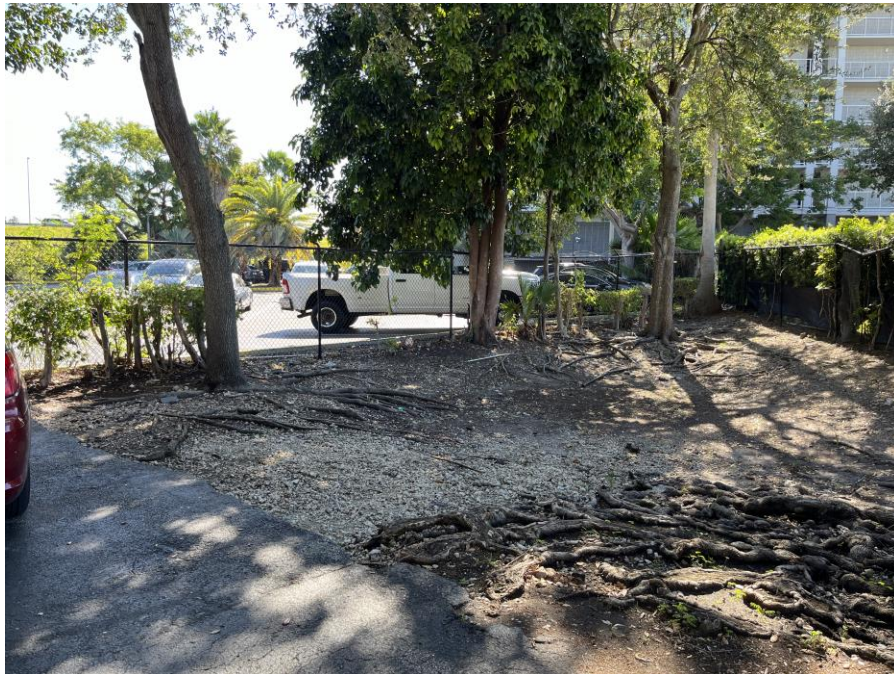
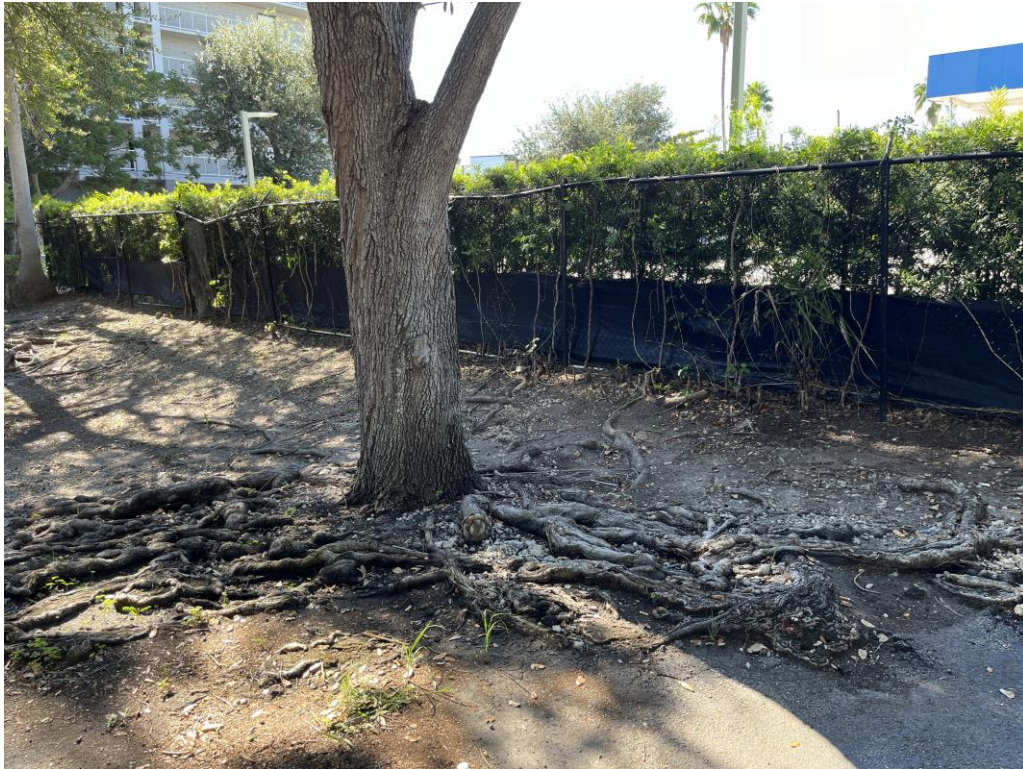
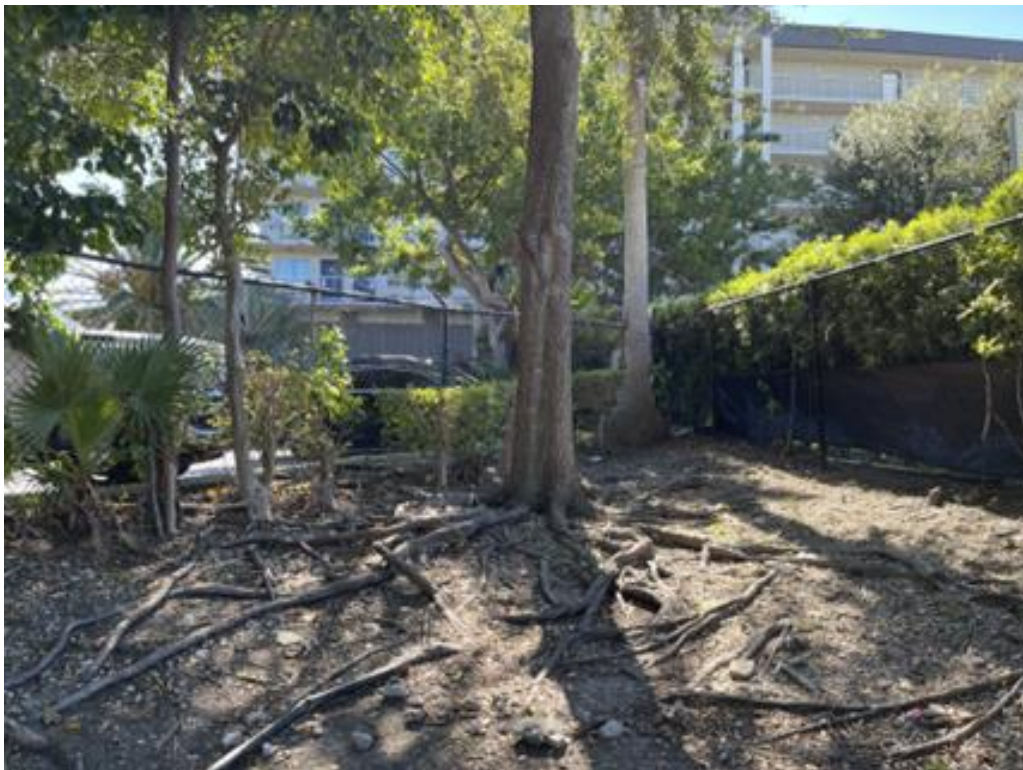
18.2.2.1 SWALE 1

The swale is currently in a deteriorated condition and requires repairs. It does not conform to the required width-to-depth ratio. Additionally, there are trees and roots present within the swale area that may need to be removed. The design swale had 2 feet depth; the current depth is 1.5 feet.

The recommended actions for this swale include root pruning and swale regrading.

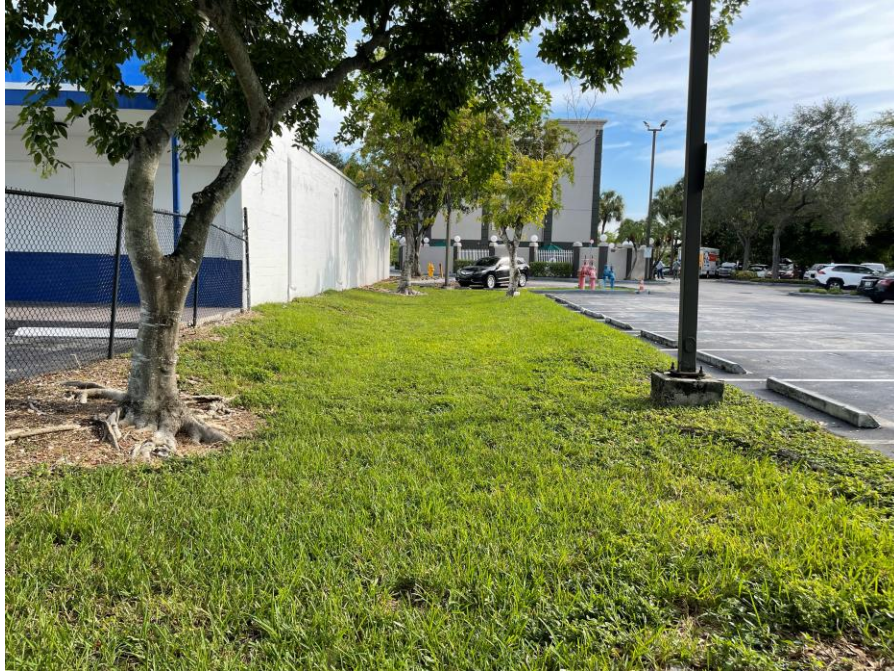
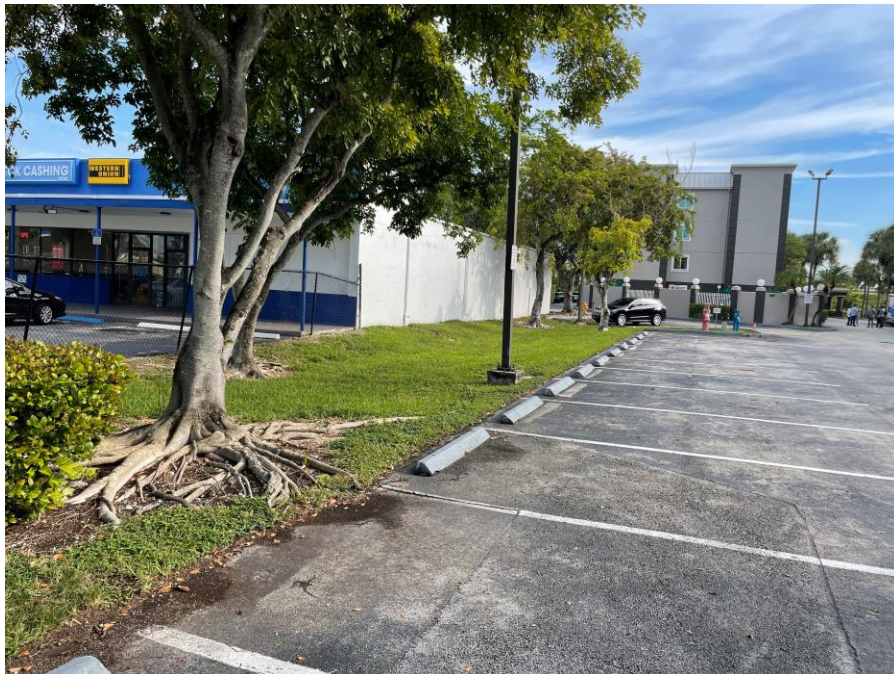
18.2.2.3 **SWALE 3**

The swale has deviated from its original design, with the presence of four trees within the swale. However, it's noteworthy that the depth of the swale remains in conformance with the original design.

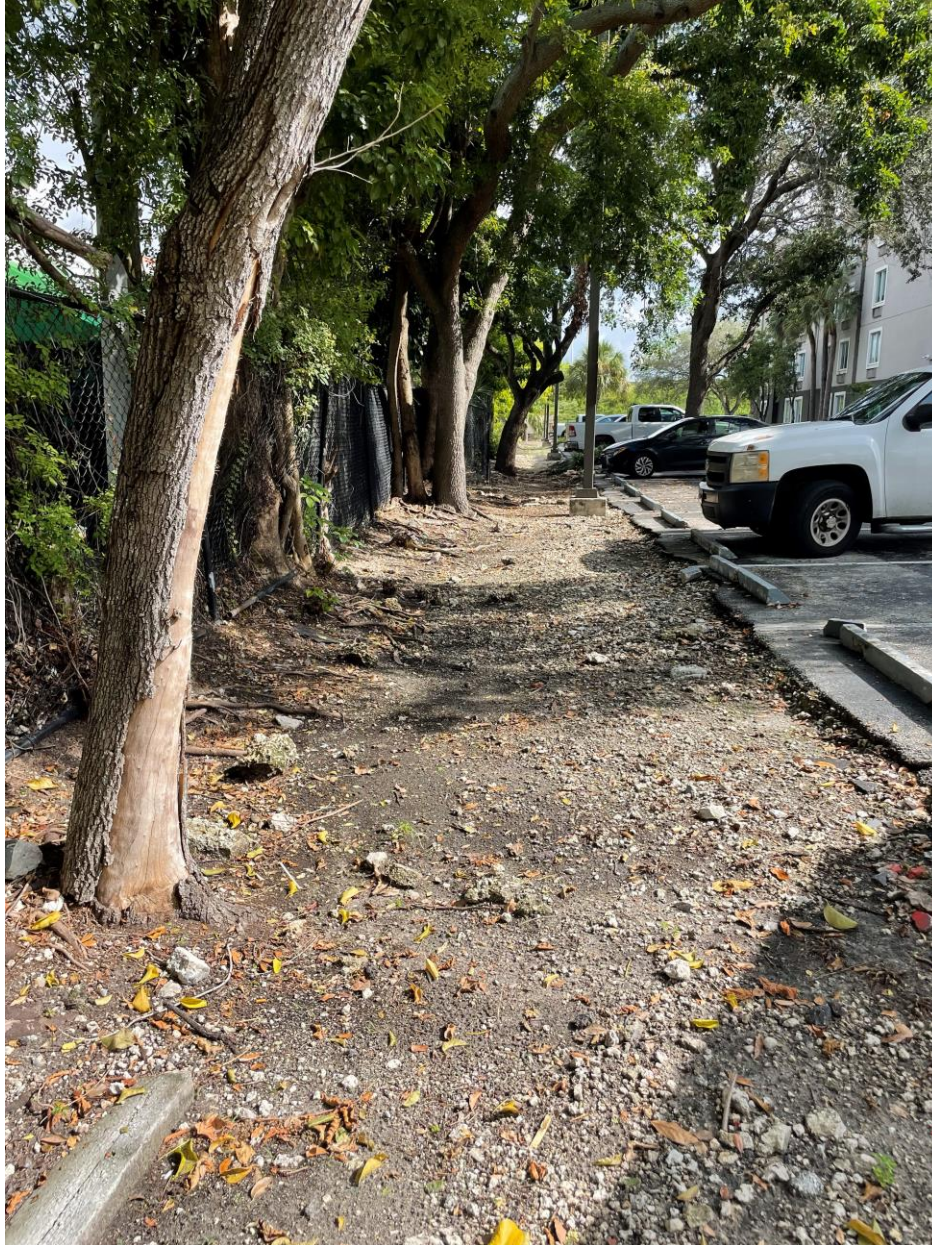
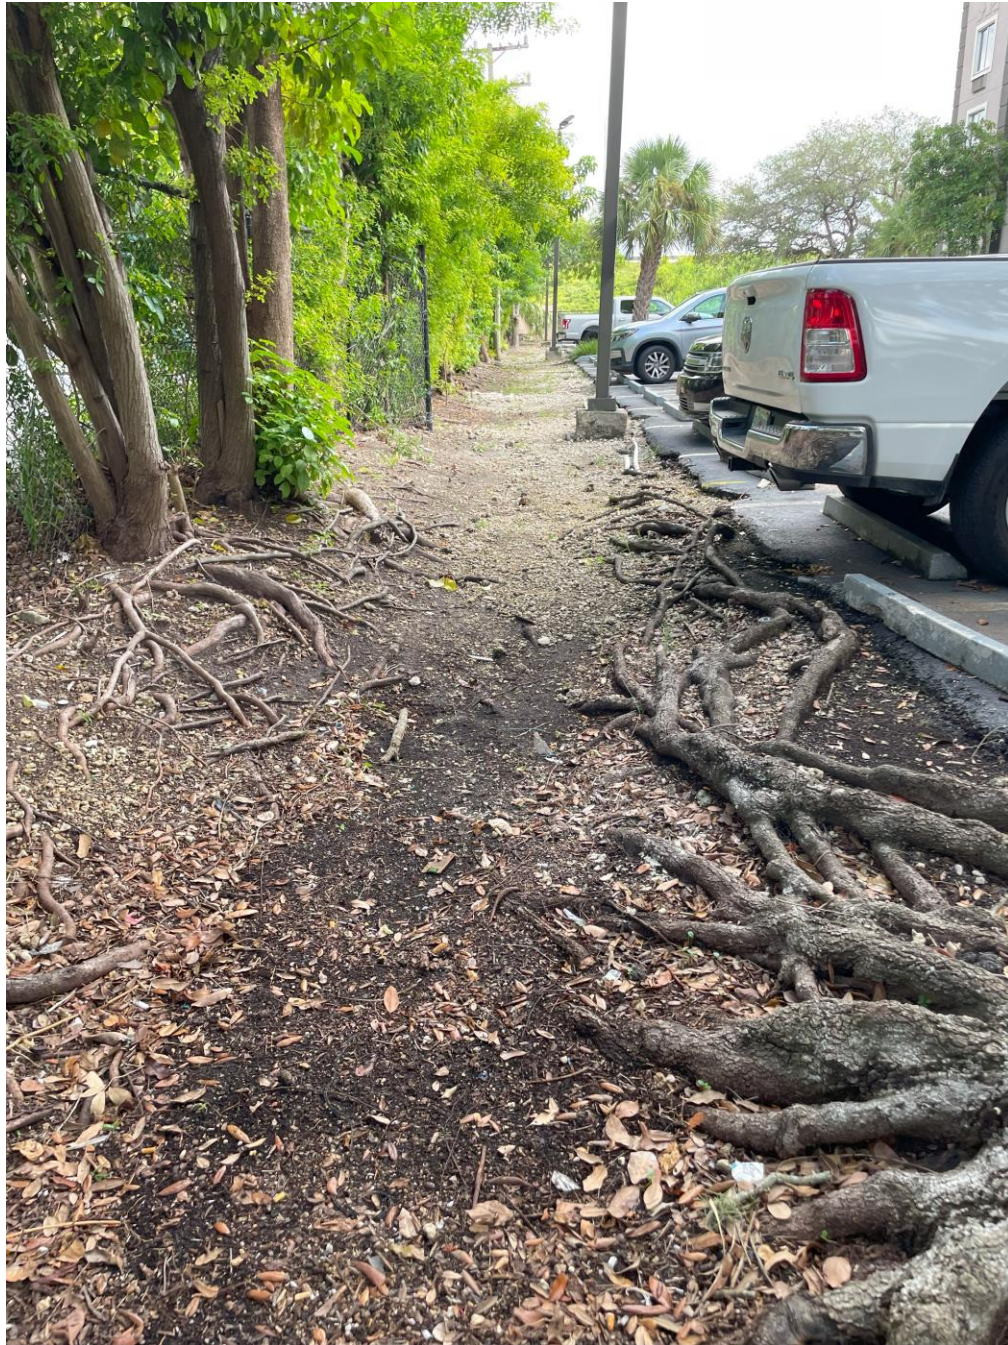
18.2.2.4 **SWALE 4**

The entire area has suffered a loss of the originally designed depth, necessitating a comprehensive reconstruction of the swale. In addition to the issues related to the swale depth, it is crucial to note that the original design for this specific area included a catch basin and an exfiltration trench that could not be located, being probably covered under the soil and completely clogged. It is recommended to restore this swale by root pruning, regarding the swale and adding a new catch basin with pollution retardant baffle and 25' of exfiltration trench with 24" pipe.

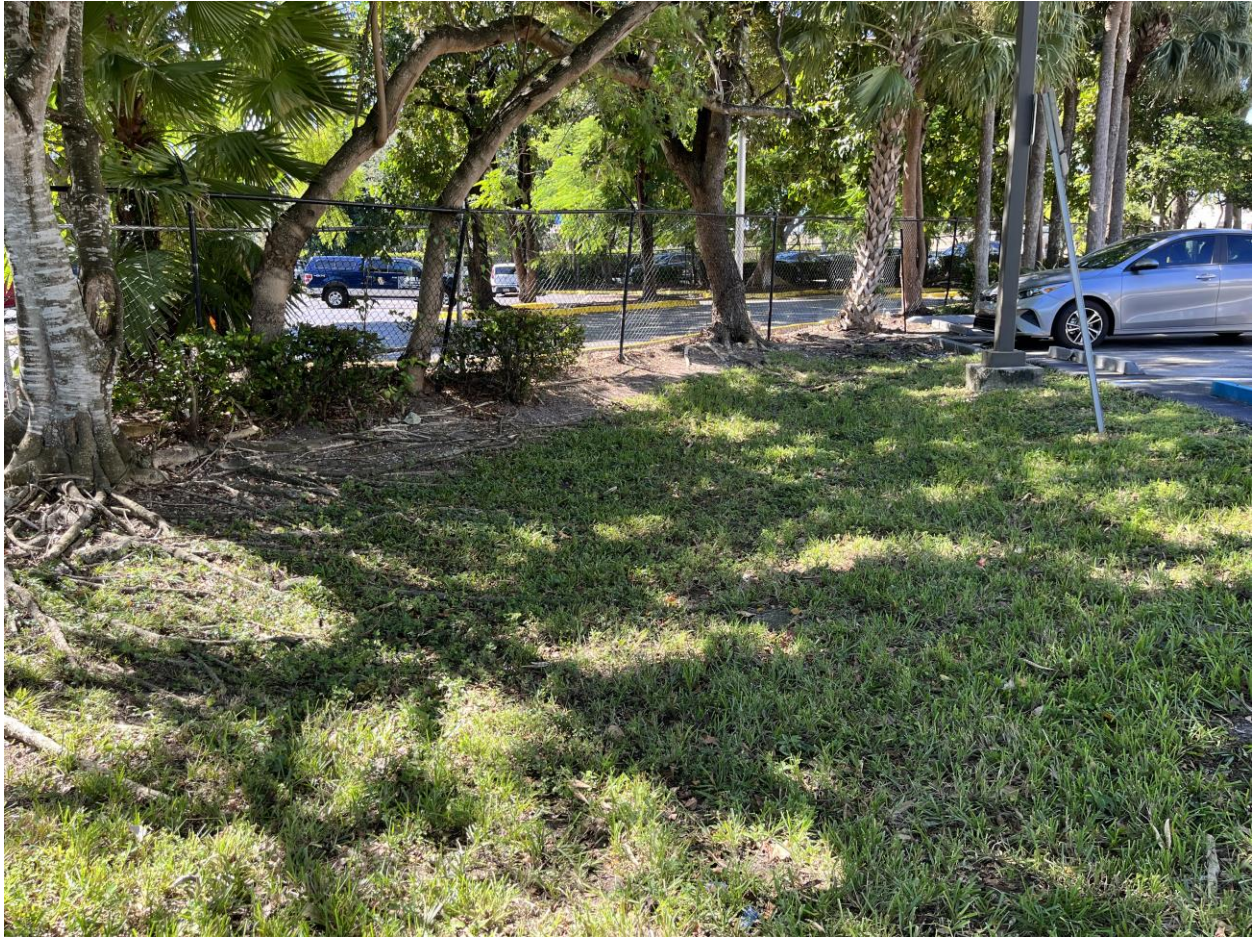
18.2.2.5 SWALE 5

The site analysis indicates a substantial deviation from the initial design conditions, necessitating a comprehensive reconstruction of the swale. In the deeper section of the swale, we observe a depth of 1.5', differing from the initially planned 2'. Furthermore, the original configuration has changed, leading to the loss of the required design slopes. As a result, a complete reconstruction is recommended to bring the swale back to the intended specifications.

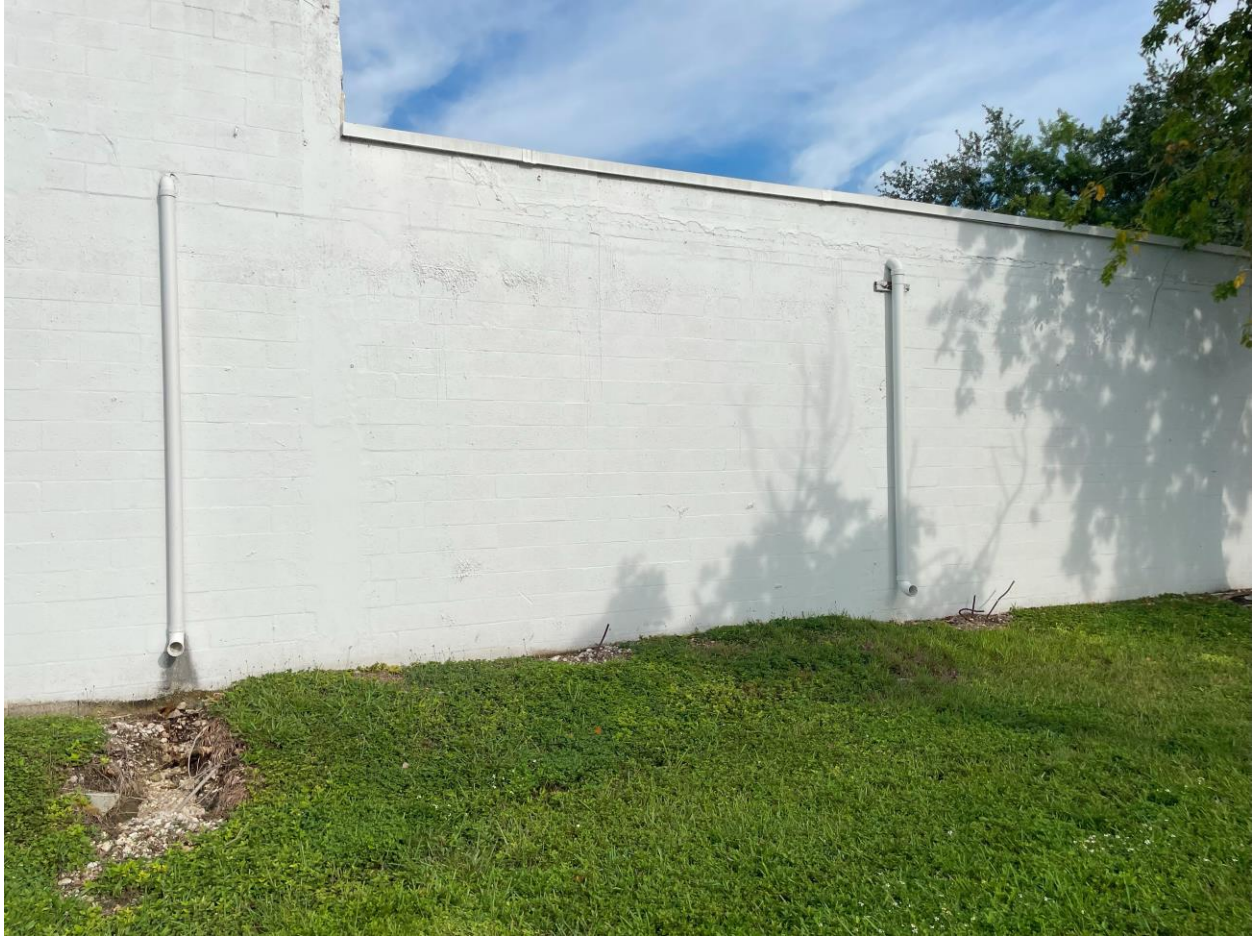
During the site visit, our crew noted that the adjacent property is utilizing the swales of the La Quinta Hotel for drainage management. This condition introduces two considerations for the project: addressing the improvements needed for the property's swales and imposing restrictions on external usage that impact the design capacity. The following image illustrates the drainage pipes affecting the property's drainage conditions.

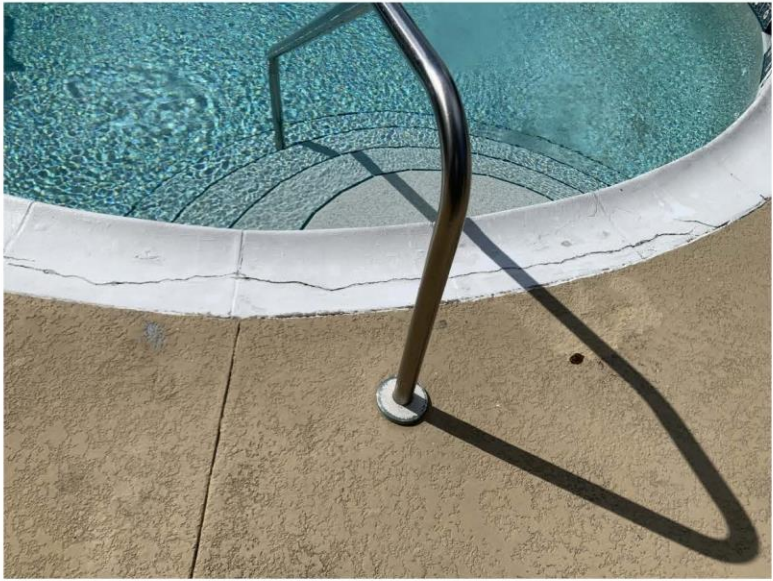
Direction Photo Taken: Exterior Pool Deck Floor		
Description: Slab Cracks Tier I Estimated Life Expectancy: More than 10 years with proper repair.		
Photo No. 2	Date: 10/19/23

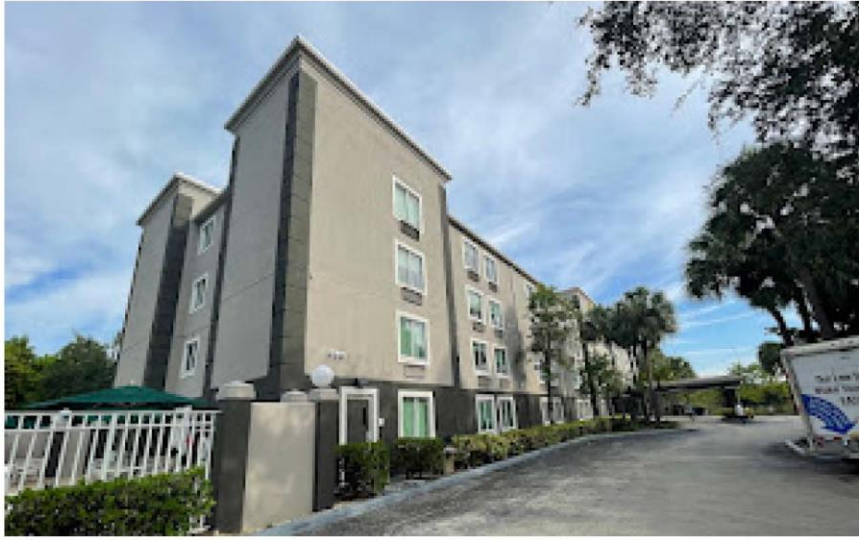
Direction Photo Taken: Exterior of building		
Description: Good alignment: no leaning, large holes, loose surface material, severe buckling, missing parts or other damage found. Estimated Life Expectancy: More than 20 years with proper maintenance.

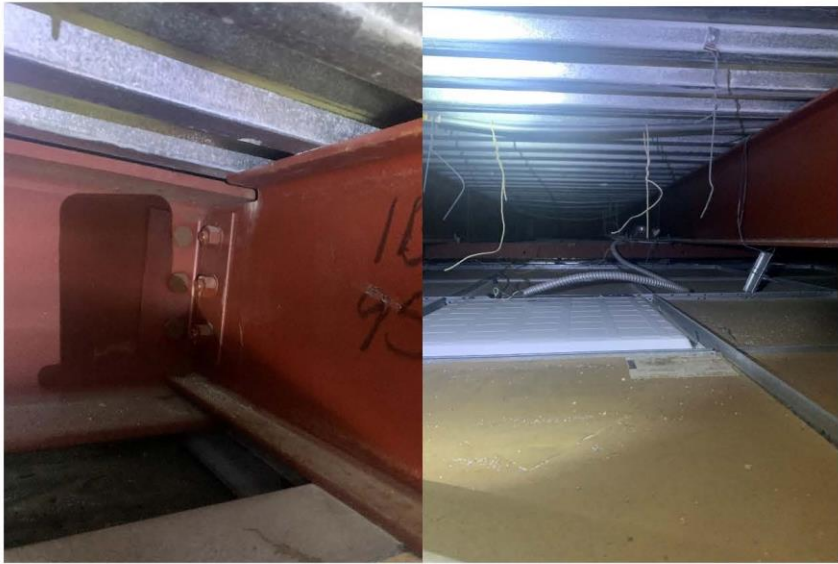
Direction Photo Taken:			
Description:			
<p>Front Canopy with ceiling tile removed looking inwards</p>			
<p>Steel framing and deck with no visible signs of water intrusion or rust. Fair Condition.</p>			
<p>Estimated Life Expectancy:</p> <p>More than 20 years with proper maintenance.</p>			
Photo No. 14	Date: 10/19/23

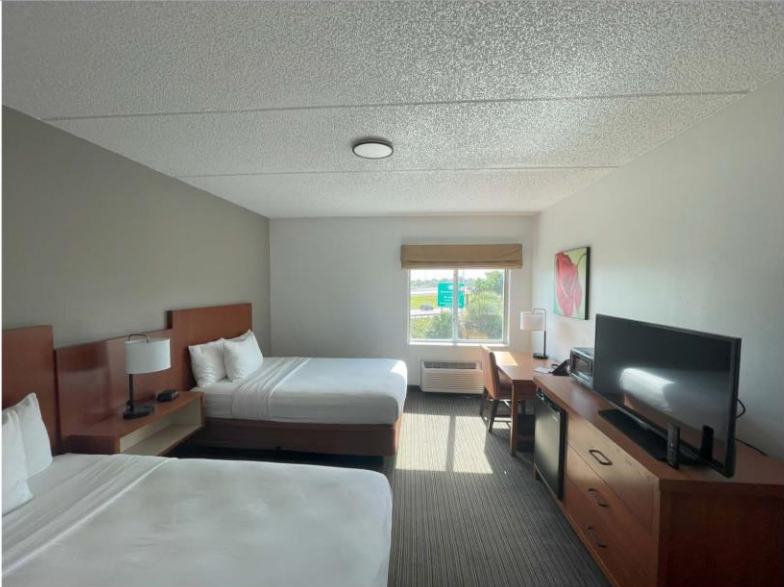
Direction Photo Taken: Double Bedroom looking Inwards		
Description: The bedrooms have drywall ceiling and walls concealing the frame of the building from being viewed. No signs of active water intrusion. Fair Condition.		
Estimated Life Expectancy: More than 20 years with proper maintenance.

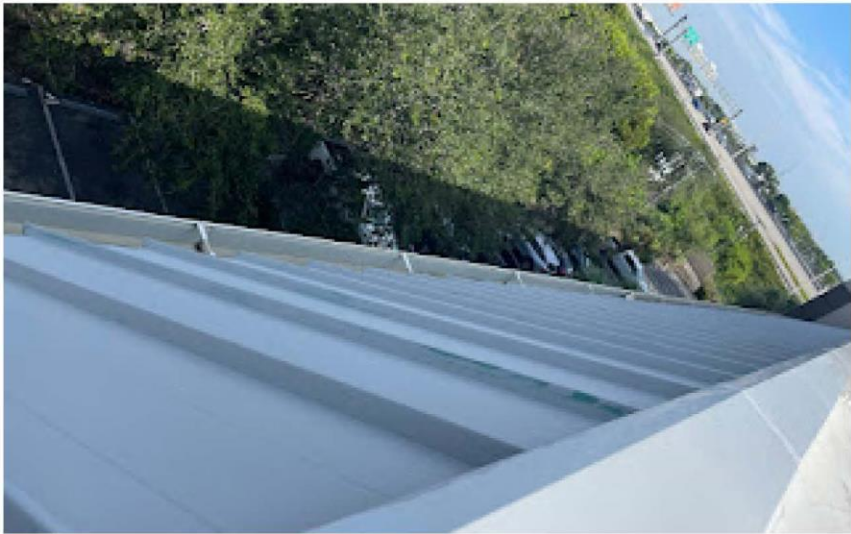
Direction Photo Taken: Roof parapet		
Description: Roof parapet with metal panels Fair Condition. Estimated Life Expectancy: More than 10 years with proper maintenance.

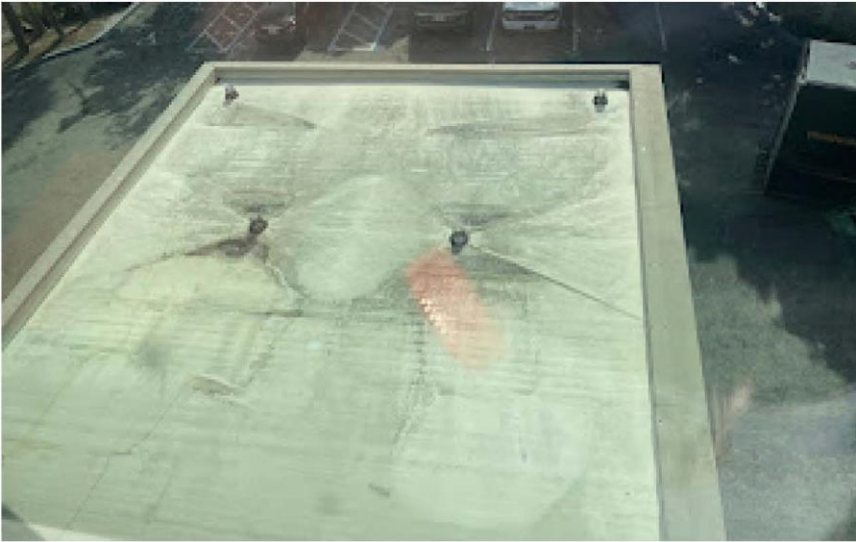
Direction Photo Taken: 2 nd level looking out towards front		
Description: Front canopy roof. No leaks found. Fair Condition.		
Estimated Life Expectancy: More than 10 years with proper maintenance.		
Photo No. 24	Date: 10/19/23

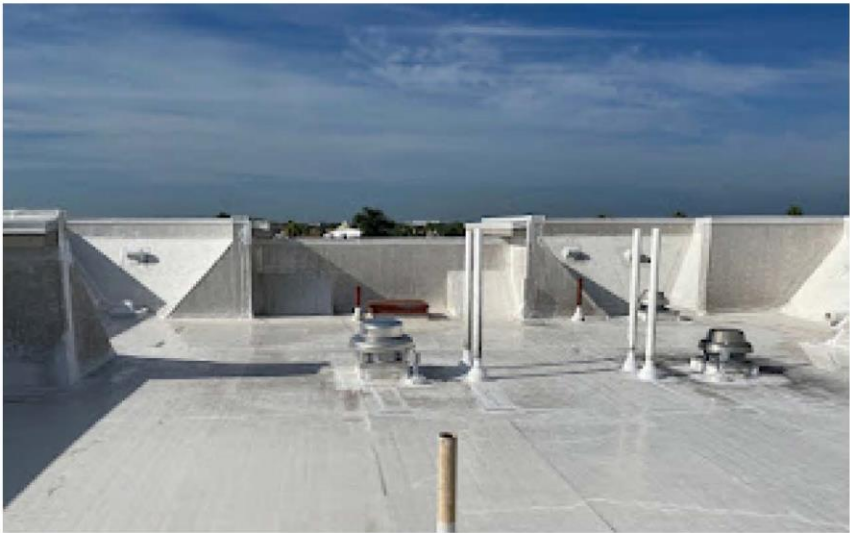
Direction Photo Taken: Roof Overview		
Description: No leaks found. Minor puddling of water. Fair Condition.		
Estimated Life Expectancy: More than 10 years with proper maintenance.
