MIAMI-DADE COUNTY INTERNAL SERVICES DEPARTMENT

La Quinta Inn Physical Condition Assessment

10821 Caribbean Blvd, Miami, FL 33189

ISD PROJECT No. W220057

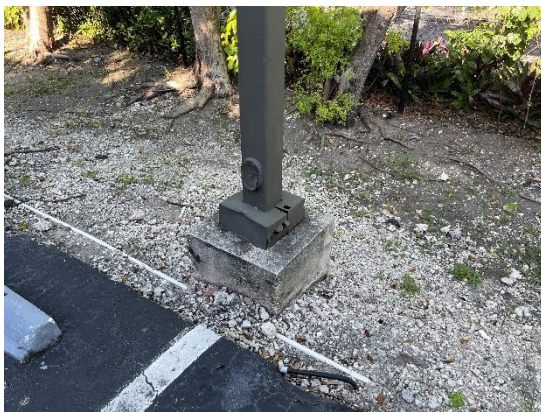
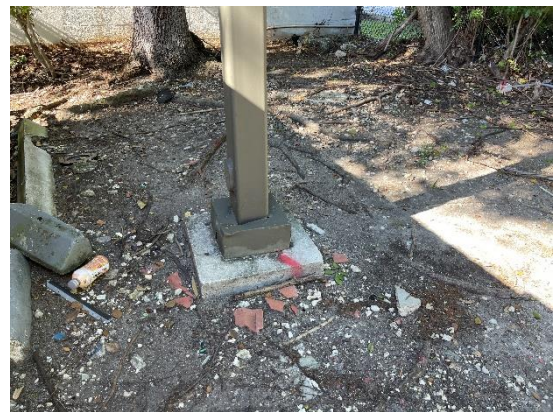
- Parking lot illumination is present in the form of light poles near the outside perimeter of parking lot.
- Light poles include chipped concrete light pole bases and damaged/dented aluminum covers and handhole caps.

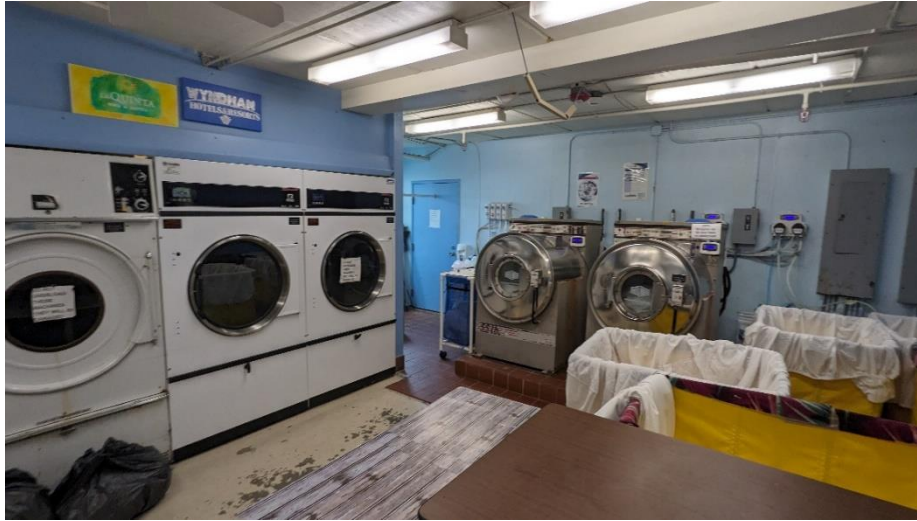
- First floor contains laundry room with industrial washing machines for cleaning of linen used by housekeeping. Flooring is a combination of painted concrete and tiles. Ceiling is exposed with surface mounted linear lighting and exposed ductwork and sprinklers.
- The laundry area also includes electrical panels that are currently blocked by movable linen baskets.
- The Florida Energy Code states that electrical panels shall have a clear 36-inch by 30-inch wide and 6-foot and 6-inch-high space in-front of the panel. Current conditions fail to meet this requirement due to the basket placement.

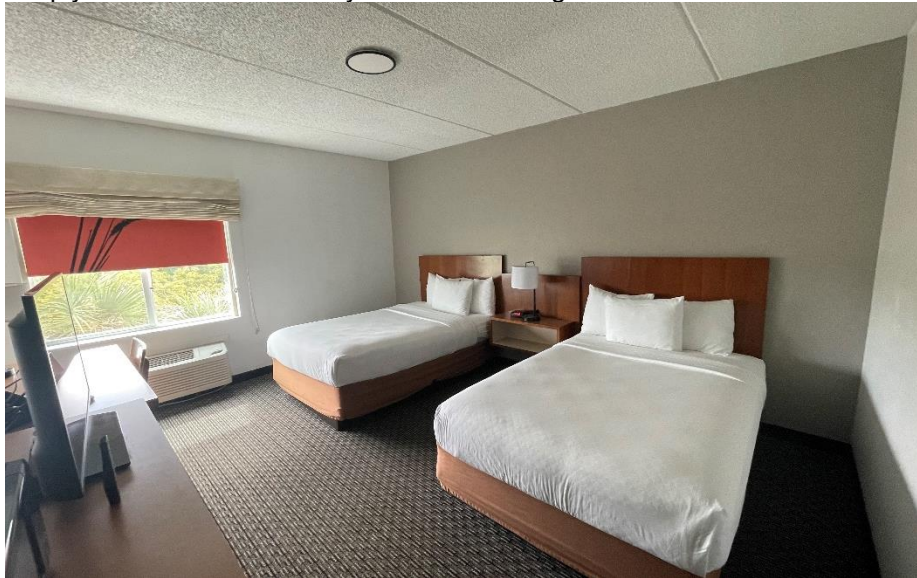
- Typical dwelling units accommodate two queen size beds and a restroom.
- First floor dwelling units include LVT flooring and second, third, and fourth floor rooms include carpet.
- ADA rooms are located on the bottom floor.
- All dwelling units include operable windows, meeting emergency egress requirements. Some windows include a hardware lock keeping windows from opening all the way. Window openings shall comply with FBC & Life Safety for multi-dwelling facilities.

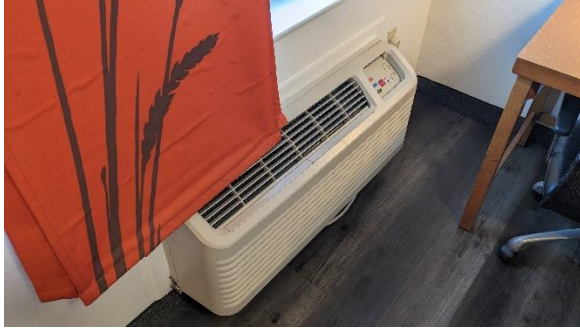
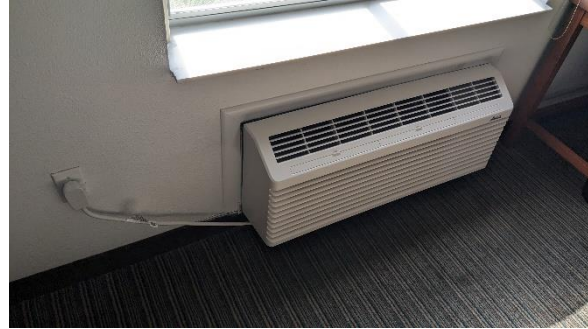
- The packaged terminal air condition units, installed on the exterior walls, are currently being replaced with newer versions. The new PTAC units can be controlled through the wall thermostat. Although the older PTAC units are not connected to the wall thermostat, each room AC includes wiring for possible future connections upon replacement.

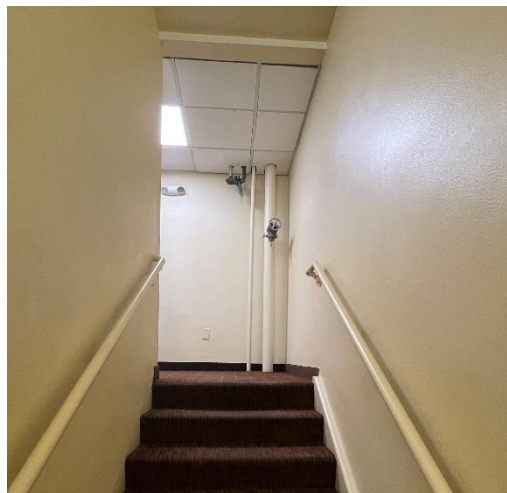
- Stairwells include carpet throughout. While carpet in egress stairs is not a code violation, proper maintenance is suggested to avoid tripping hazards and potential indoor air quality related issues for the future occupants.

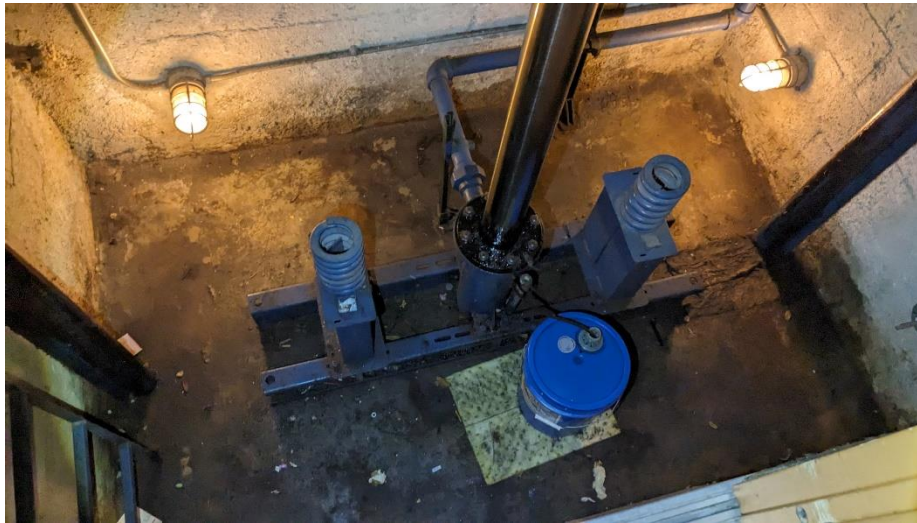
- The pit of the elevator shaft does not contain a drain or sump pump to remove any oil leaking. However, the elevator pit includes a drain bucket to collect minor leaks; this bucket is placed on a cloth and does not seem to be fixed to the floor. While a drain bucket at the base of an elevator shaft is common for the elevator shafts without a drain or pump, it's important to affix the bucket to the floor to avoid any loose items that may risk the safety and operation of the elevator.

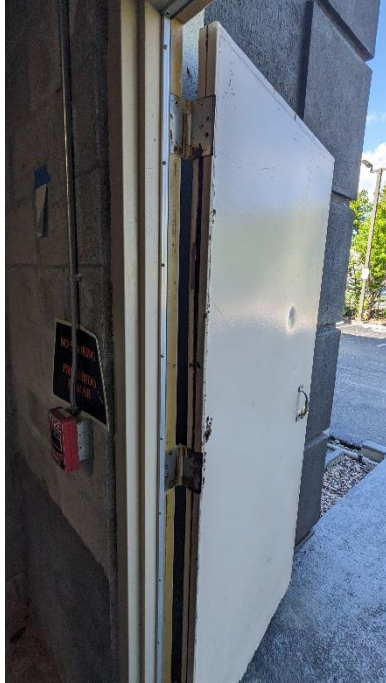
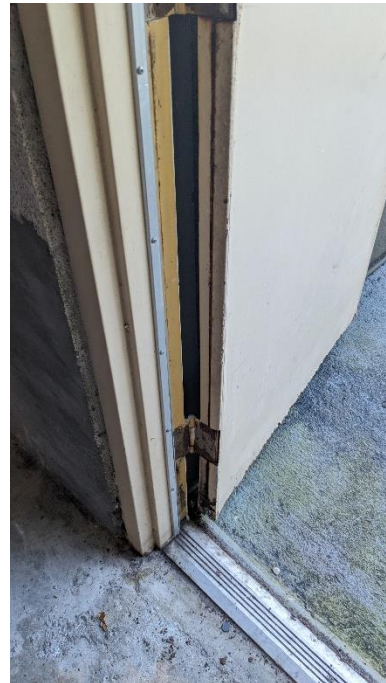
- Interior and exterior doors seem to be in acceptable conditions.
- All doors in dwelling units have a door closer except for the hotel manager's suite which is not currently being used as a suite but as a storage area.
- Multiple doors and door frames are missing or have painted over their fire rated tags and fire rating needs to be confirmed through the door manufacturer.
- Some first-floor exterior doors have some minor coating/paint peeling, particularly the door jambs. This peeling should be recoated for proper maintenance and ensure longevity and protection of doors from corrosion.

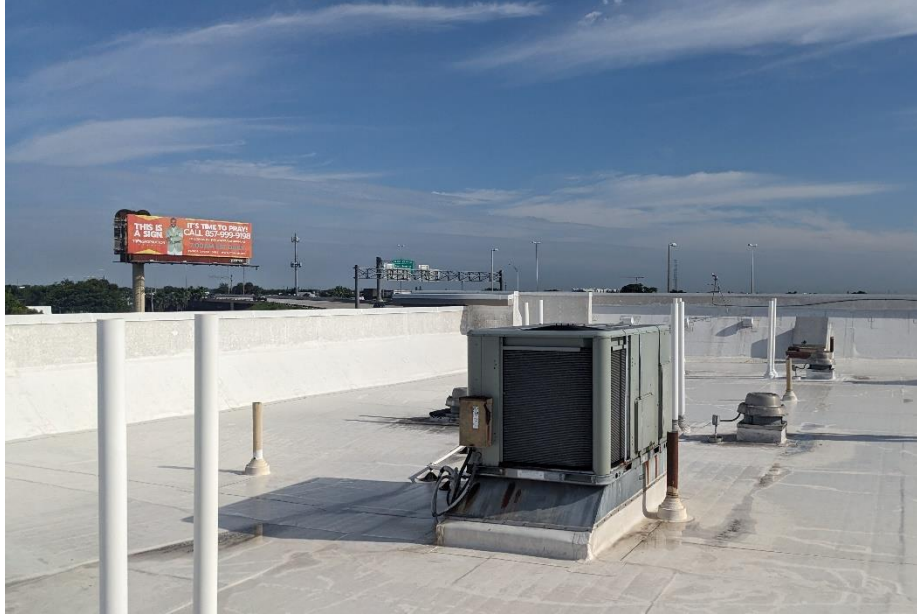
- Roof assembly was replaced through permit process with the City of Cutler Bay on 2013, with seemingly TPO membrane over rigid insulation. Roof seems to be in acceptable condition.
- Cant strips are not installed during areas where a 90-degree surface meets the roof. Installation of cant strips are recommended.
- Roof is experiencing minor ponding.
- Majority of roof membrane weathering is located at roof apertures for rooftop equipment, such as condenser units and exhaust fans.

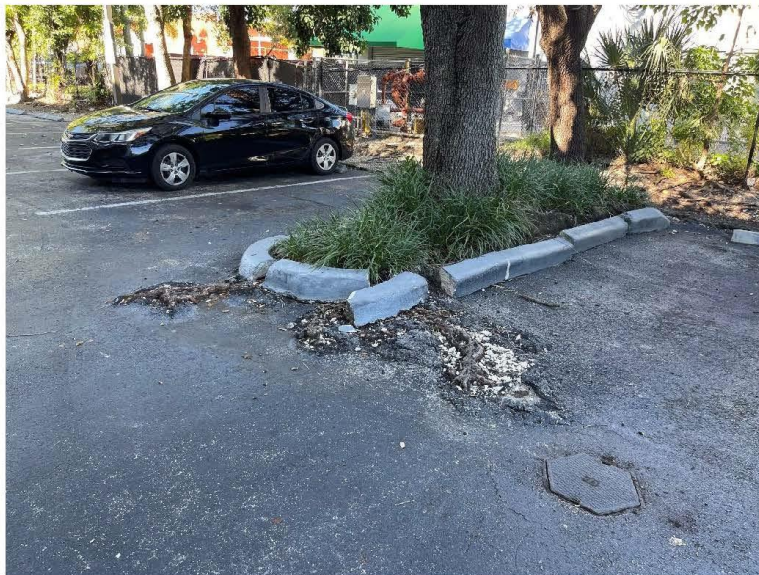
Photo No.
4

Tree roots damaging parking lot asphalt as well as the curbs.

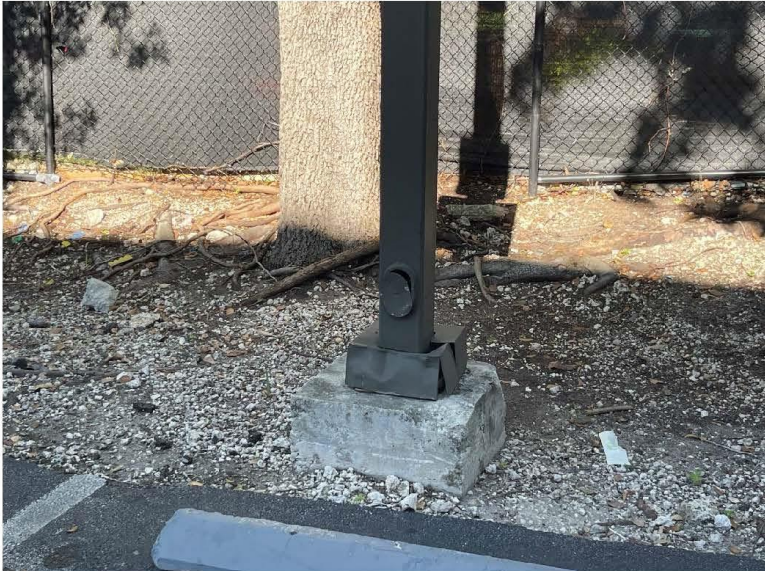
Direction Photo Taken: Northwest		
Description: Damaged exterior light fixture base, around 20 throughout property.

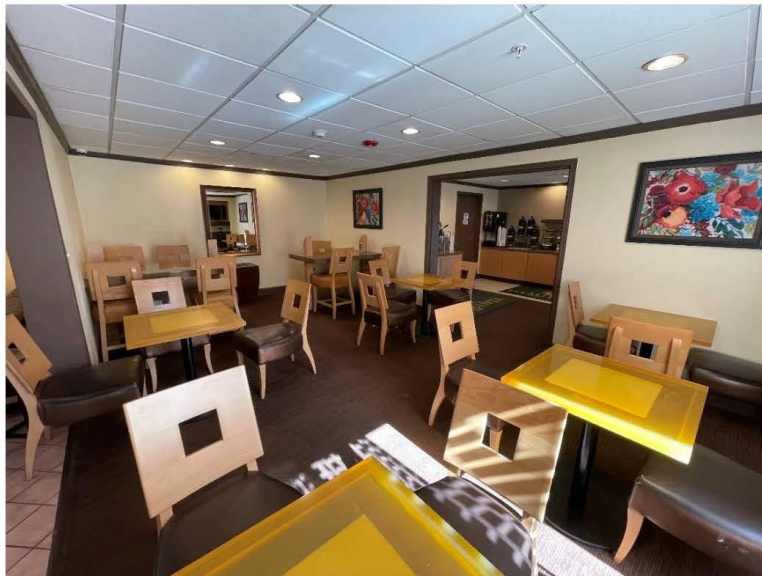
Dining area with carpet flooring and stained acoustic ceiling tiles. No existing water damage found.

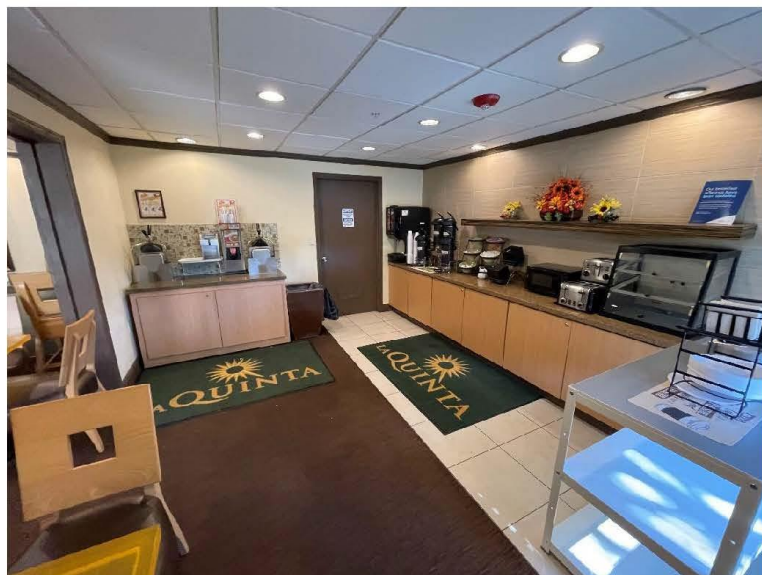
Photo No.
14

Dining Preparation Area with carpet and tile flooring and stained acoustic ceiling tiles. No existing water damage found.

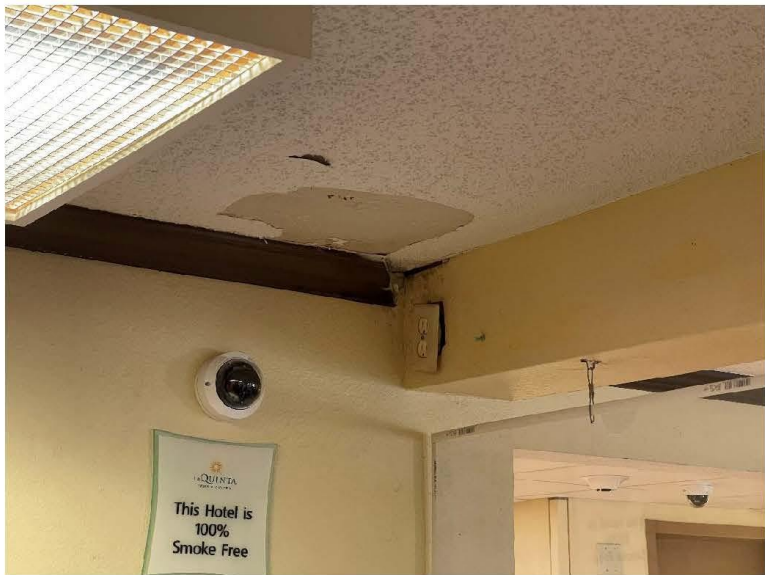
Direction Photo Taken: Toward Ceiling		
Description: Damage on popcorn ceiling of front desk area.

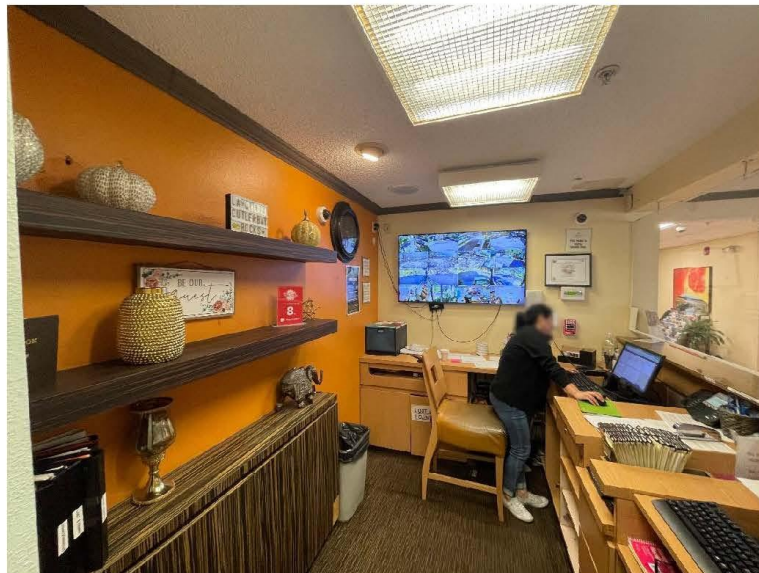
Photo No.
22

Typical front desk area with damaged popcorn ceiling.

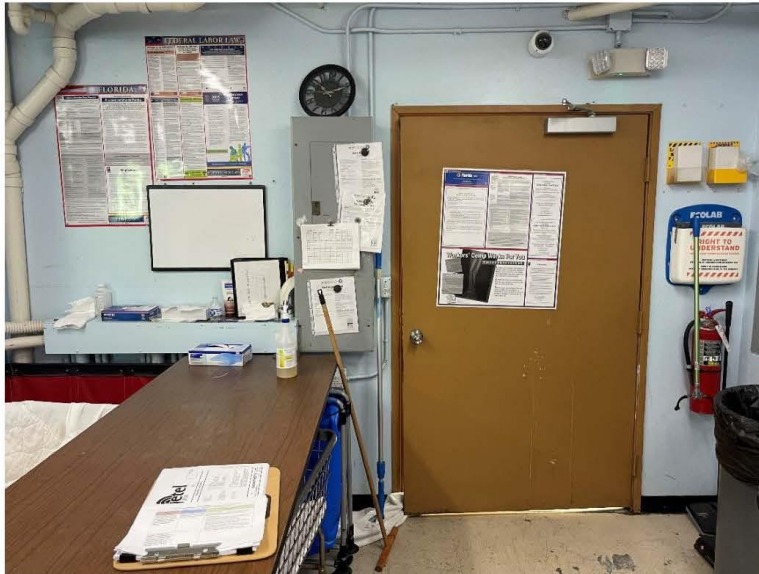
Door to the Laundry Room, electrical panels do not meet clearance requirements. Furniture is not fixed and can be moved to meet clearances.

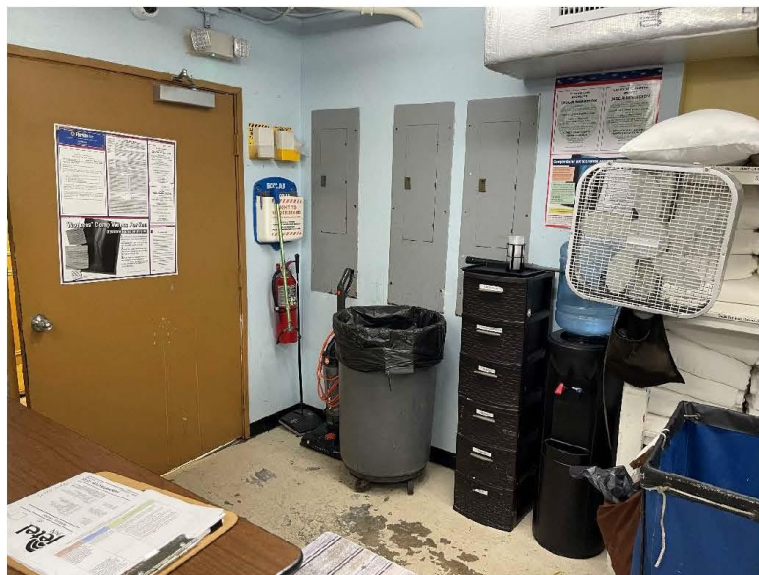
Photo No.
24

Laundry Room, electrical panels do not meet clearance requirements. Furniture is not fixed and can be moved to meet clearances.

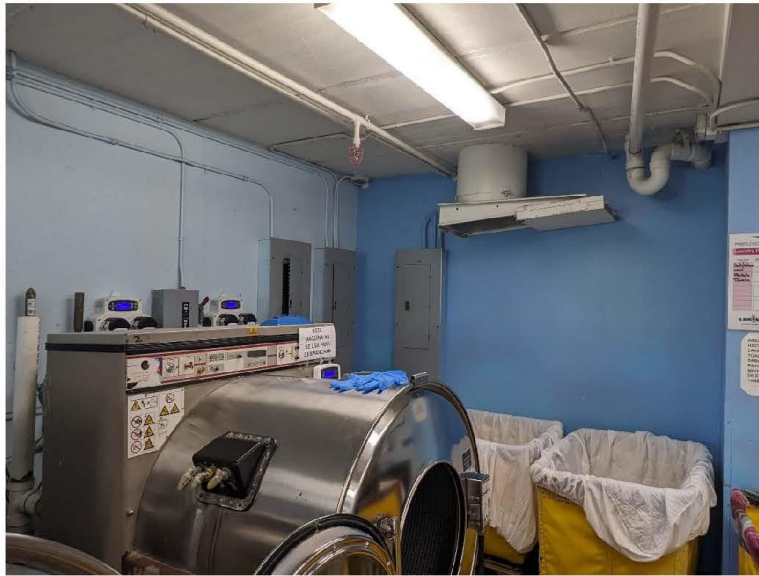
Laundry chute, electrical panels and industrial dryer. Electrical panels do not meet clearance requirements. Furniture is not fixed and can be moved to meet clearances.

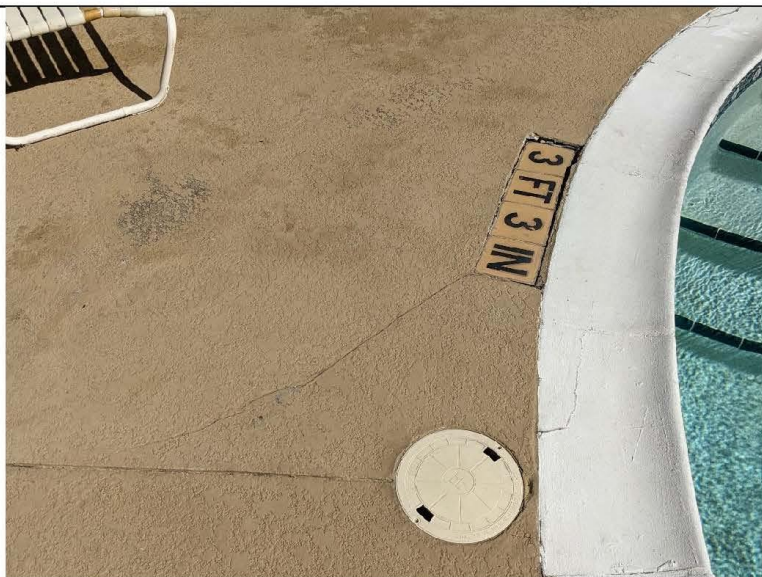
Photo No.
32

Cracks on pool deck slab

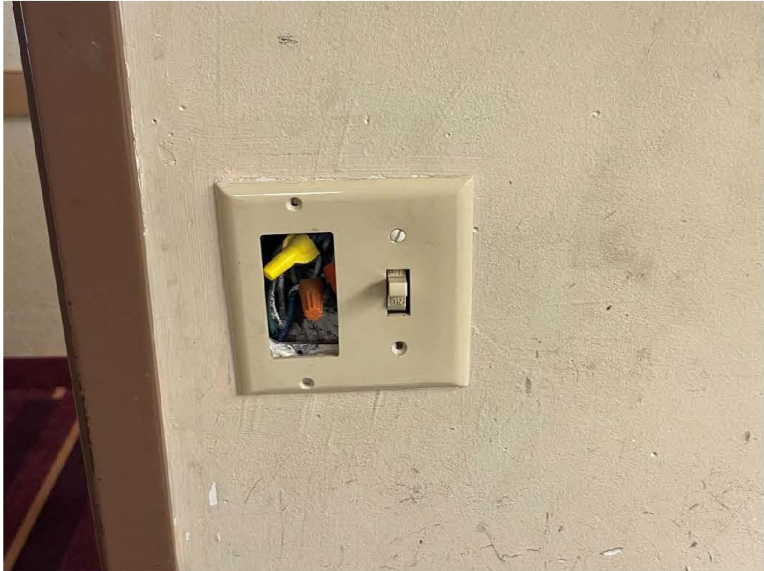
Direction Photo Taken: N/A		
Description: Exposed cabling in light switch in maintenance storage room.

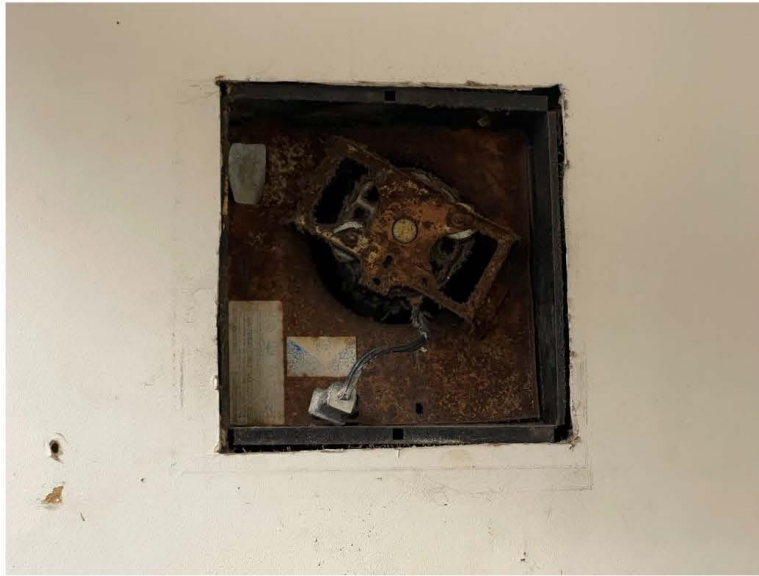
Exposed and rusted exhaust fan in storage rooms. Poor working conditions.

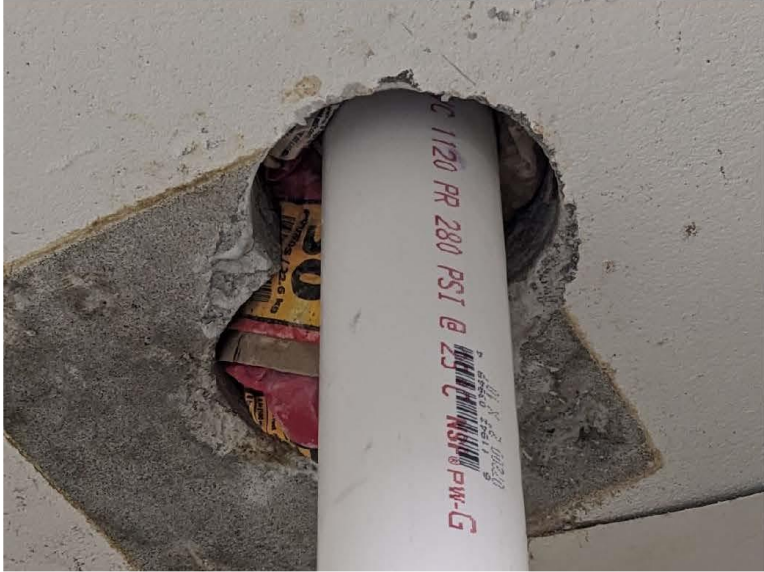
Direction Photo Taken: N/A		
Description: Perforation on gypsum hard ceiling.		
Photo No. 52	Date: 10/19/23

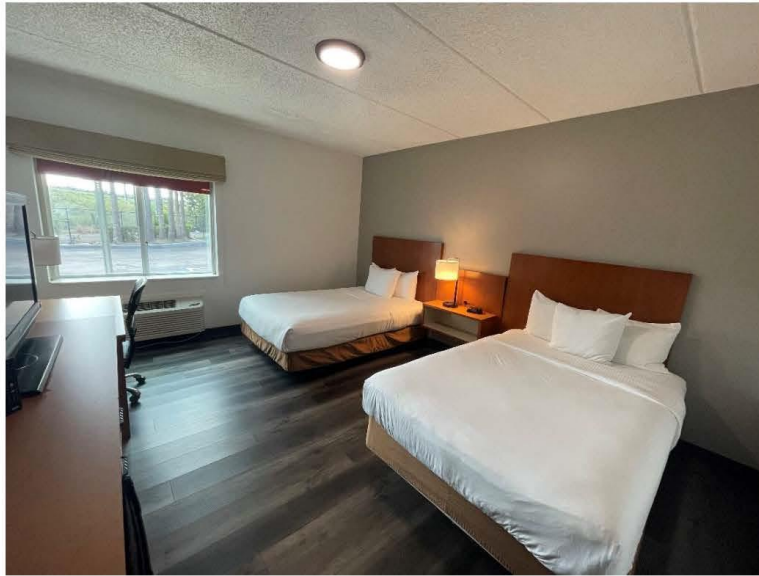
Typical 1st floor Dwelling Unit.

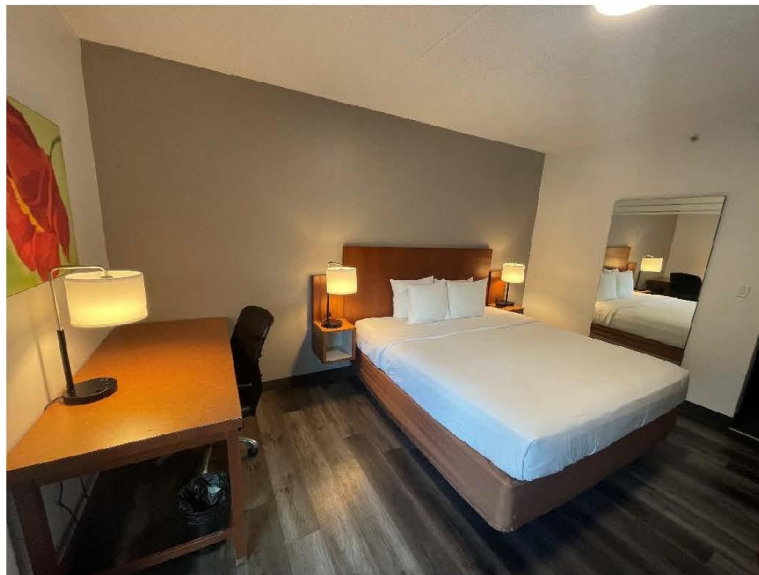
Photo No.
56

Typical 1st floor Dwelling Unit.

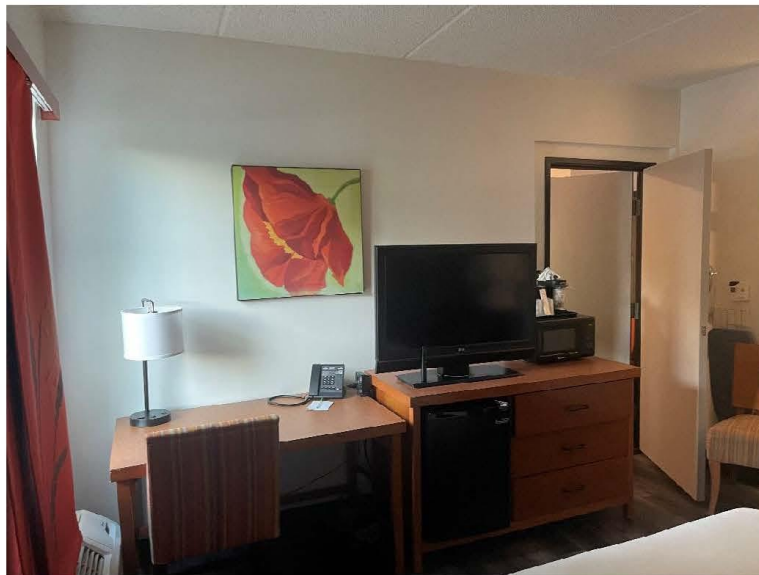
Photo No.
62

Rooms with connecting doors in between each room. Found in 5 dwelling units, 2 on 1st floor and 1 on 2nd, 3rd, and 4th floor.

- Electrical panels in all areas, specifically in laundry room, to have proper clearance.
- If the connecting dwelling unit rooms are to be repurposed as one apartment units, connecting doors should be removed and replaced with a single door with appropriate bedroom-lock-style hardware.

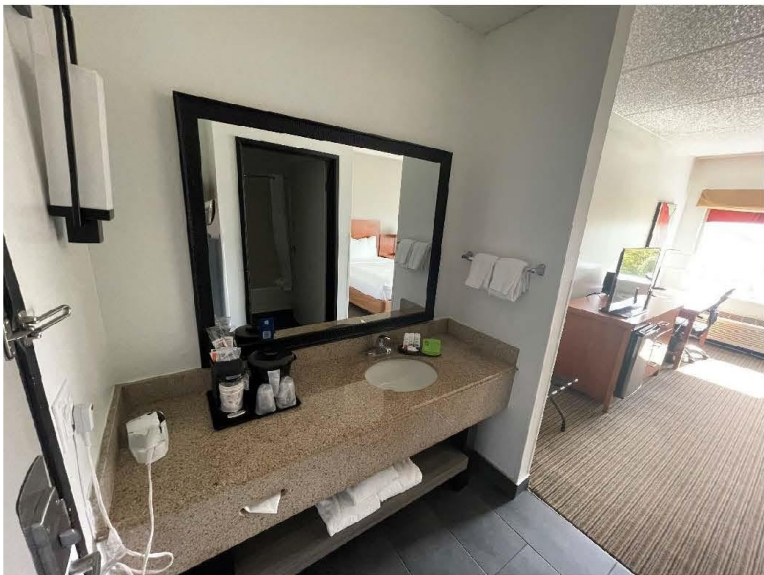
Direction Photo Taken: Northwest		
Description: Entrance to Dwelling Units. Existing Doors equip with Door Closers. Bathroom hand sink and reduced counterspace found in 16 units due to chase for ductwork, in each floor.		
Photo No. 64	Date: 10/24/23

Direction Photo Taken: Southeast		
Description: Typical entrance to Dwelling Units. Typical bathroom hand sink and counterspace with outlets.

- Missing and Damaged Downspouts throughout the exterior of the building should be replaced and repaired.
- Add fixed basin to bathroom (see layout.)
- Add kitchenette at entry corridor (see layout.)

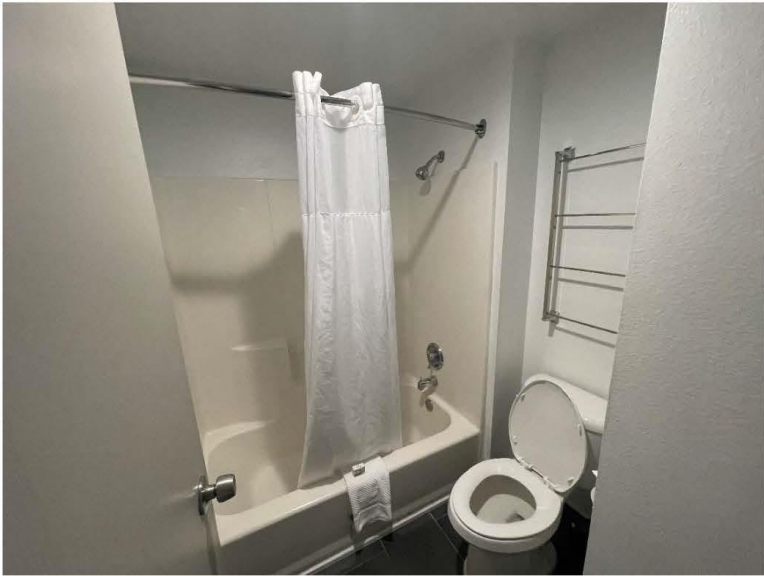
Direction Photo Taken: N/A		
Description: Typical bathroom in dwelling units with bathtub.		
Photo No. 66	Date: 10/24/23

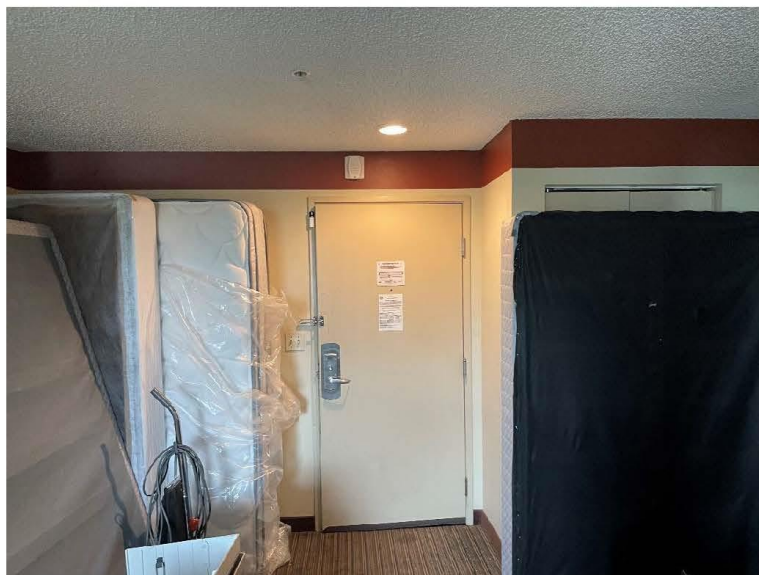
Photo No.
74

Hotel manager's suite entrance – suite not used as intended use, currently used as storage – missing door closer.

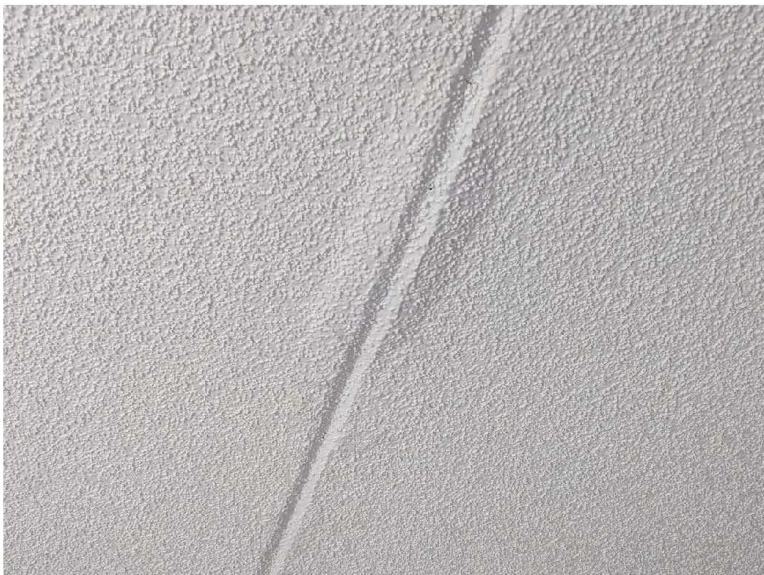
Direction Photo Taken: N/A		
Description: Slight damage found in ceiling. No existing liquid damage of any kind found.

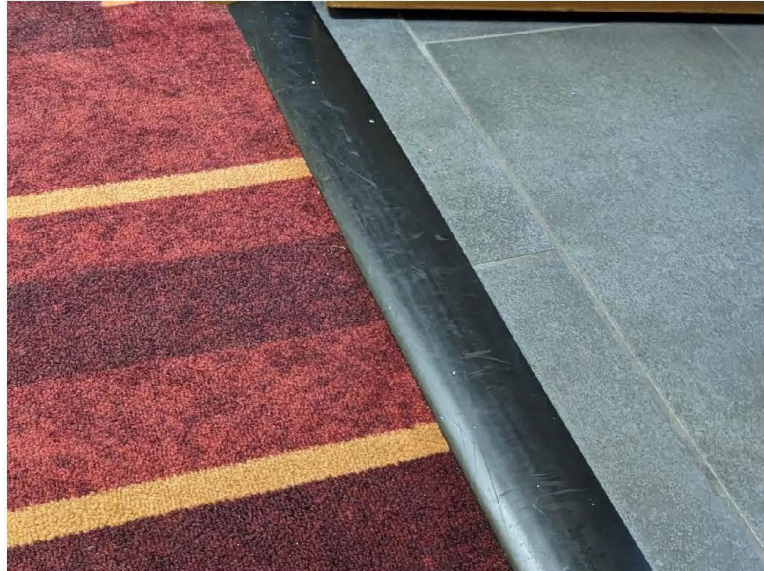
Direction Photo Taken: N/A		
Description: Threshold between Hallway carpet finish and Room VCT finish

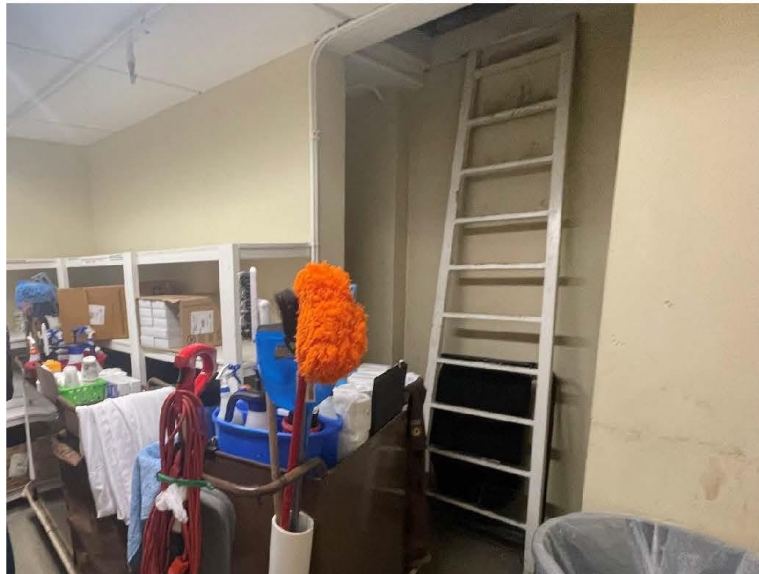
Ladder towards roof access – Ladder seems to be in good conditions, attached to the wall.

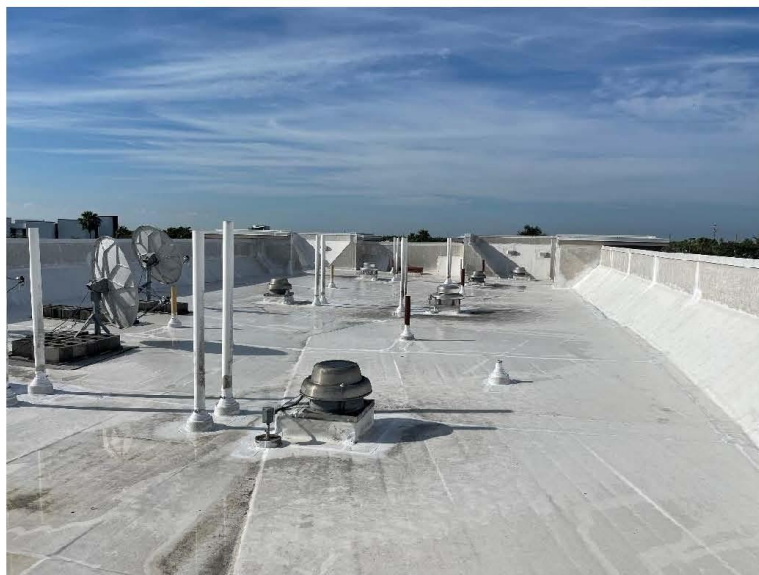
Photo No.
82

Roof, roof components and penetrations – all seems to be in good state.

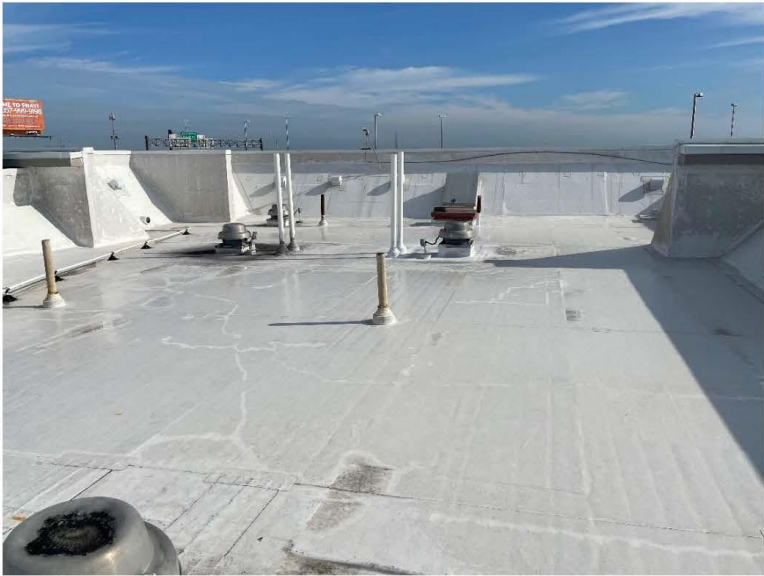
Direction Photo Taken: Northeast		
Description: Roof, roof components and penetrations – all seems to be in good state.		
Photo No. 84	Date: 10/10/23

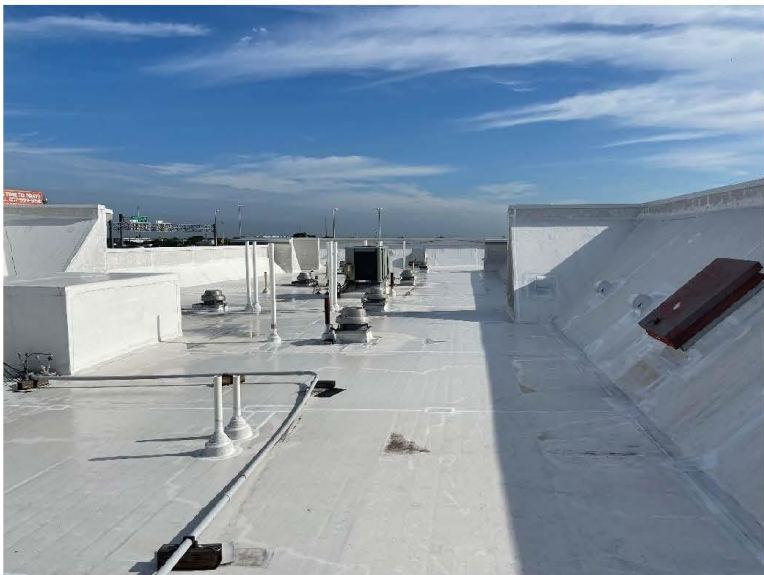
Direction Photo Taken: Northeast		
Description: Roof, roof components, and roof hatches. (2) Roof hatches for Roof Storage Area - all seem to be in good state.

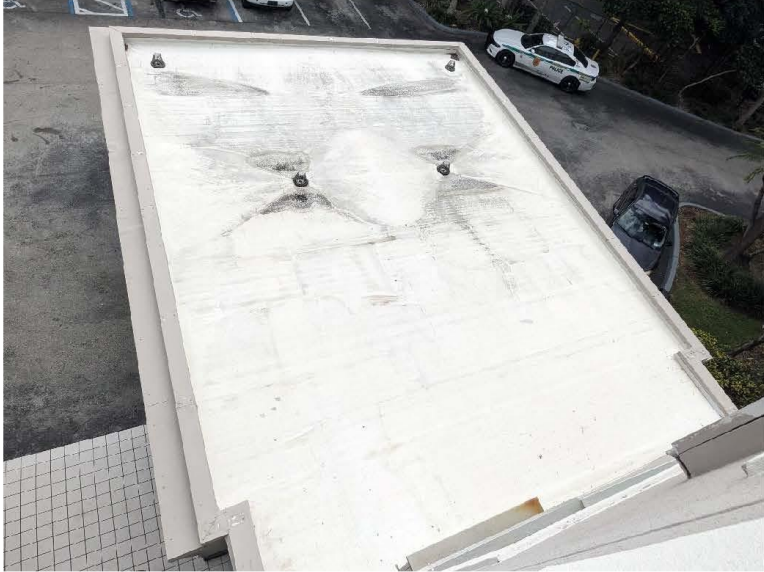
Direction Photo Taken: Southeast		
Description: Roof of entrance carport canopy and drainage. Stains of ponding, typical, no damage found. Canopy no longer has decorative railing on top as shown on photo #105.		
Photo No. 90	Date: 10/24/23

- Carport Canopy should be repaired and 9'-0" clearance sign to be added on all entry/exit sides.
- Replacing metal bases of exterior lighting posts.
- Confirm with door manufacturers that door frames are fire rated due to missing tags.

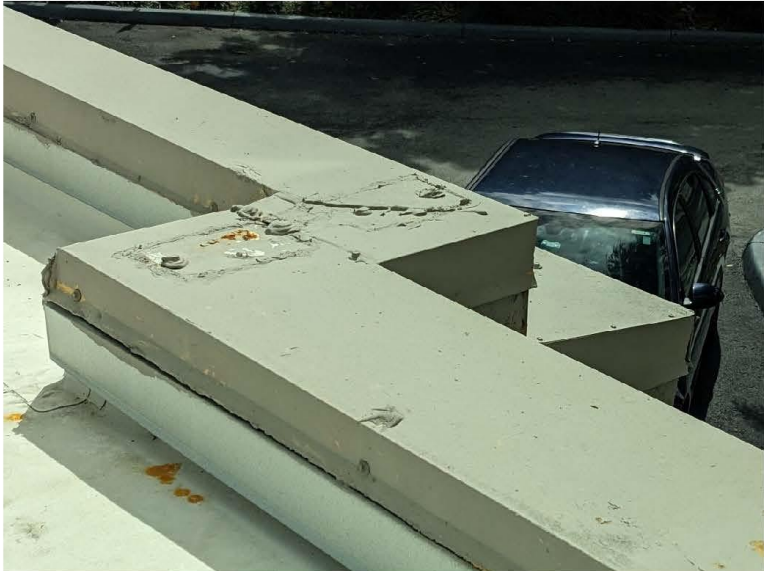
Direction Photo Taken: N/A		
Description: Flashing on entrance carport canopy roof with rust and markings of previous decorative railing as seen on photo #105.

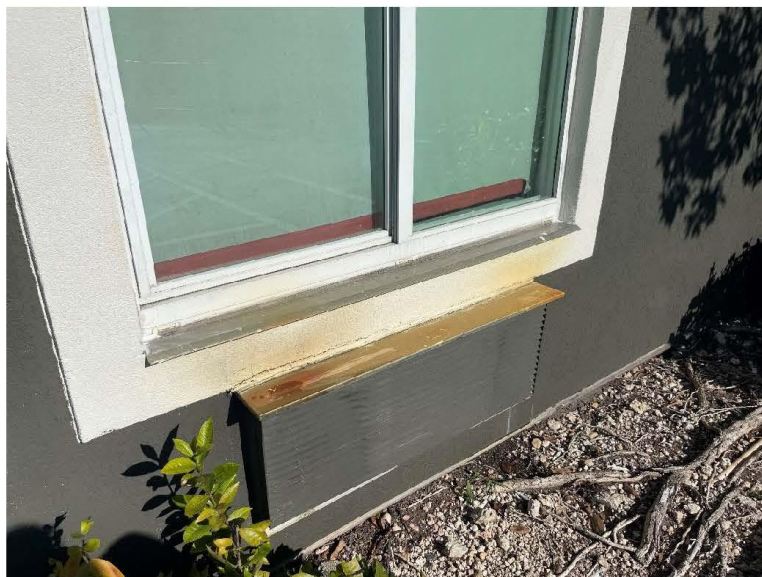
Photo No.
92

Rust above cover of individual packaged terminal air conditioning (PTAC) causing staining on window sill – typical.

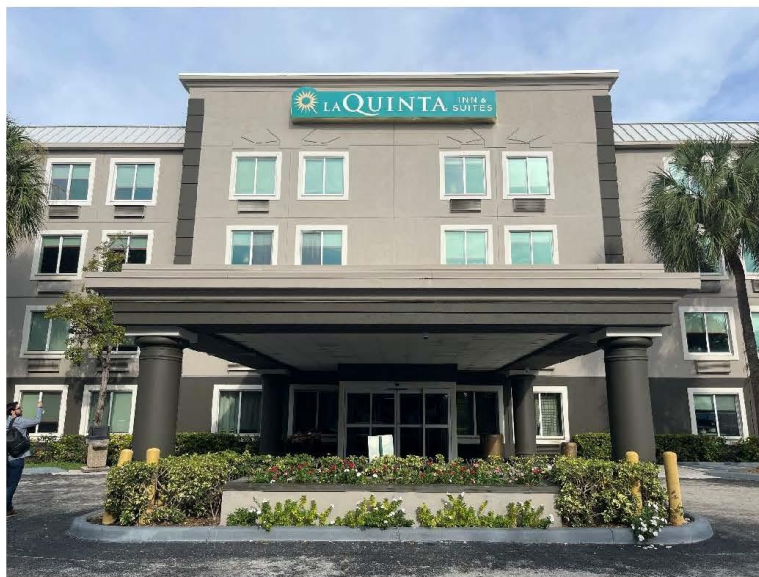
Photo No.
96

Northeast Façade, entrance carport canopy. Seems to have no major damages except for construction foam damage on side, see photo #5. Canopy no longer has decorative railing on top as shown on photo #105.

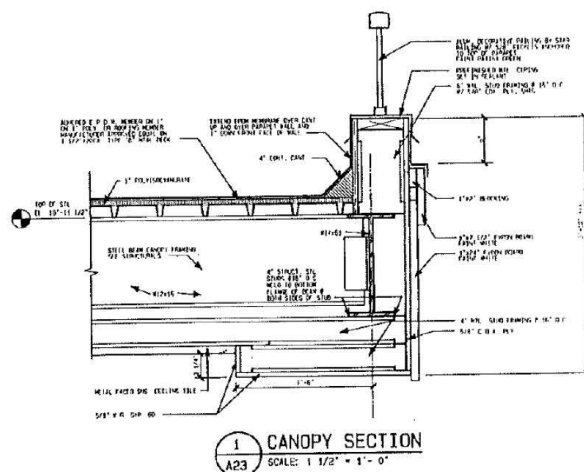
Canopy Section from Budgetel Inn Set by Richard F Steldt. Architects LTD showing how original entrance carport canopy had a decorative railing which was removed.

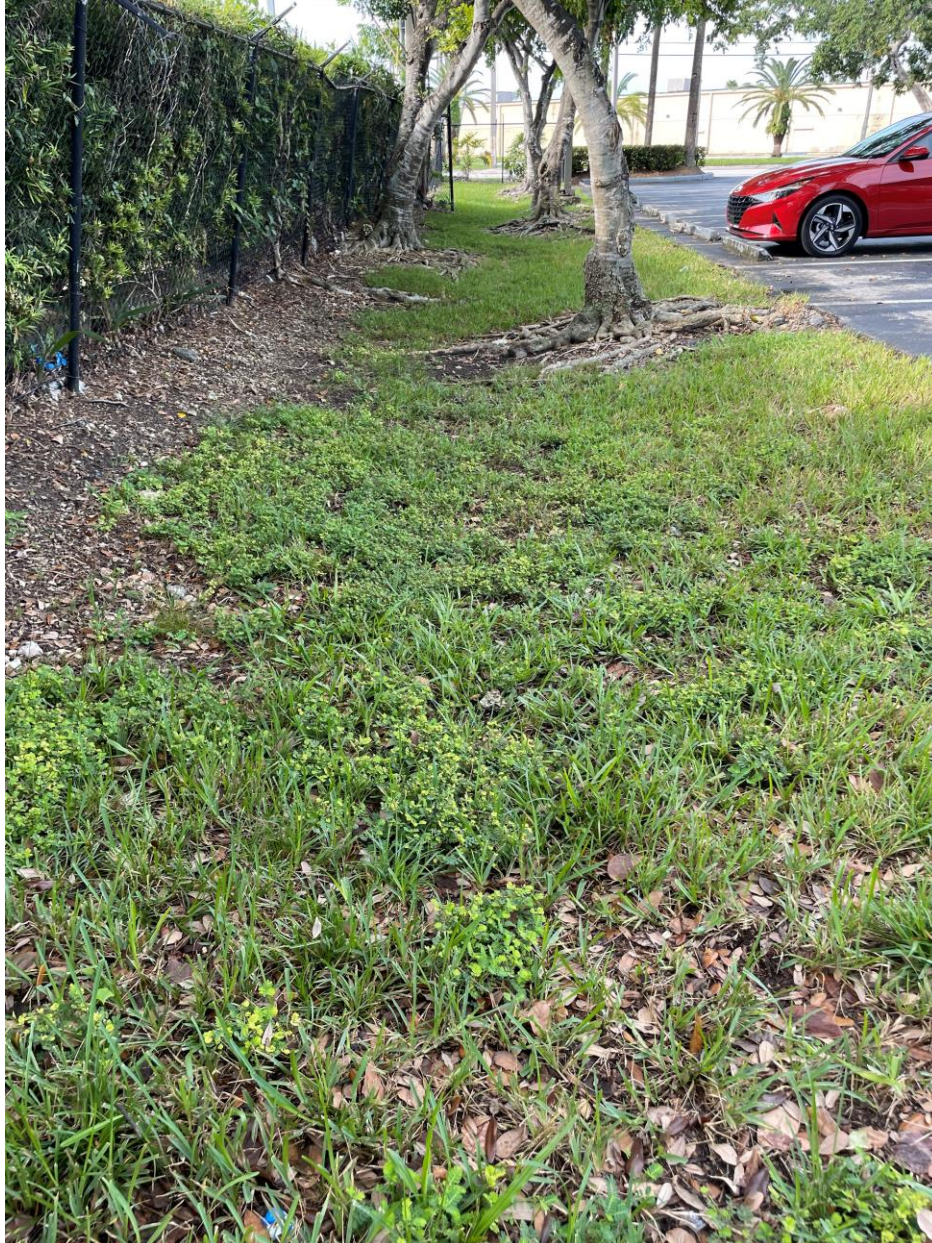
18.2.2.2 **SWALE 2**

The swale was originally designed to measure approximately 150 feet in length, 20 feet in width, and 2.5 feet in depth. However, under current conditions, it has experienced significant degradation, resulting in a reduced depth of only 1.1 feet. Additionally, the area is now occupied by 5 trees that may require removal. It is imperative that the swale undergoes repairs to restore its intended functionality. The recommended actions for this swale include root pruning, possible tree removal, and swale regrading.
