MIAMI-DADE COUNTY INTERNAL SERVICES DEPARTMENT

La Quinta Inn Physical Condition Assessment

10821 Caribbean Blvd, Miami, FL 33189

ISD PROJECT No. W220057

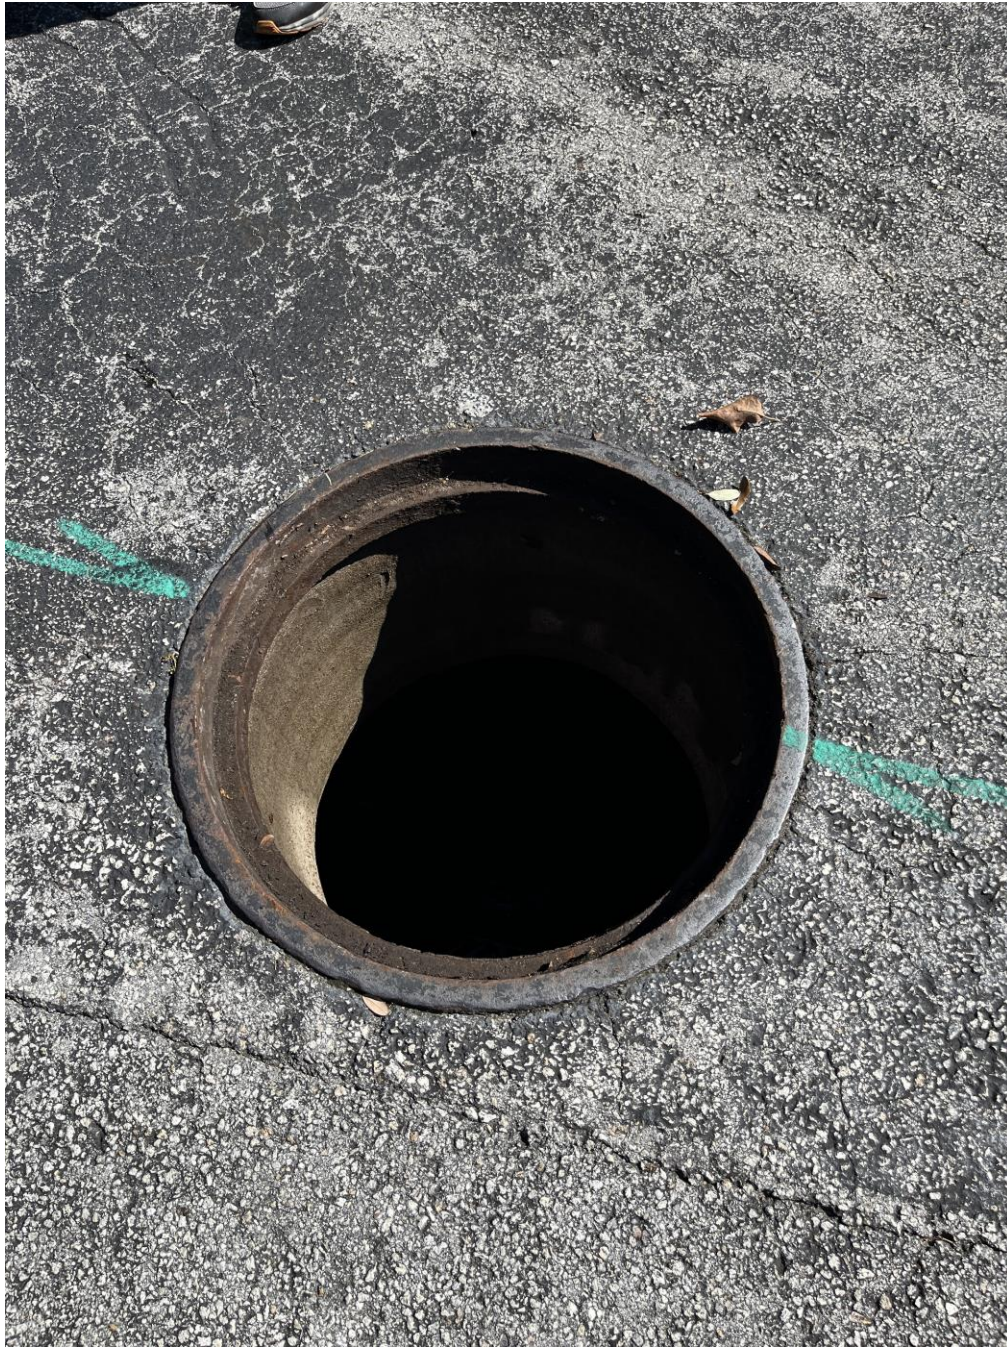
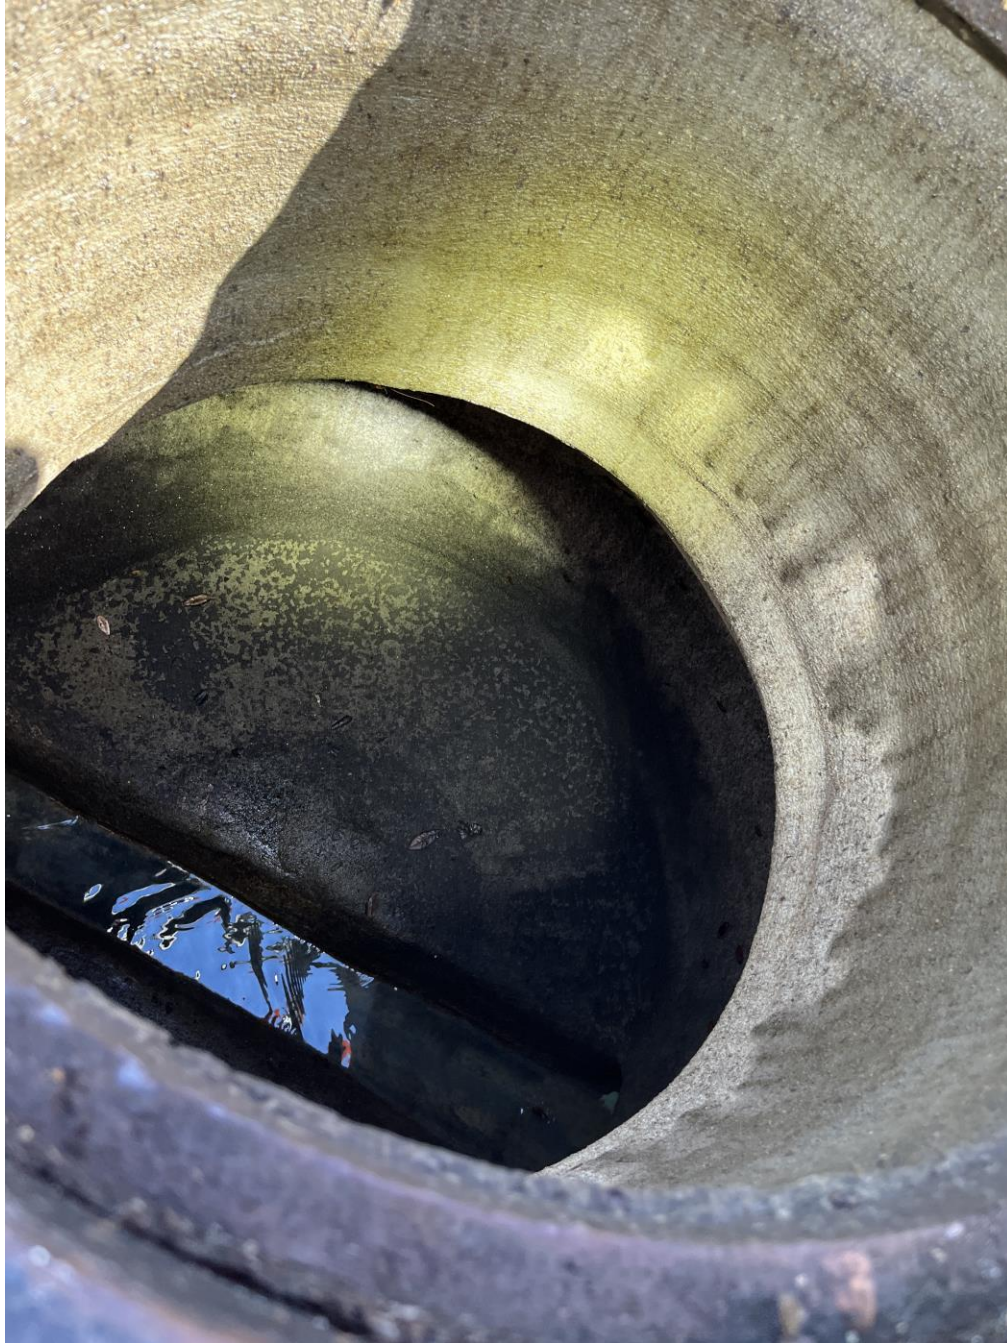
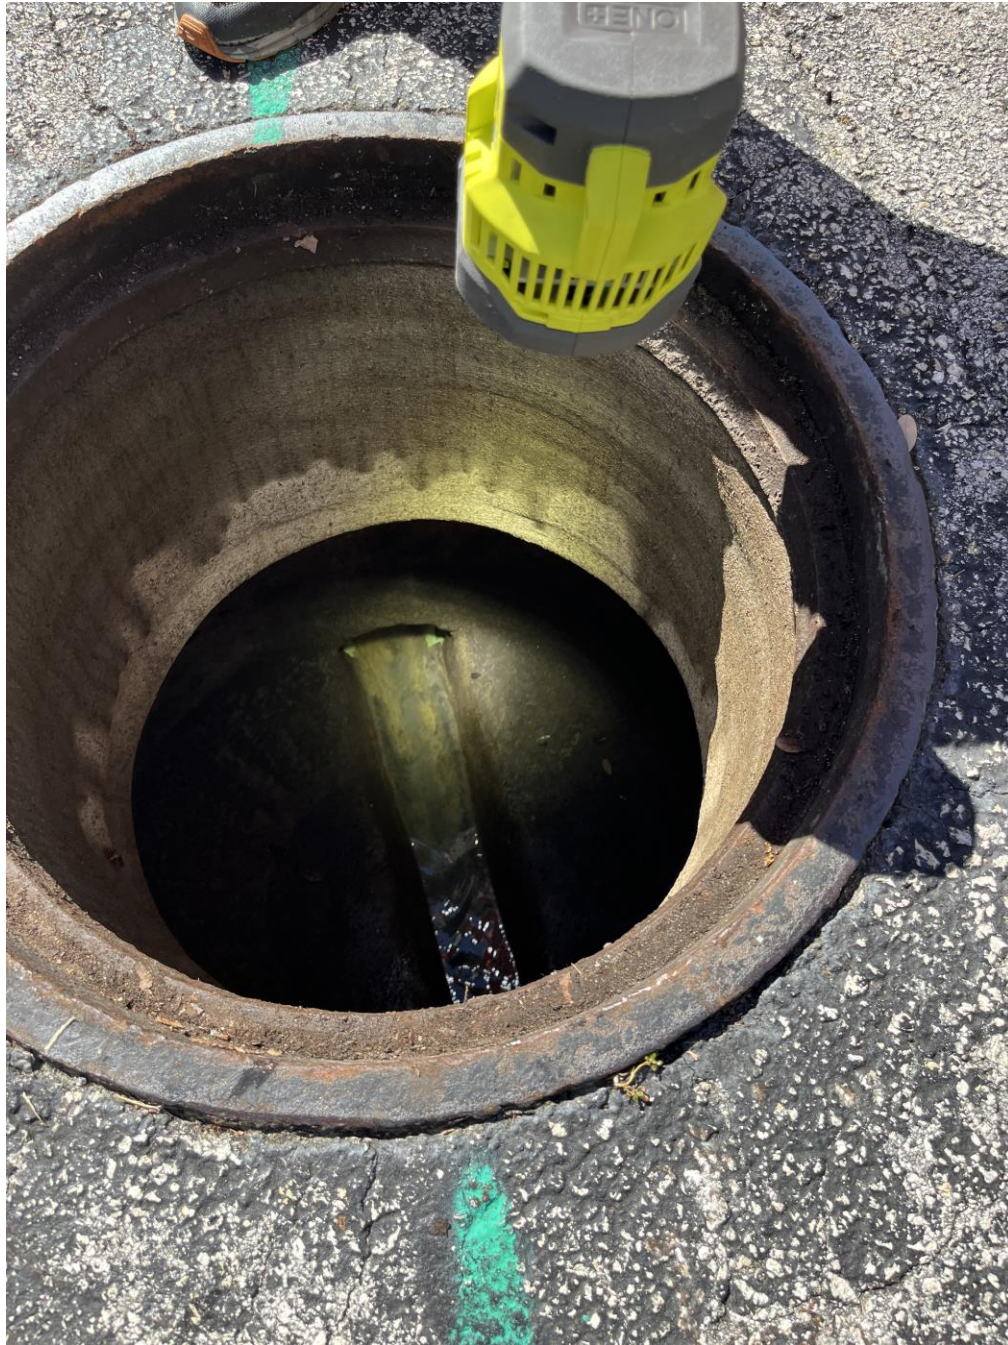
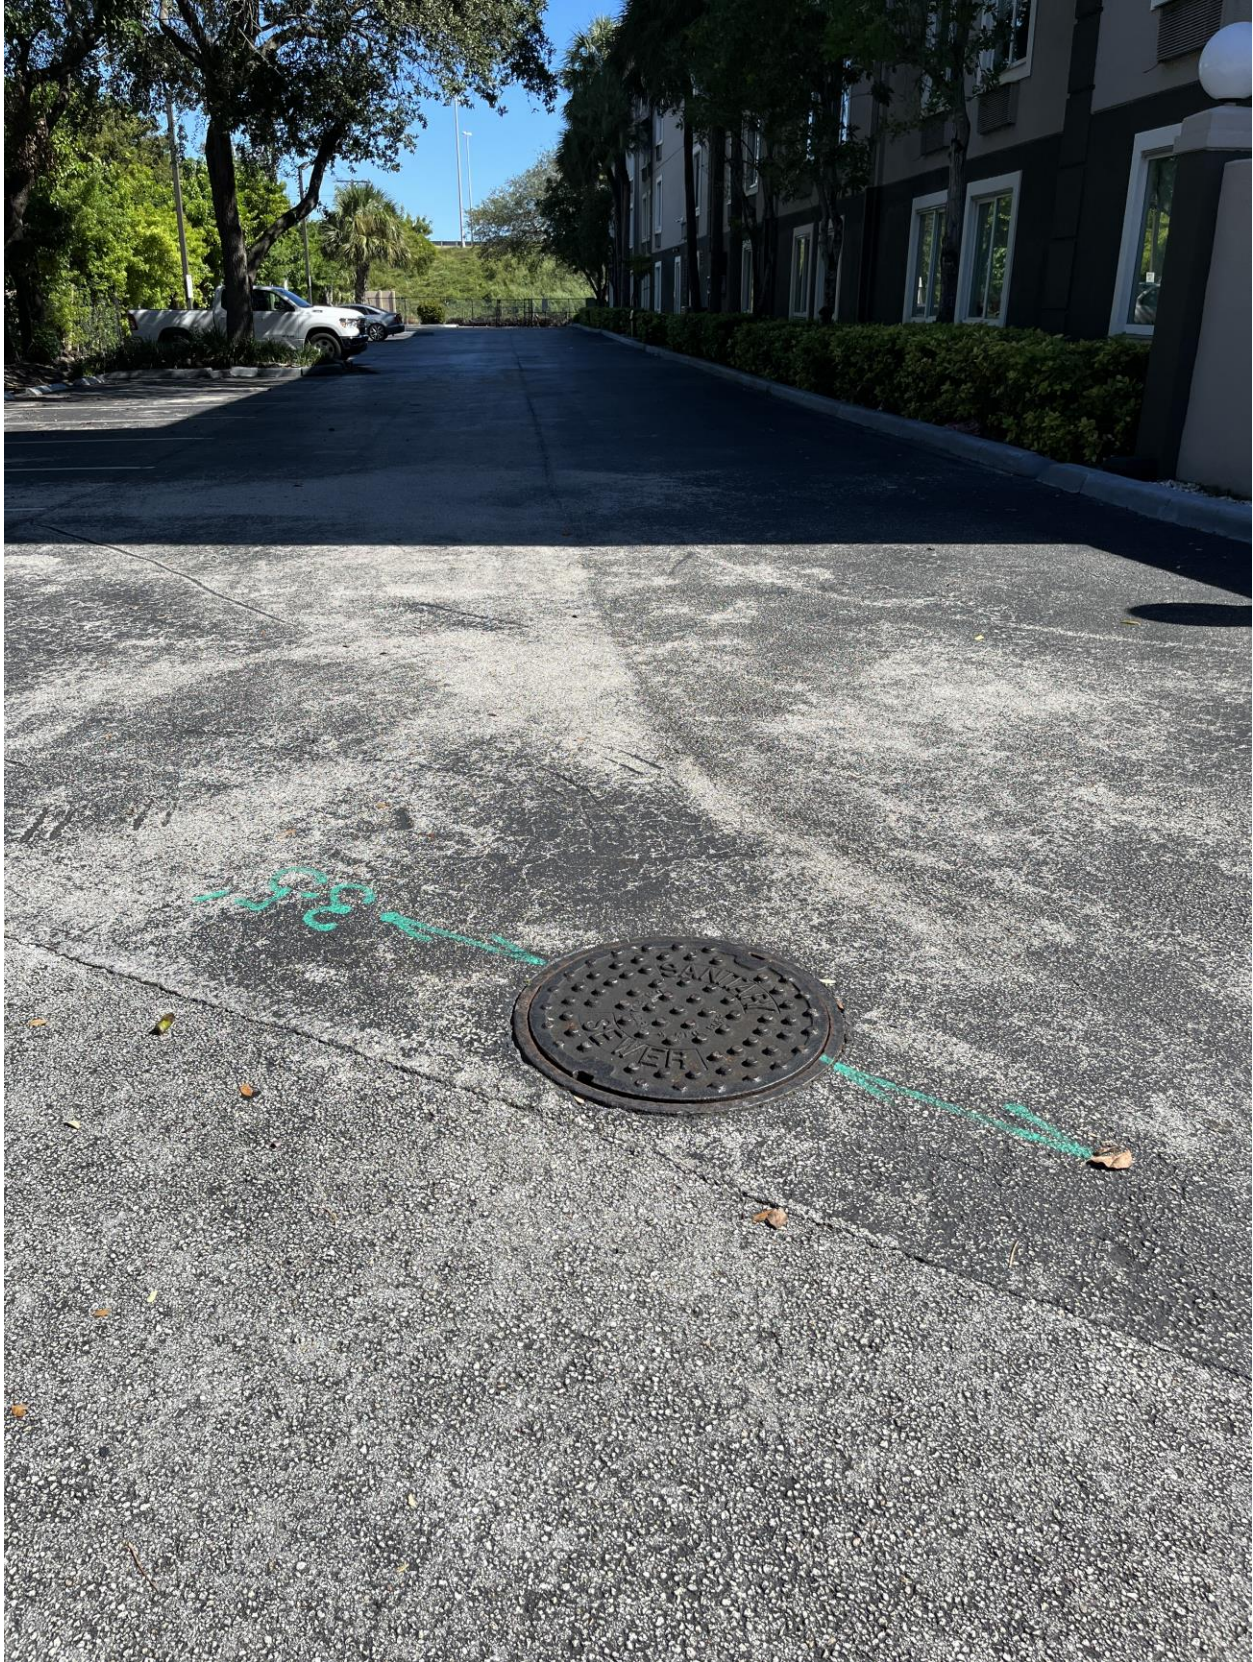
18.3.3 MANHOLE 3

Discrepancies were observed between the as-built plan and the actual field conditions, specifically in the case of Manhole 3. While the as-built plan indicated three pipes, our field inspection revealed that Manhole 3 only contains two pipes. Additionally, the pipe connecting the 6-inch cleanout which we assume collect and conveys the sewer flows from this building to the Manhole 3, as indicated in the plan, is not present in the field.

As a result, it is recommended that the county take steps to unify and rectify the as-built information by combining accurate and valuable data from both sources. This combination will ensure a comprehensive and accurate representation of the sewer system. We assess that the sewer system is constructed according to the ES6912-1 as-built, and we can attribute any elevation issues to a minimal datum difference. Importantly, the sewer system is functioning correctly, and based on our evaluation, no further actions are recommended for the sanitary sewer system.

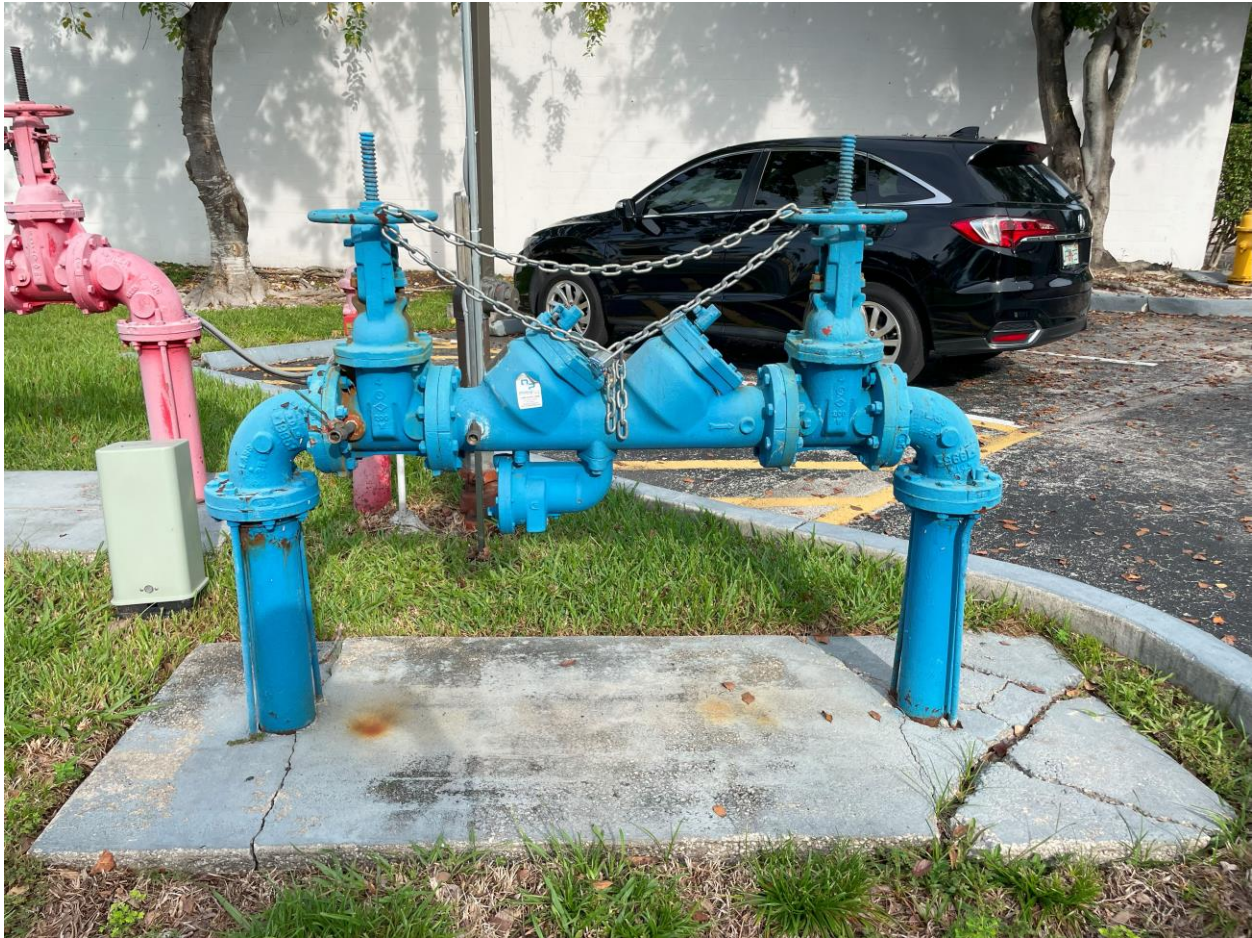
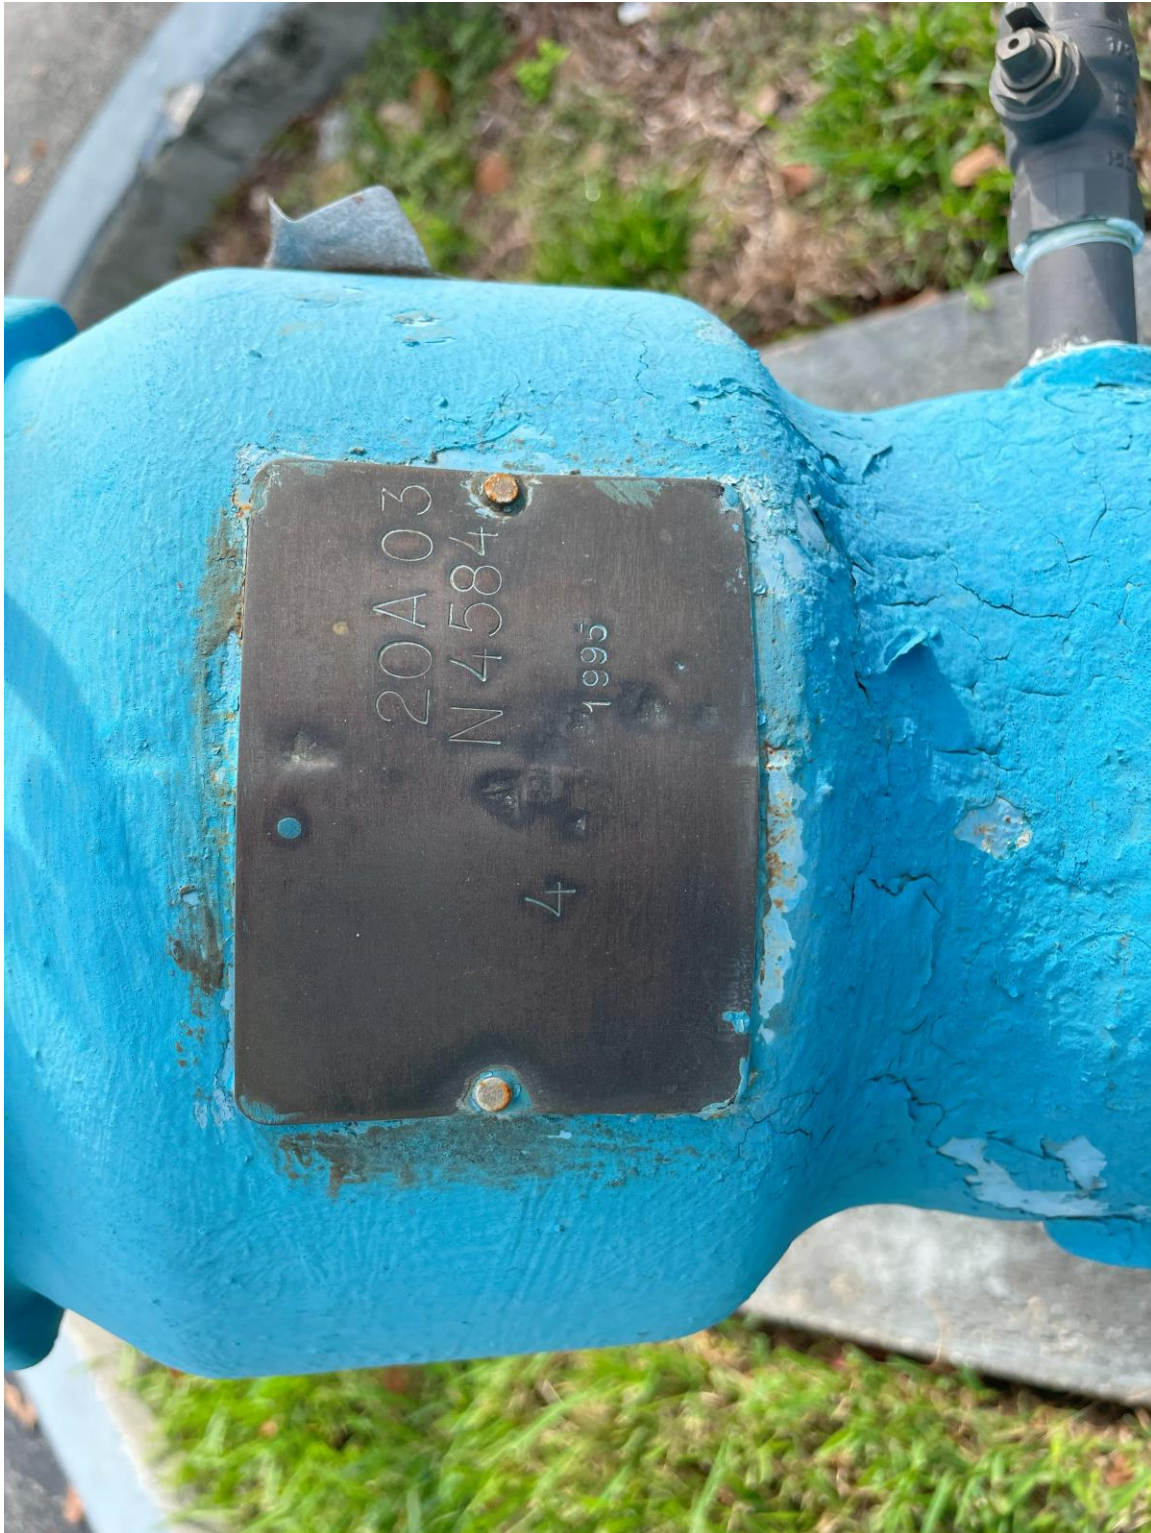
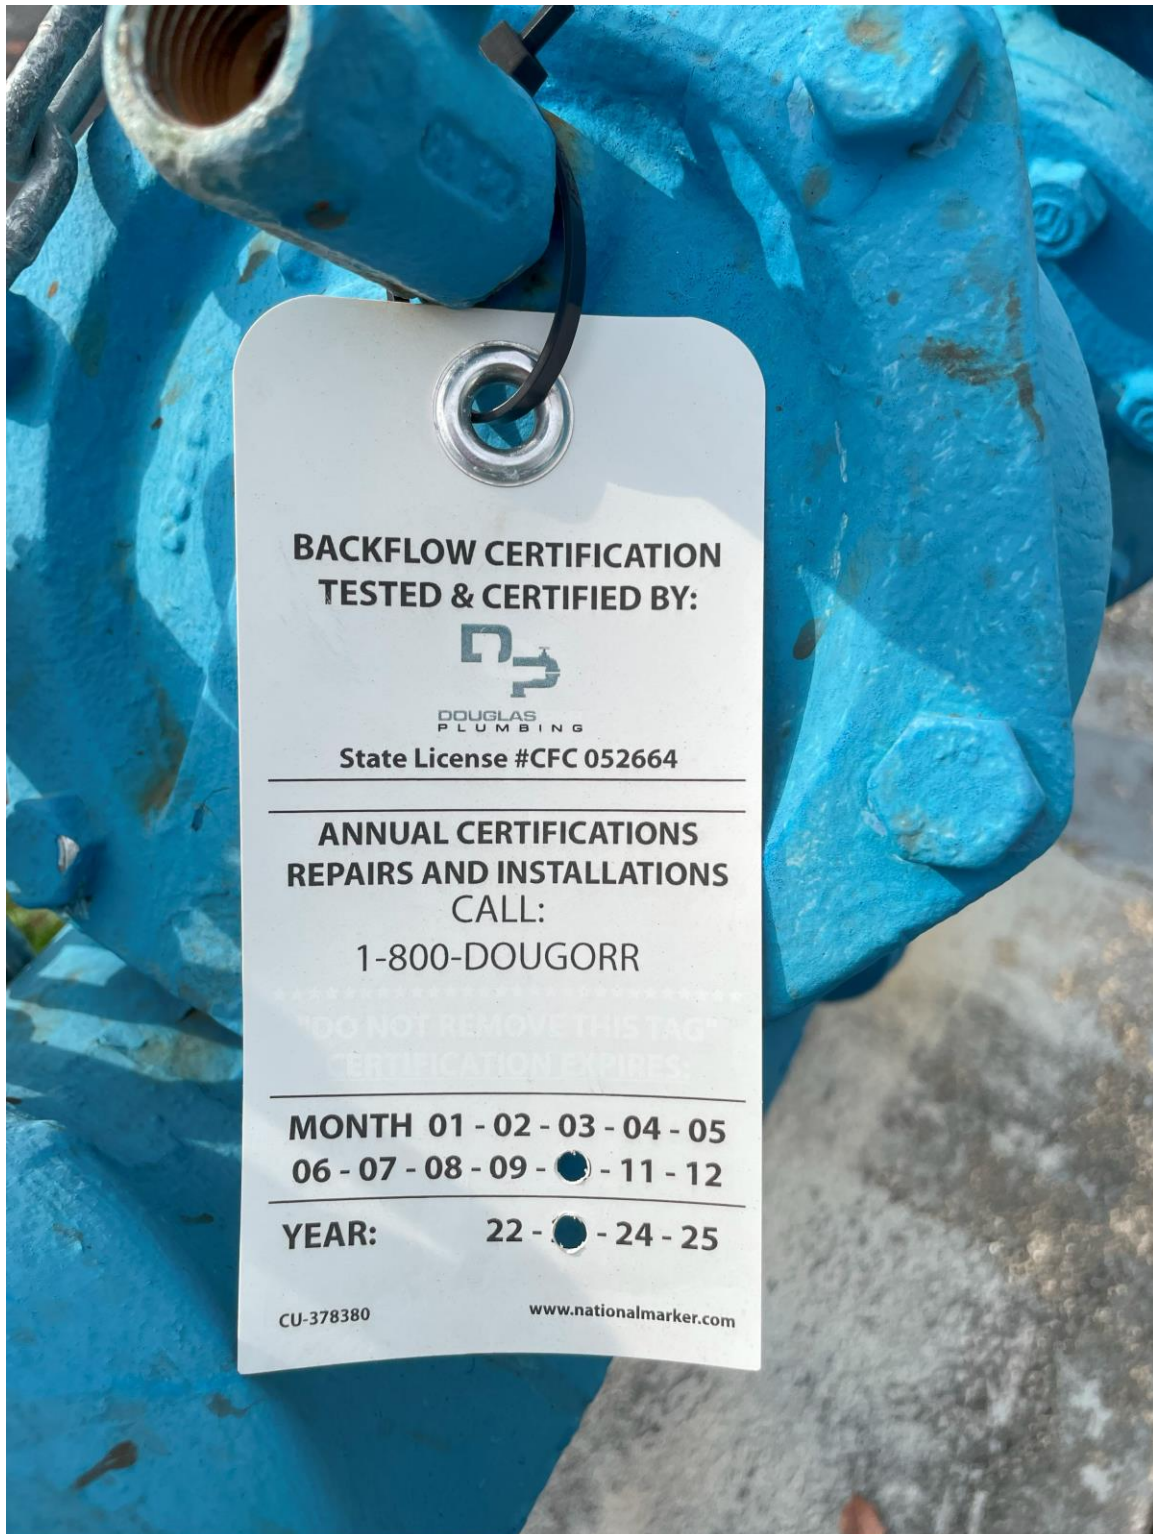
A 4" blue backflow preventer is located in the property's parking lot. Upon inspection, the 4" backflow preventer is in acceptable condition. The backflow preventer has a visible test certificate dated October 2023, indicating that it has been recently tested and is in compliance.

The concrete slab under the backflow preventer is found to be deteriorated. In light of this, we recommend the construction of a new concrete slab to ensure the protection of the system. This proactive measure will contribute to the longevity and stability of the infrastructure.

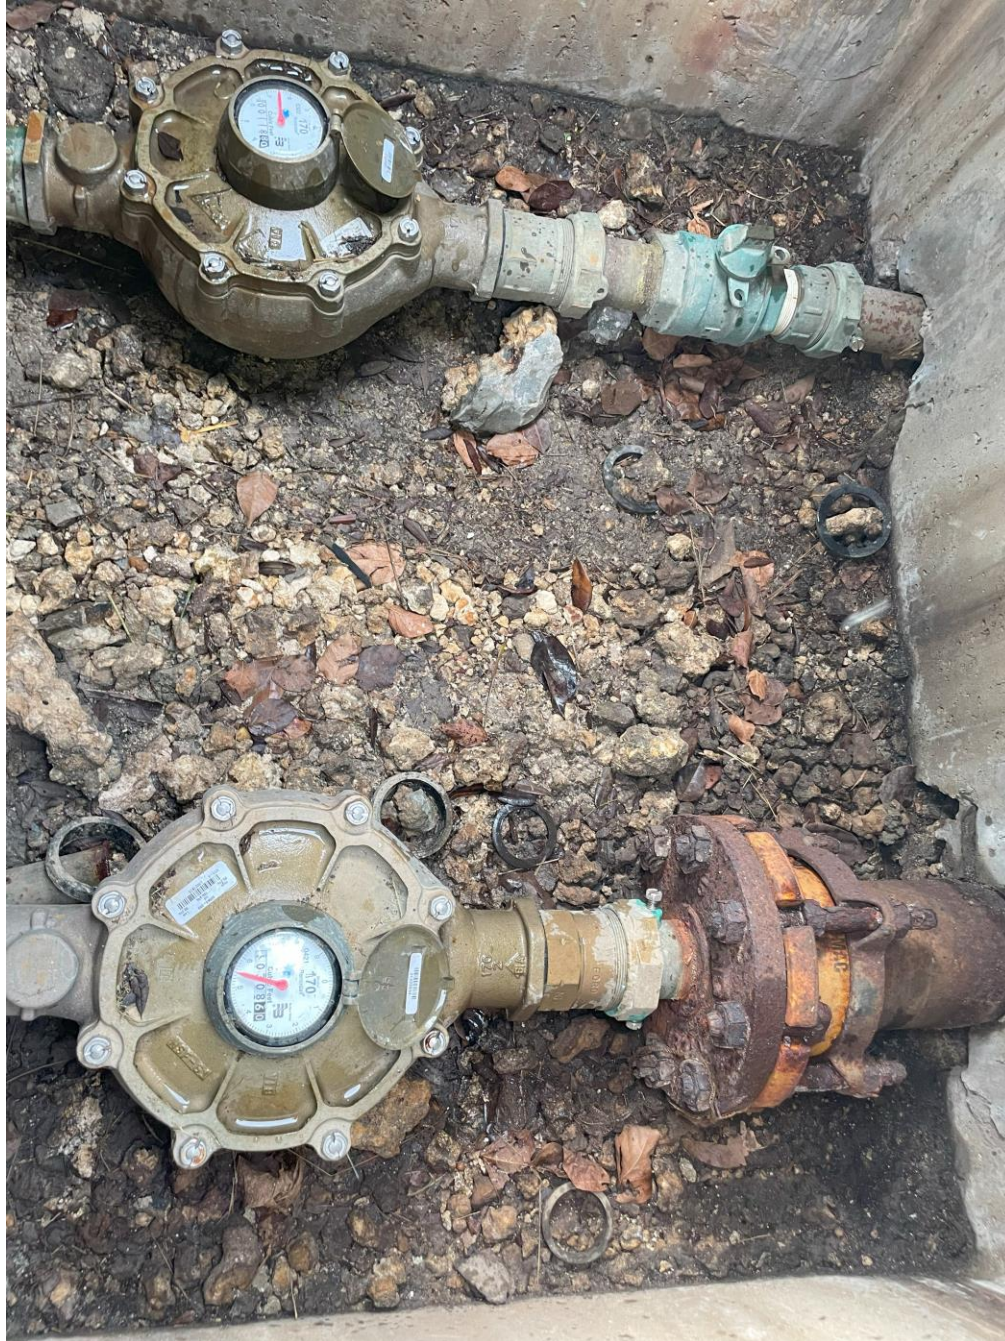
18.4.1.2 2" WATER METERS

The field crew identified two 2" water meters near the backflow. Upon inspection, these meters appear to be relatively new and are in excellent condition.

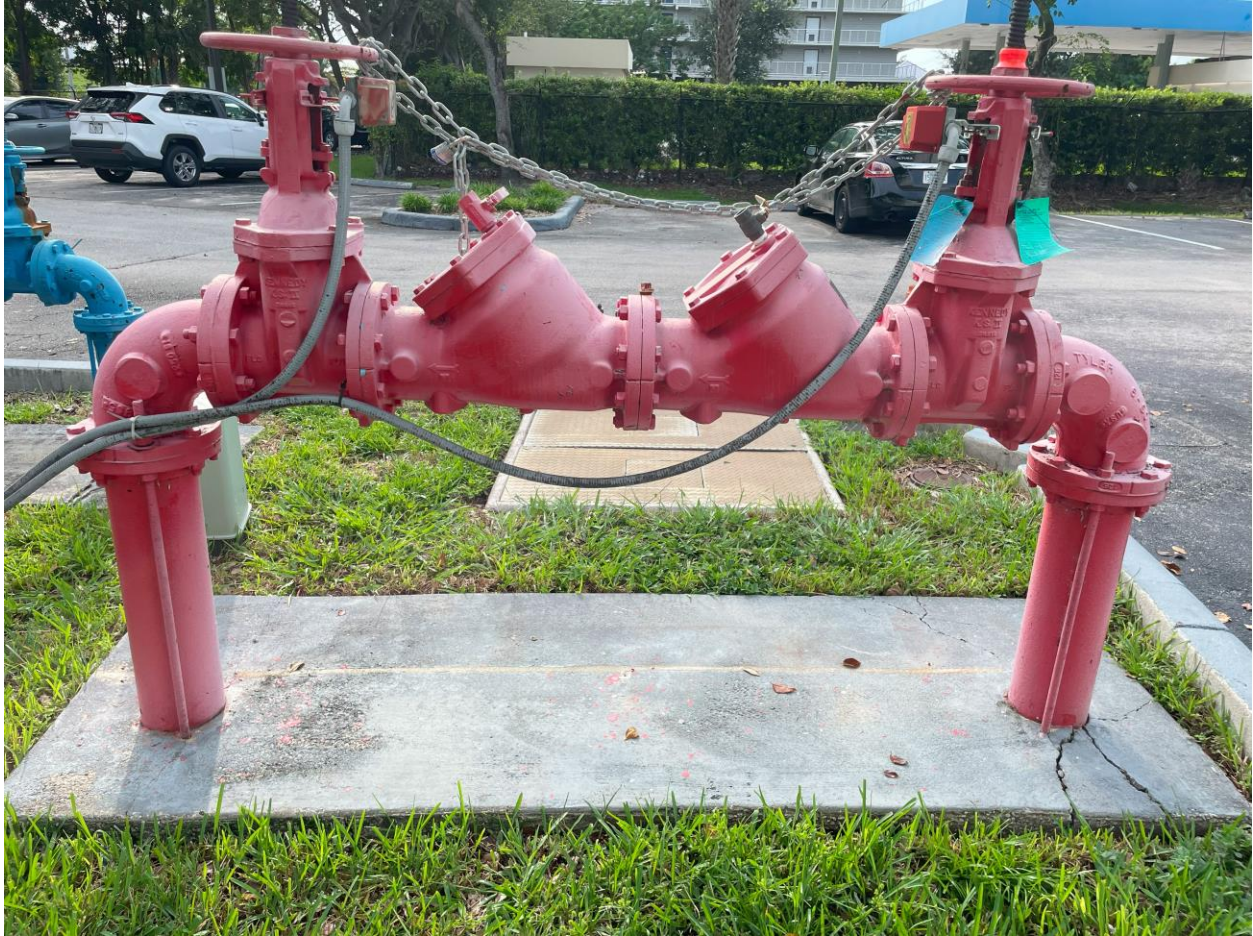
18.4.2.1 6" BACKFLOW PREVENTER

A 6" red backflow preventer is installed in the premises for the sprinkles and the fire hydrants, the system is in acceptable condition, the system counts with an inspection certificate dated February 24 2023.

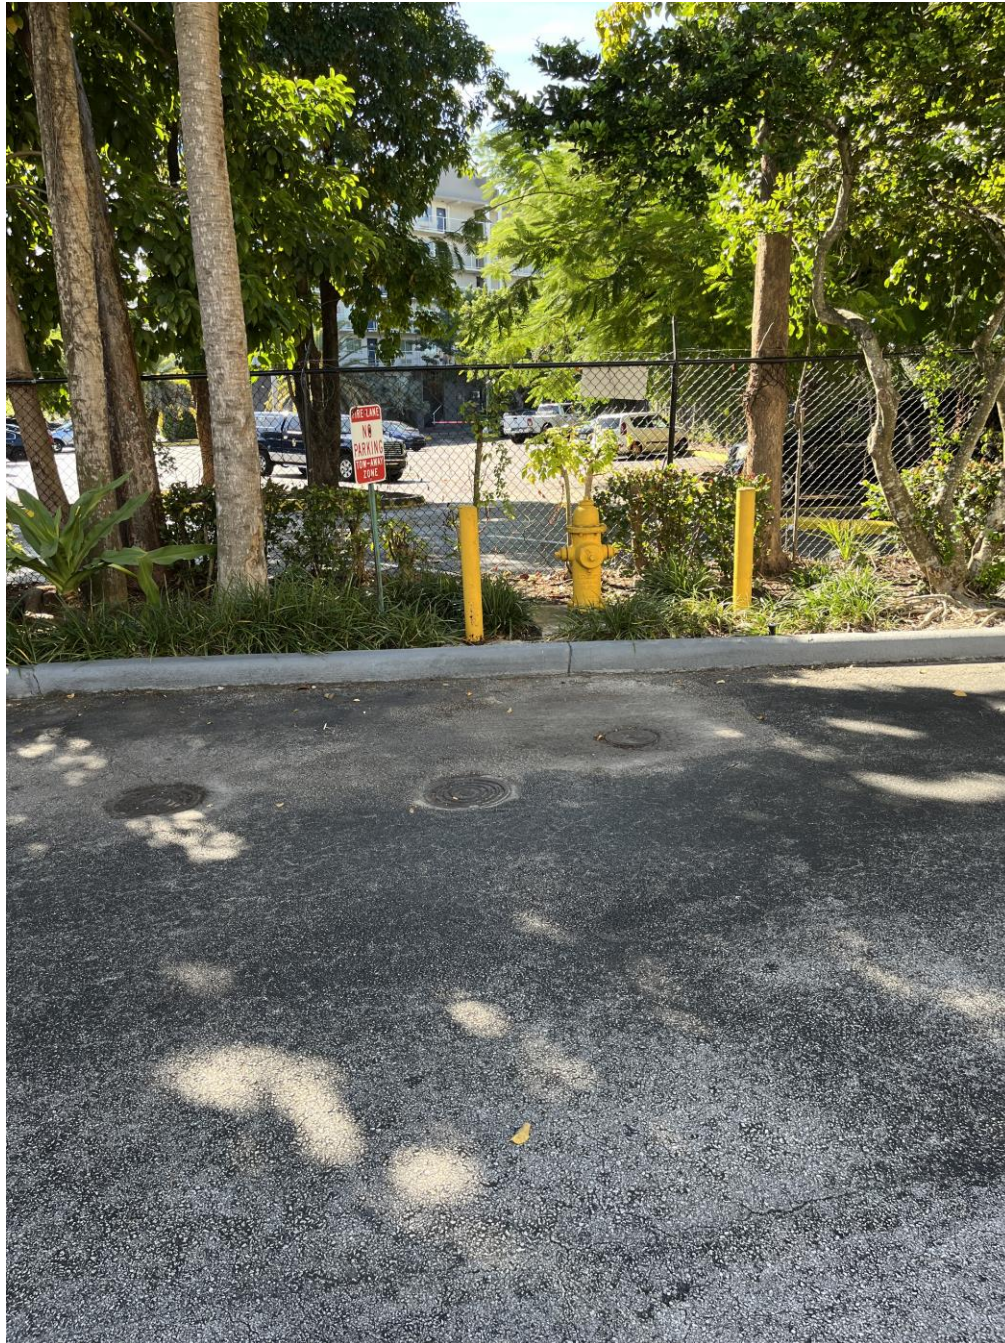
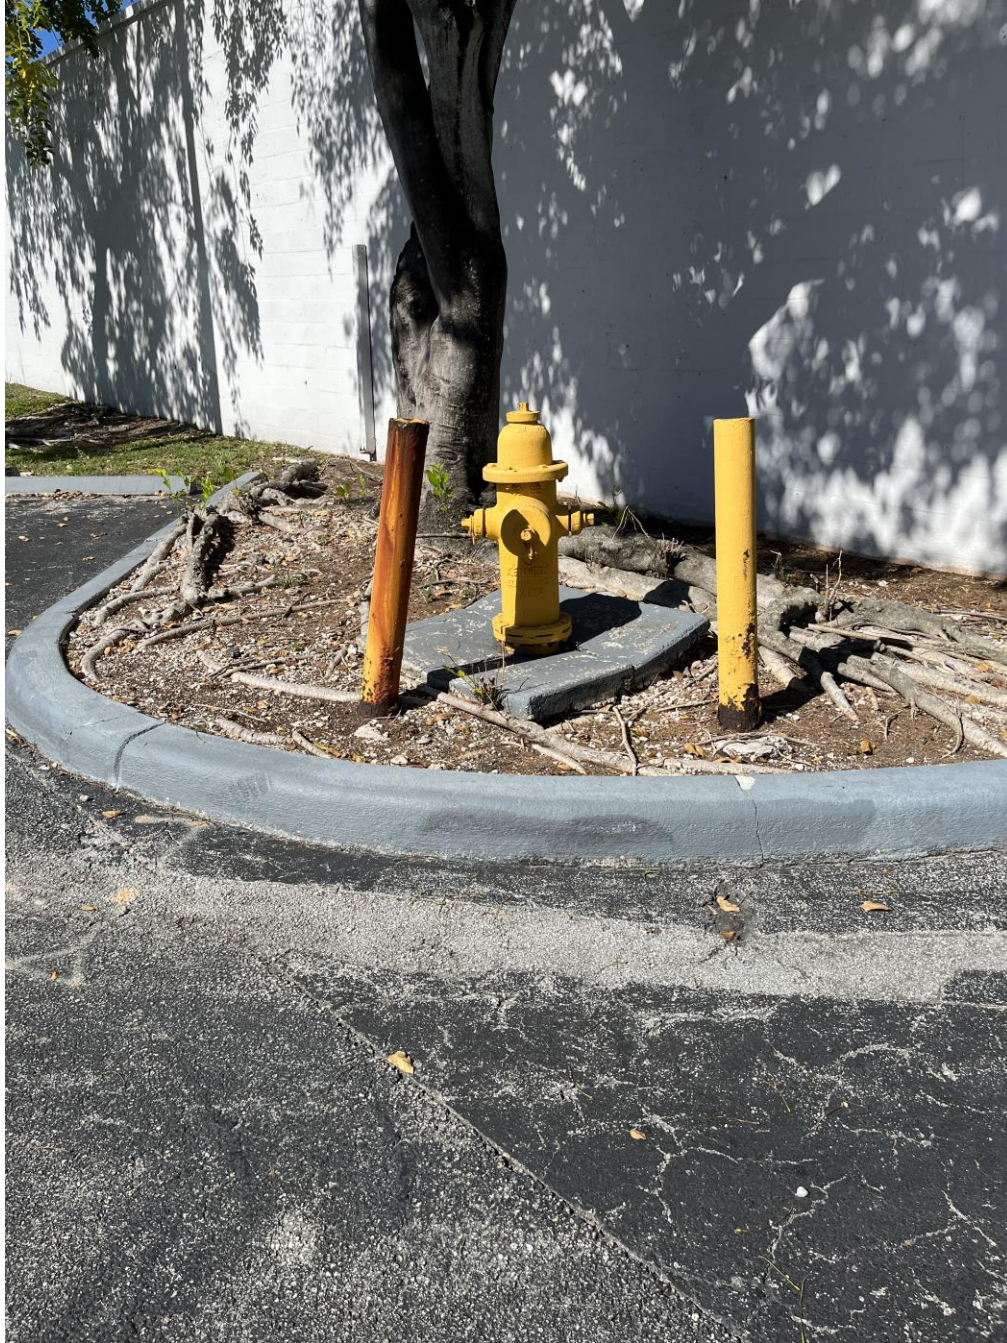
18.4.2.2 **FIRE HYDRANTS**

The property is equipped with two fire hydrants. Upon assessment, the first hydrant appears to be in fair condition, and we recommend no further activities at this time. However, for the second hydrant, it has been observed that the concrete slab and the associated bollard are in poor condition. In light of this, we recommend the reconstruction of both the slab and the bollards for the second hydrant to ensure optimal functionality and safety of this hydrant.
