MIAMI-DADE COUNTY INTERNAL SERVICES DEPARTMENT

La Quinta Inn Physical Condition Assessment

10821 Caribbean Blvd, Miami, FL 33189

ISD PROJECT No. W220057

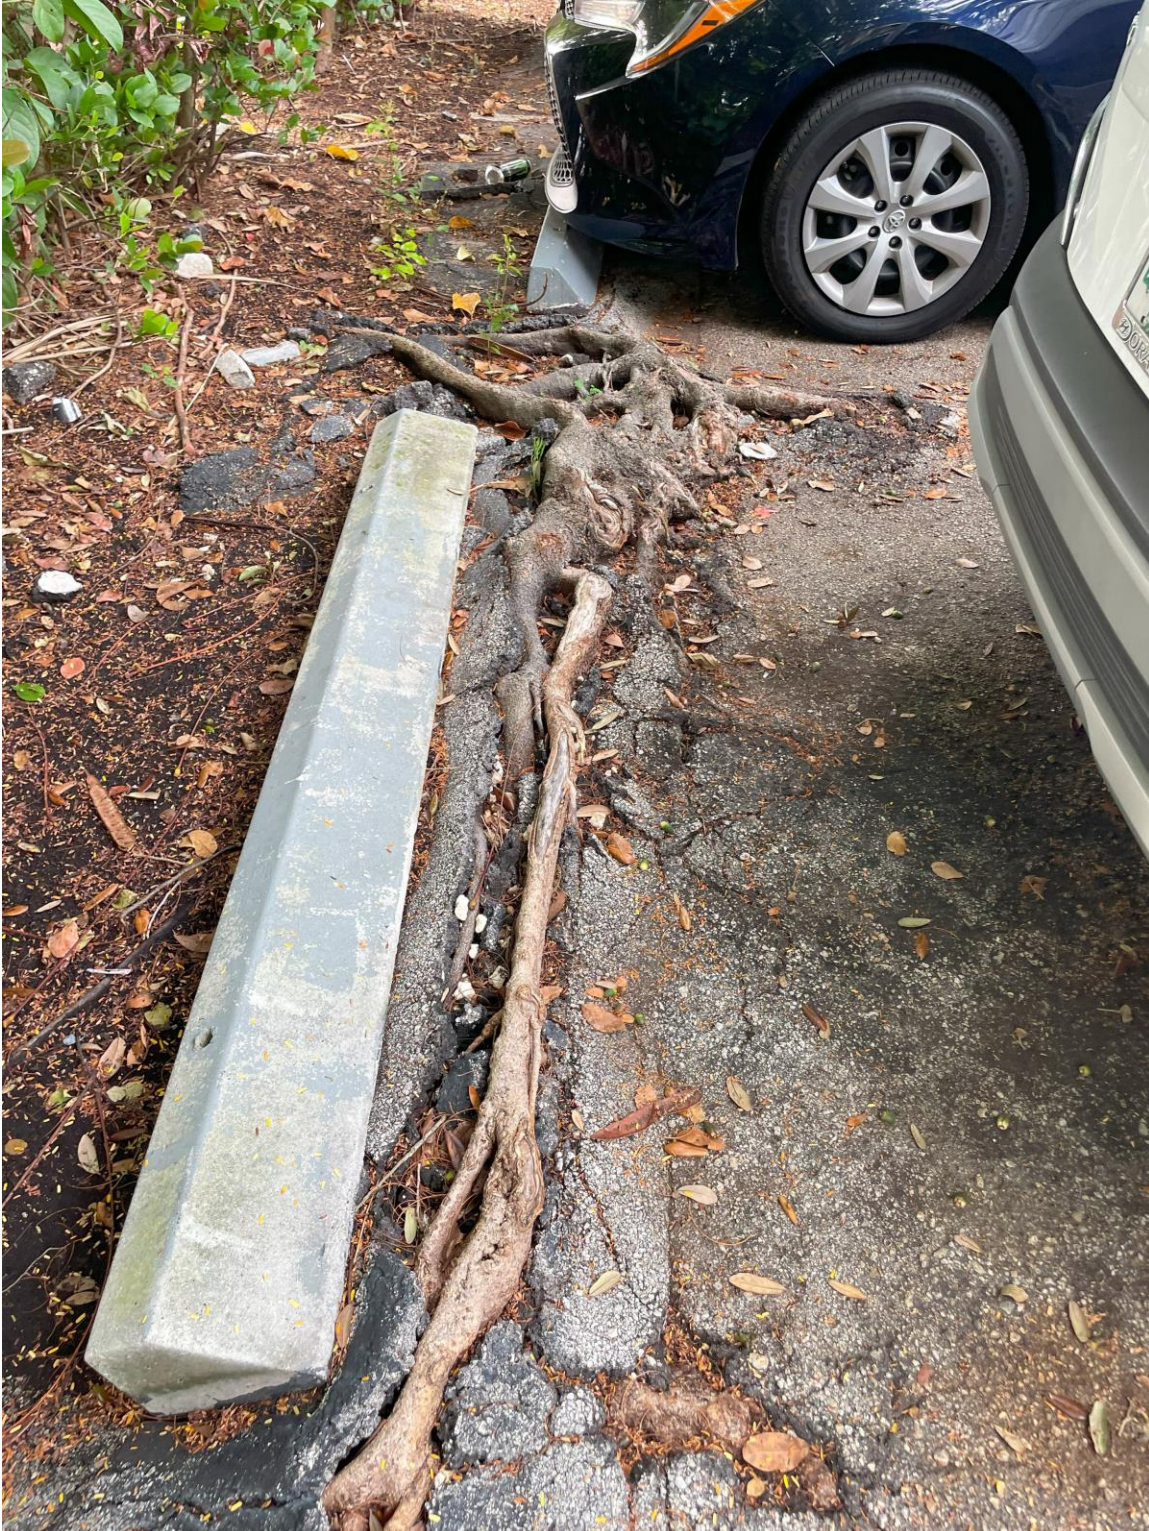
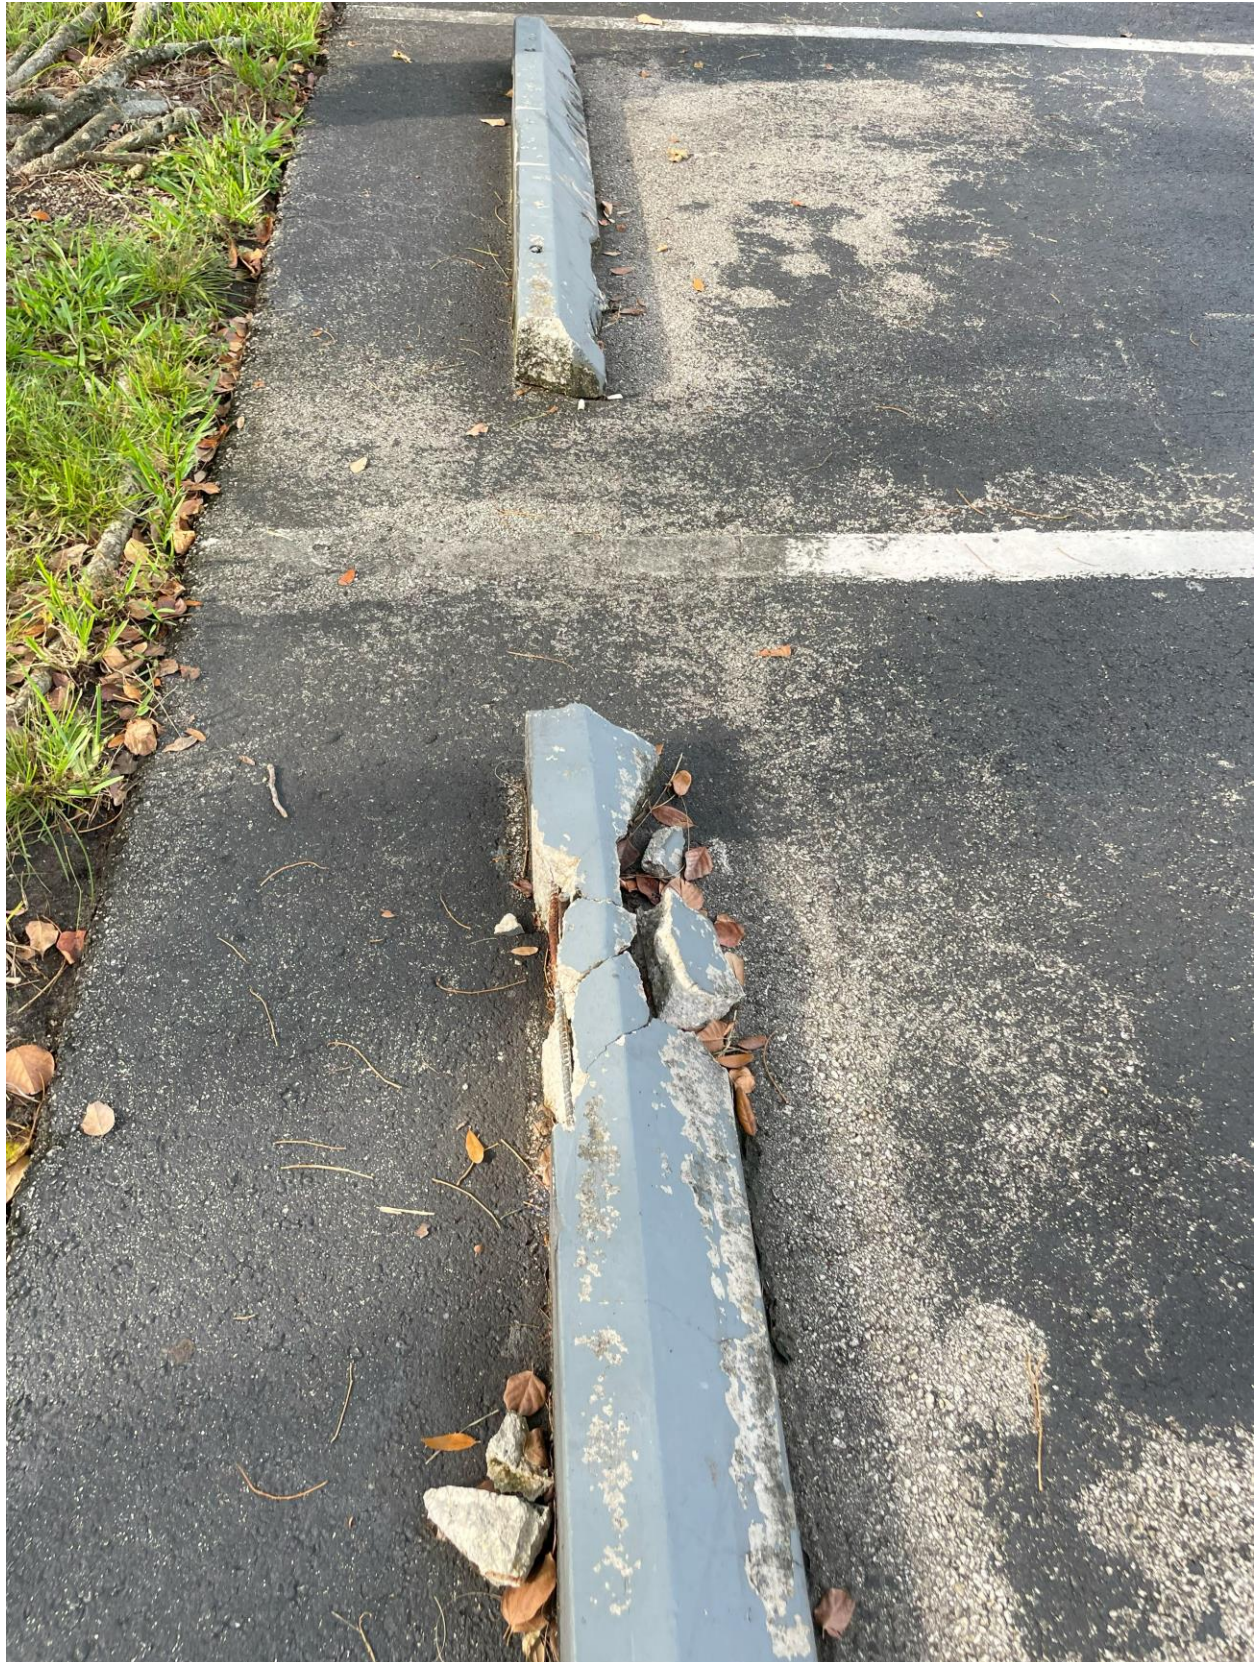
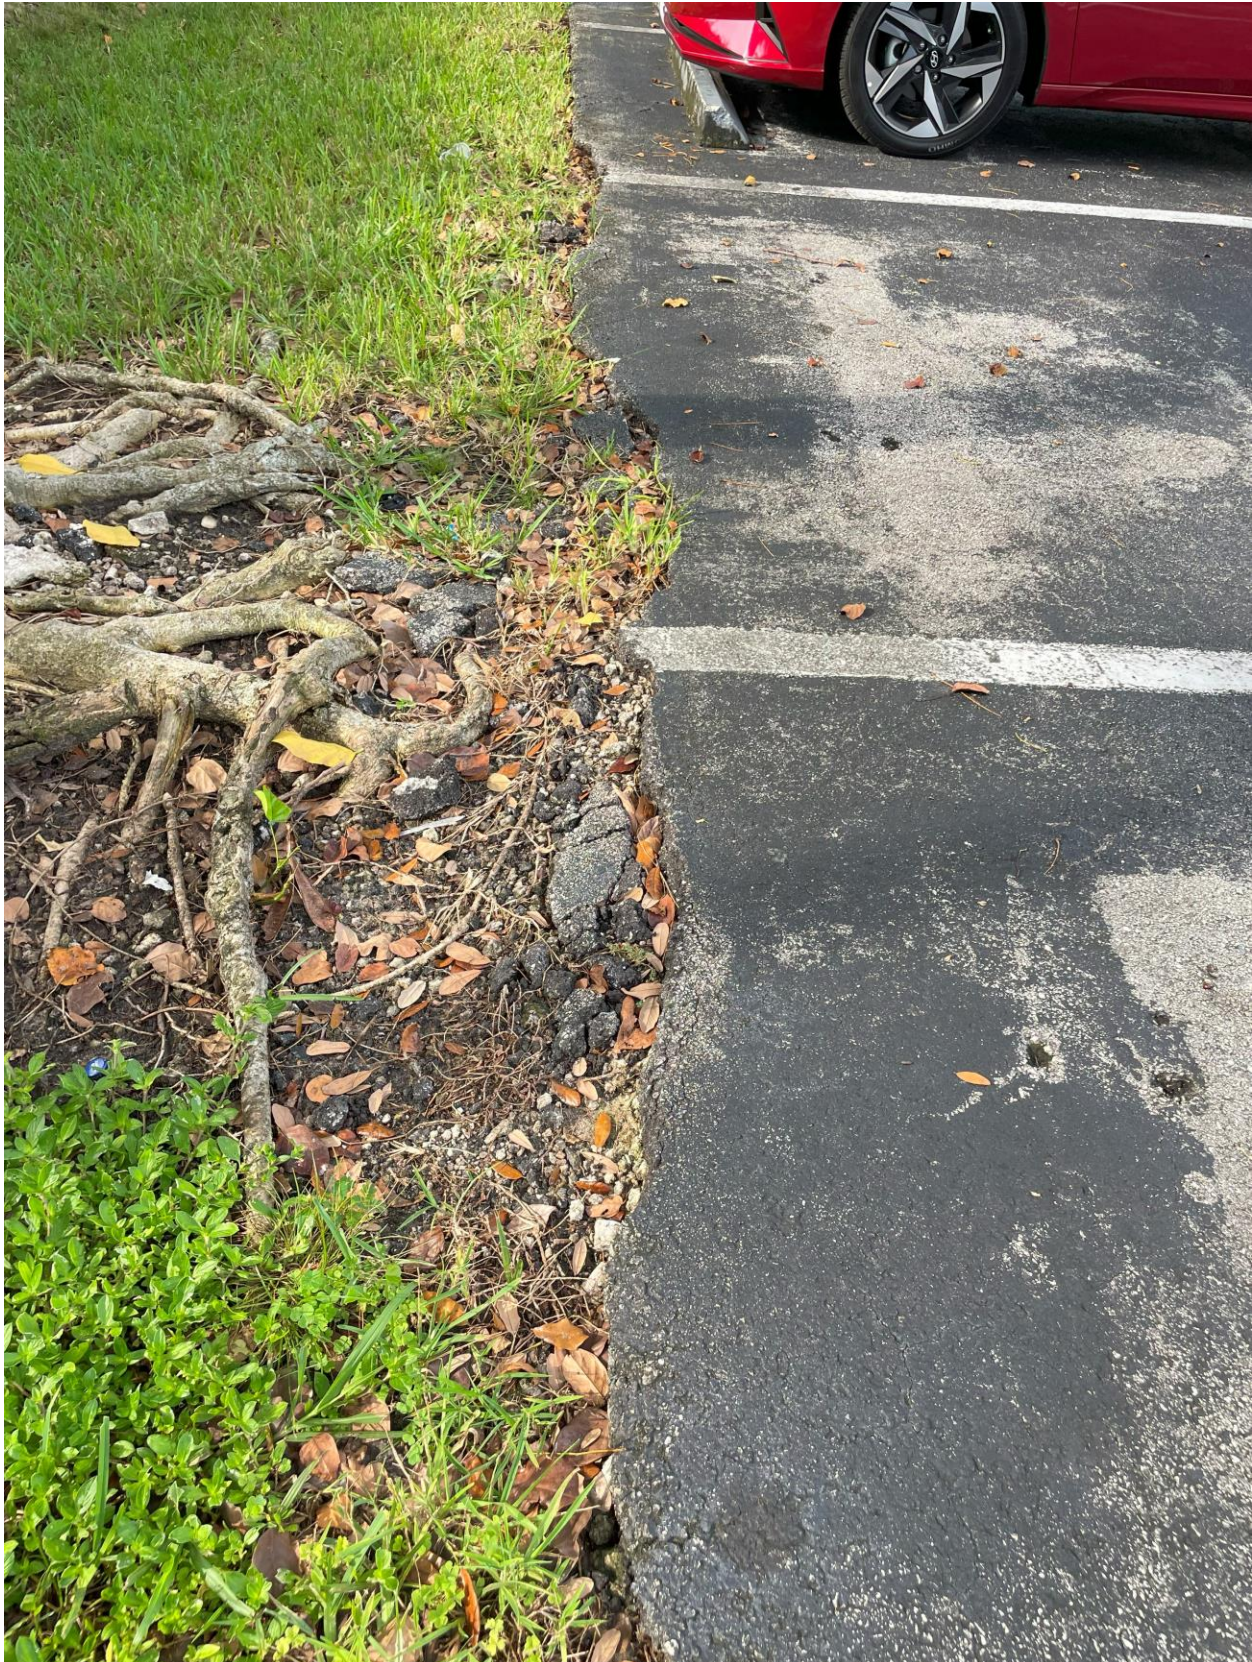
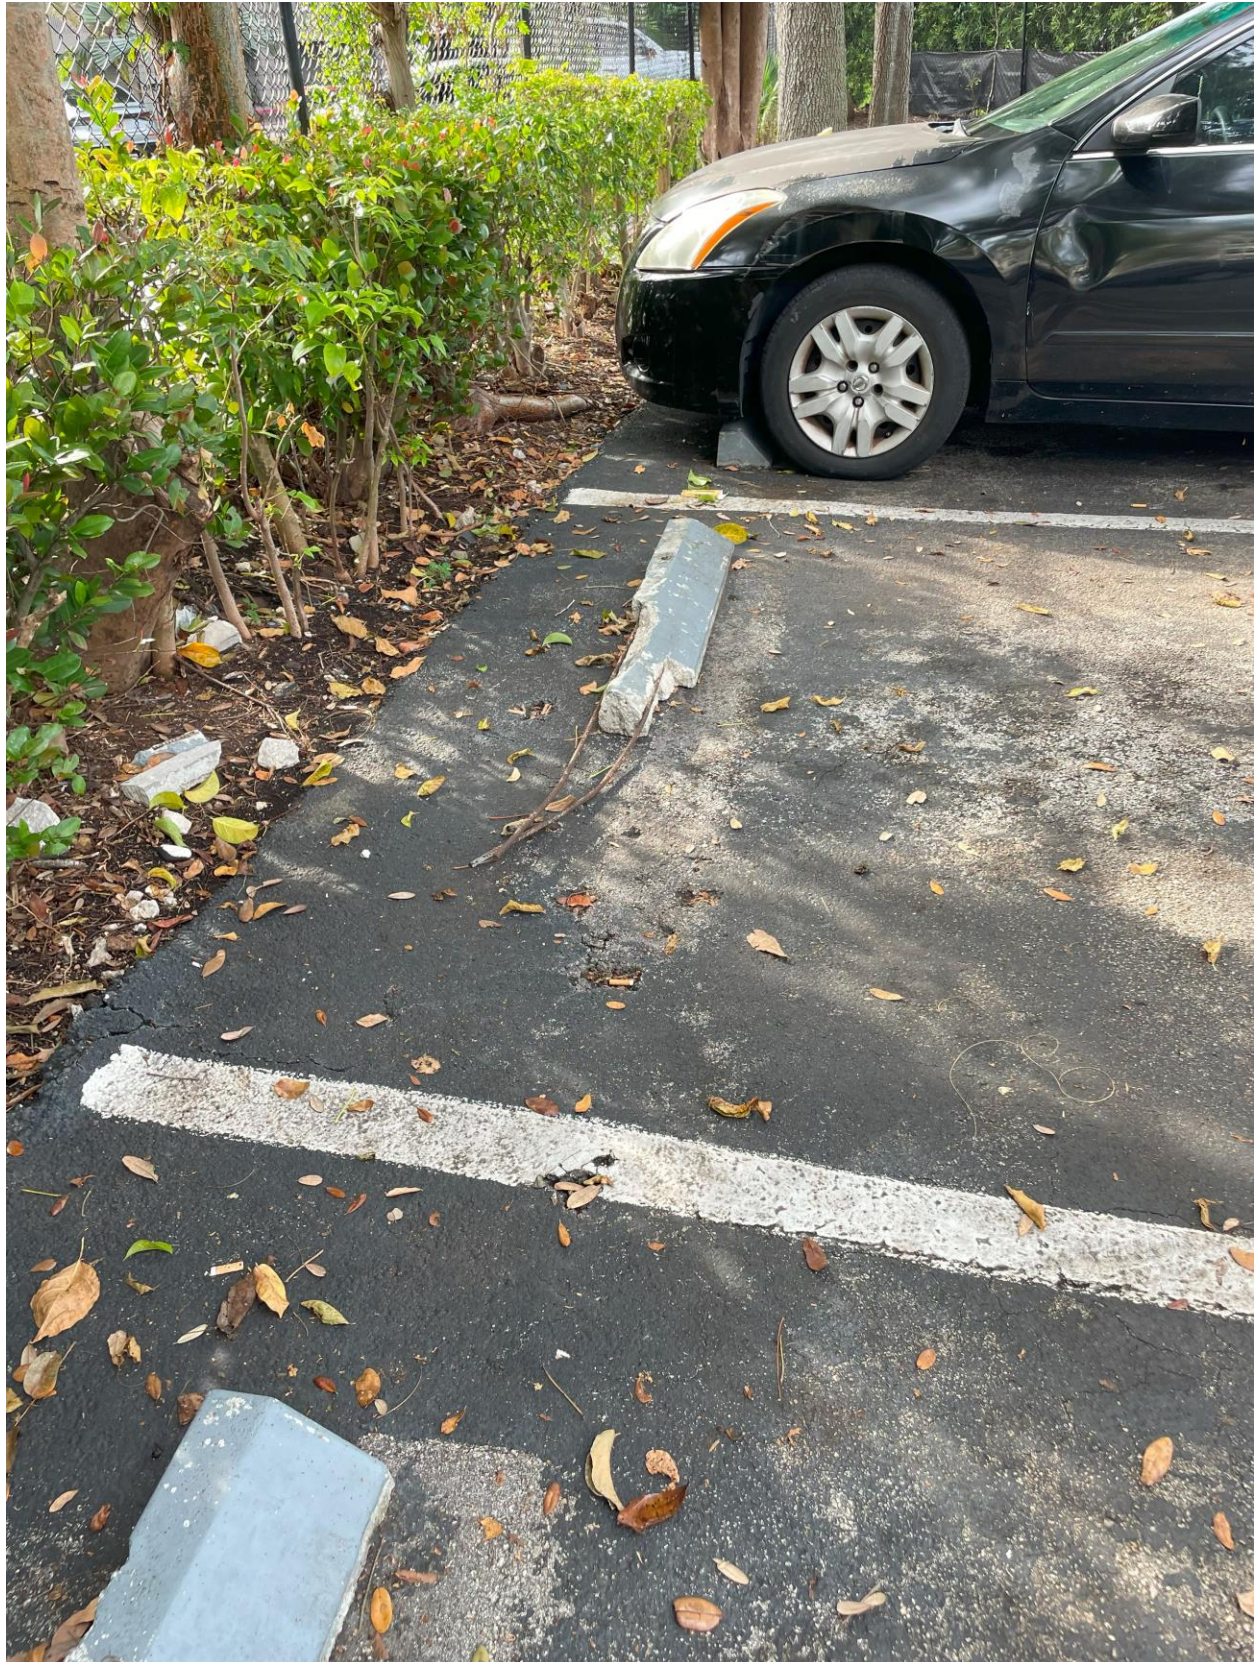
18.5.1 PARKING SPACES AND WHEEL STOPS

Furthermore, the visual inspection has revealed damages to the wheel stops in several parking spaces. Ten parking spaces lack wheel stops, and ten exhibit severe damage.

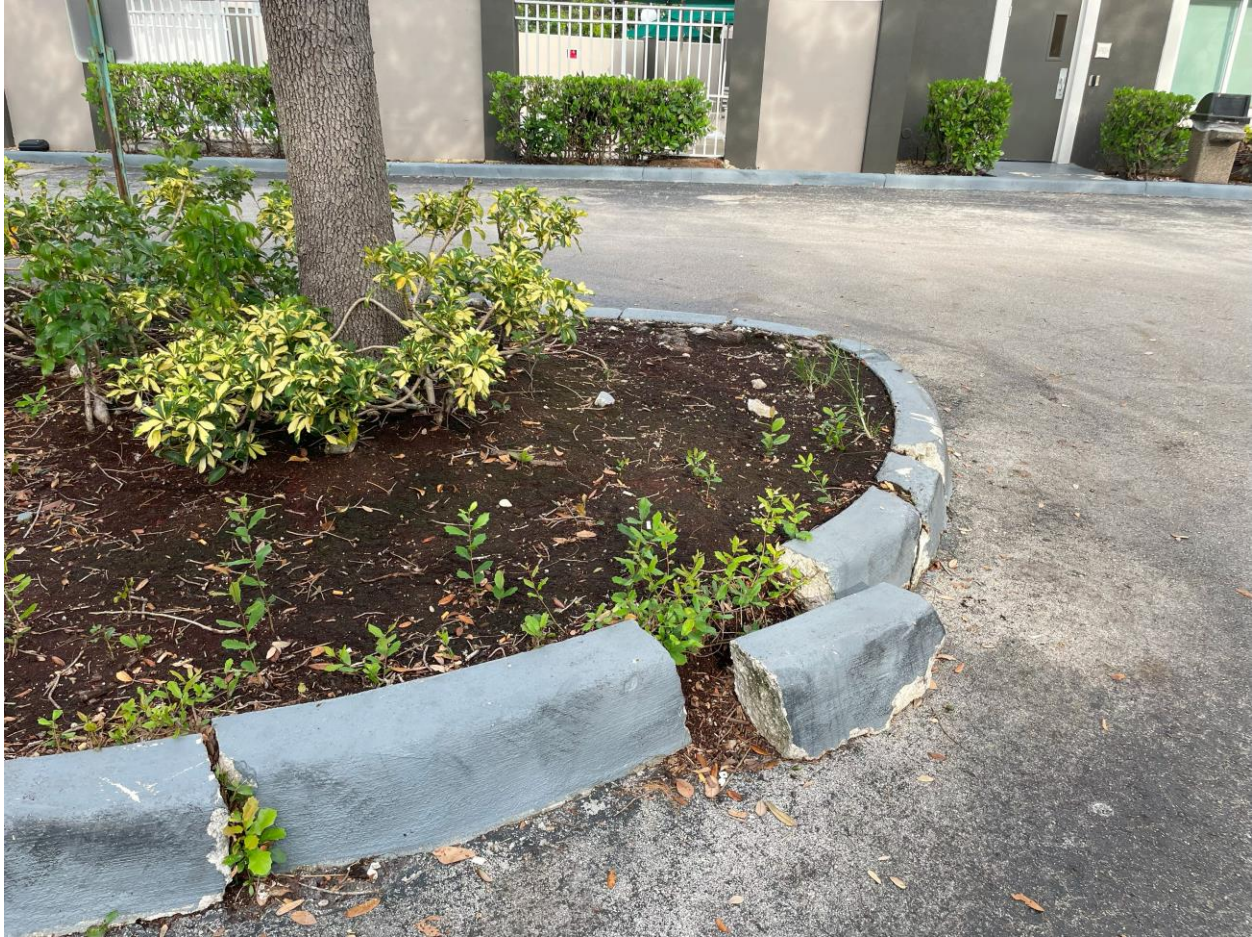
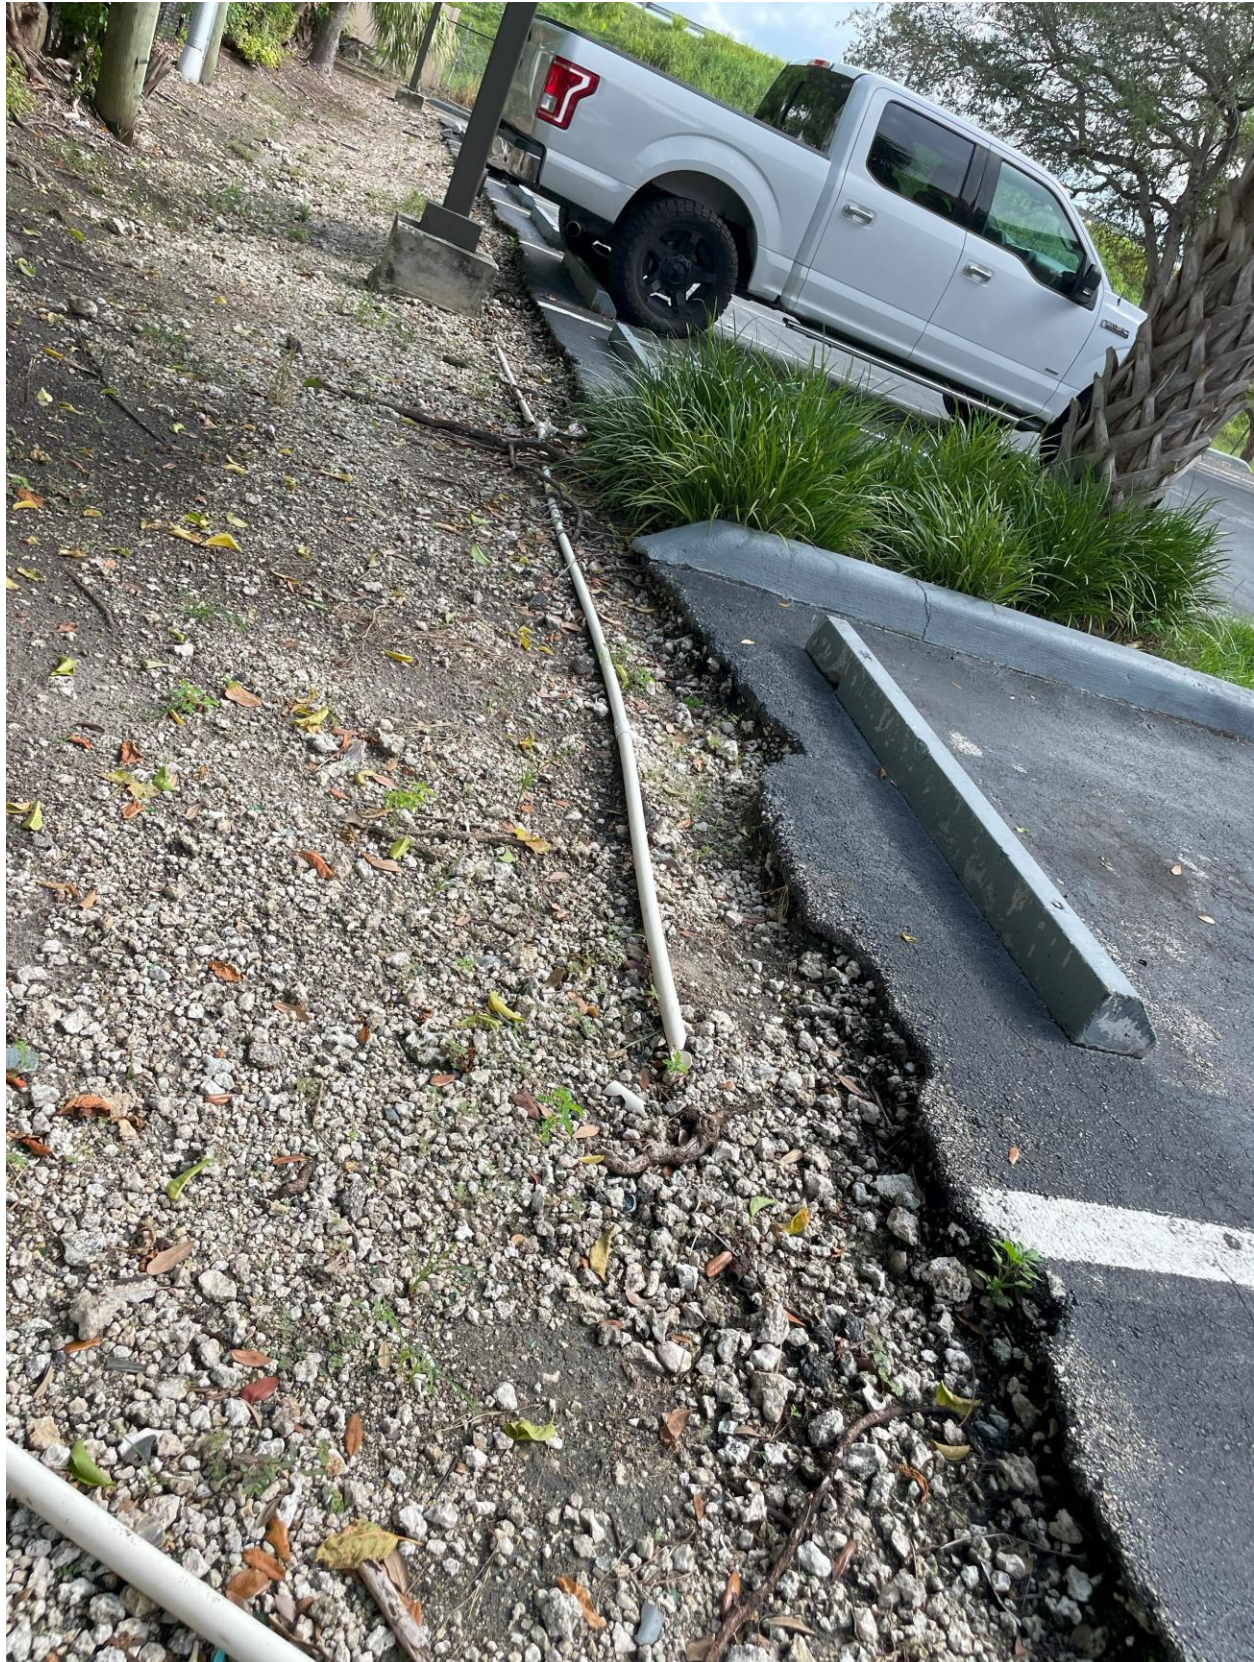
18.5.2 PARKING LOT PAVEMENT AND CURB CONDITION

The circulation area of the parking lot is suitable for its intended use. However, there is damage to the pavement structure, particularly evident along the swales where tree roots have impacted the structure. Approximately 300 linear feet of curbs on the property are identified to be in poor condition. Additionally, our on-site team estimates that around 7,000 square feet of the parking lot pavement surface shows visible damage.

The pavement perimeter of the parking lot spans approximately 1600 linear feet. Following the visual civil assessment, our field team has identified that roughly 50% of this perimeter, totaling 800 linear feet, is adversely affected by tree roots or the sodded grassed areas. It is deemed necessary to address this concern by repairing the affected areas.

To mitigate further damage and enhance durability, we recommend the installation of flushed concrete curbs or concrete bands along the perimeter. These curbs will impede root damage and act as a protective barrier, isolating the asphalt pavement from the sodded areas. This comprehensive approach will contribute to the long-term stability and resilience of the parking lot infrastructure.

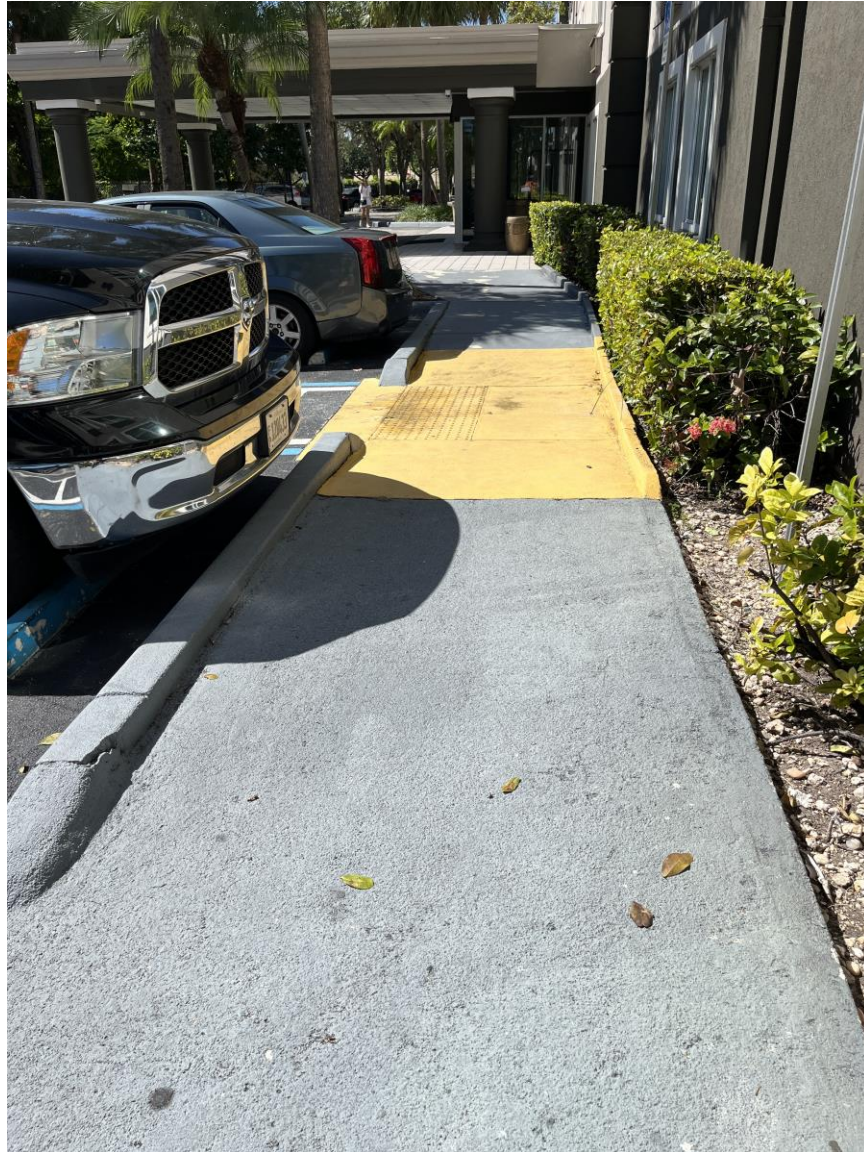
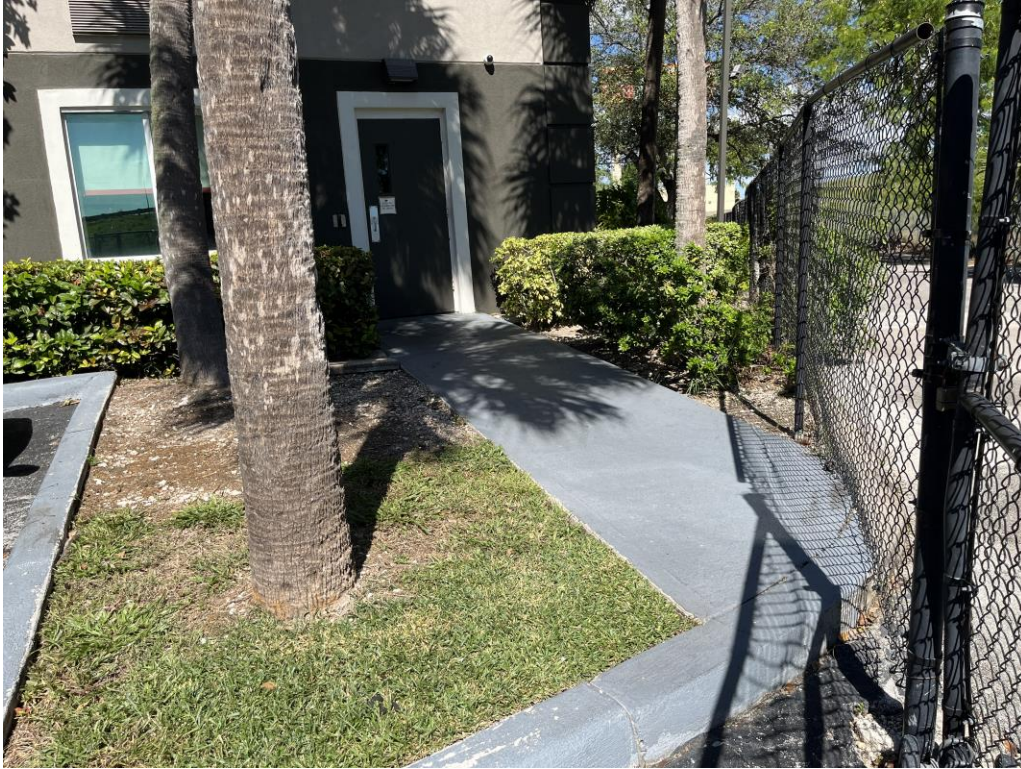
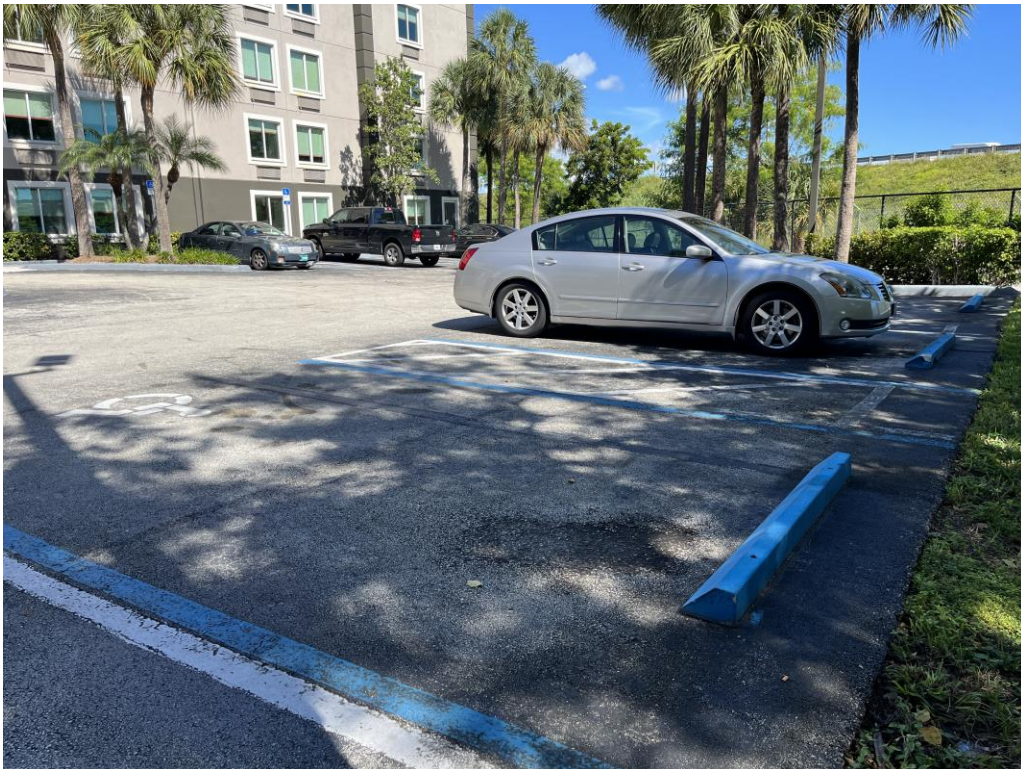
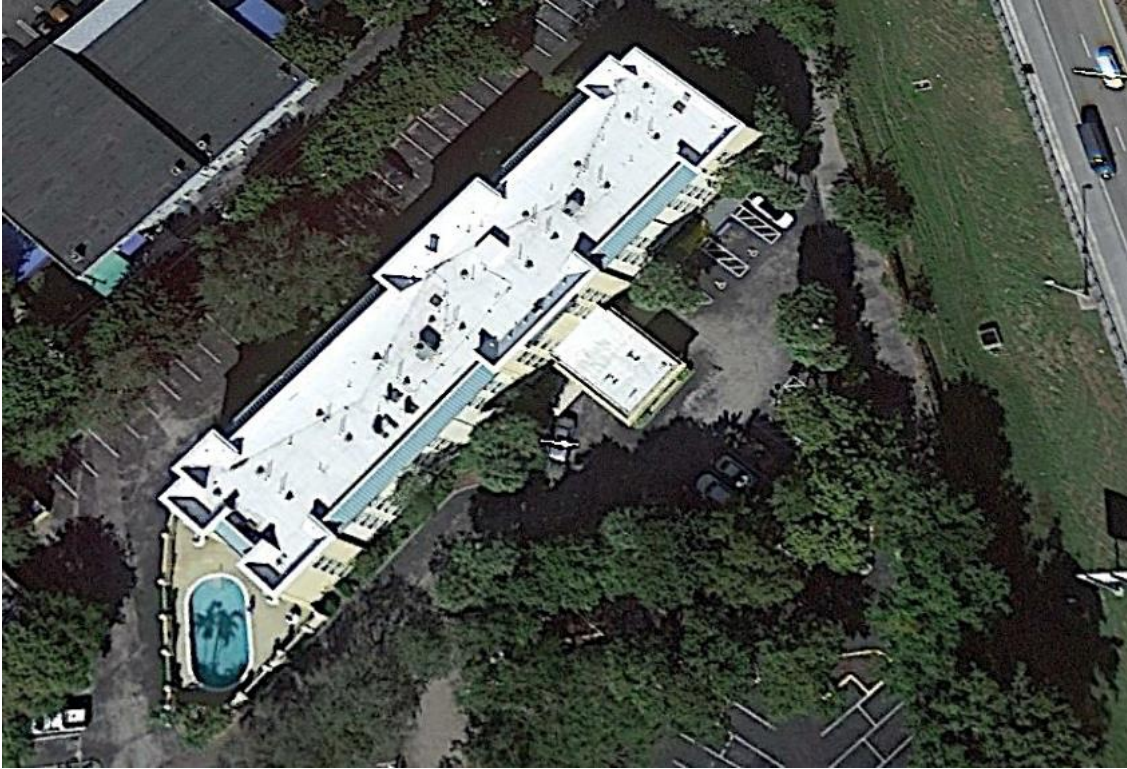
18.5.3 PEDESTRIAN ACCESSIBILITY

During the site visit, our field crew noted the absence of pedestrian accessibility from the public sidewalk to the building's entrance, violating ADA requirements. Addressing these accessibility deficiencies is imperative to ensure full compliance with ADA standards and provide an inclusive and accessible environment for all individuals.

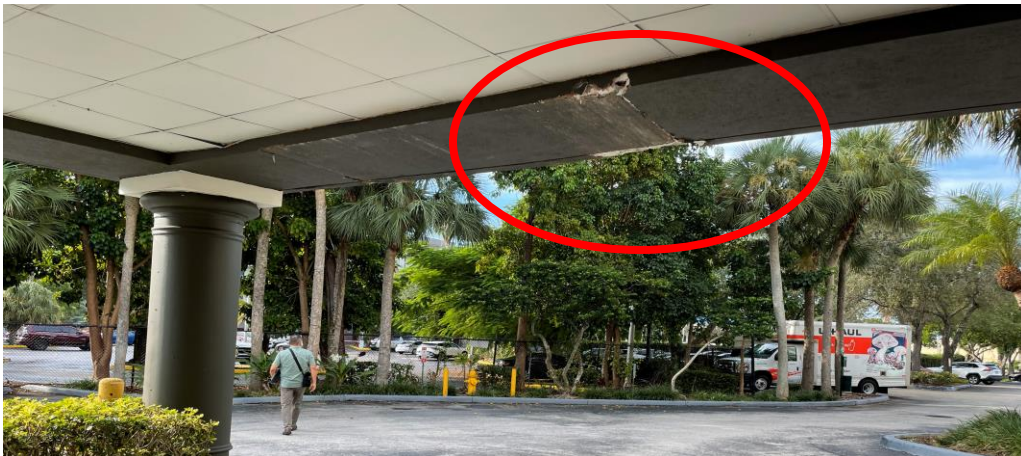
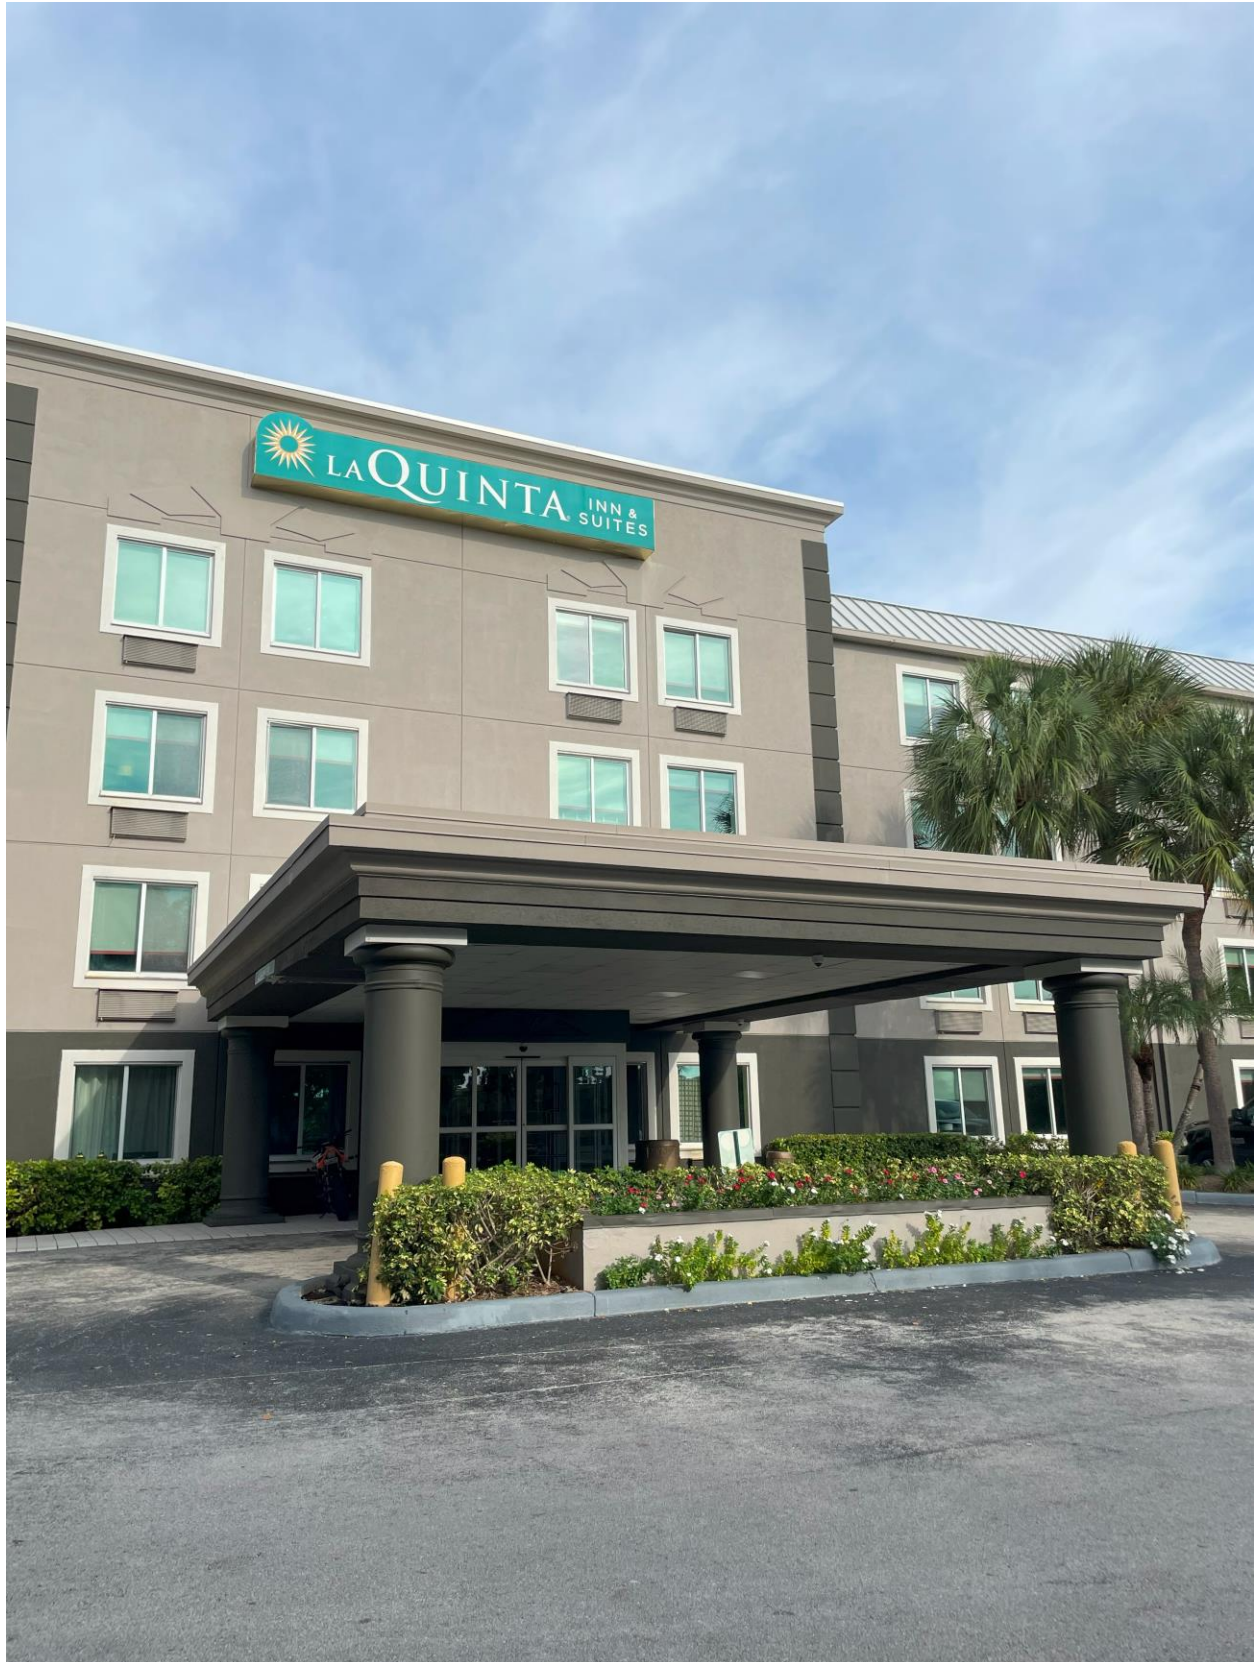
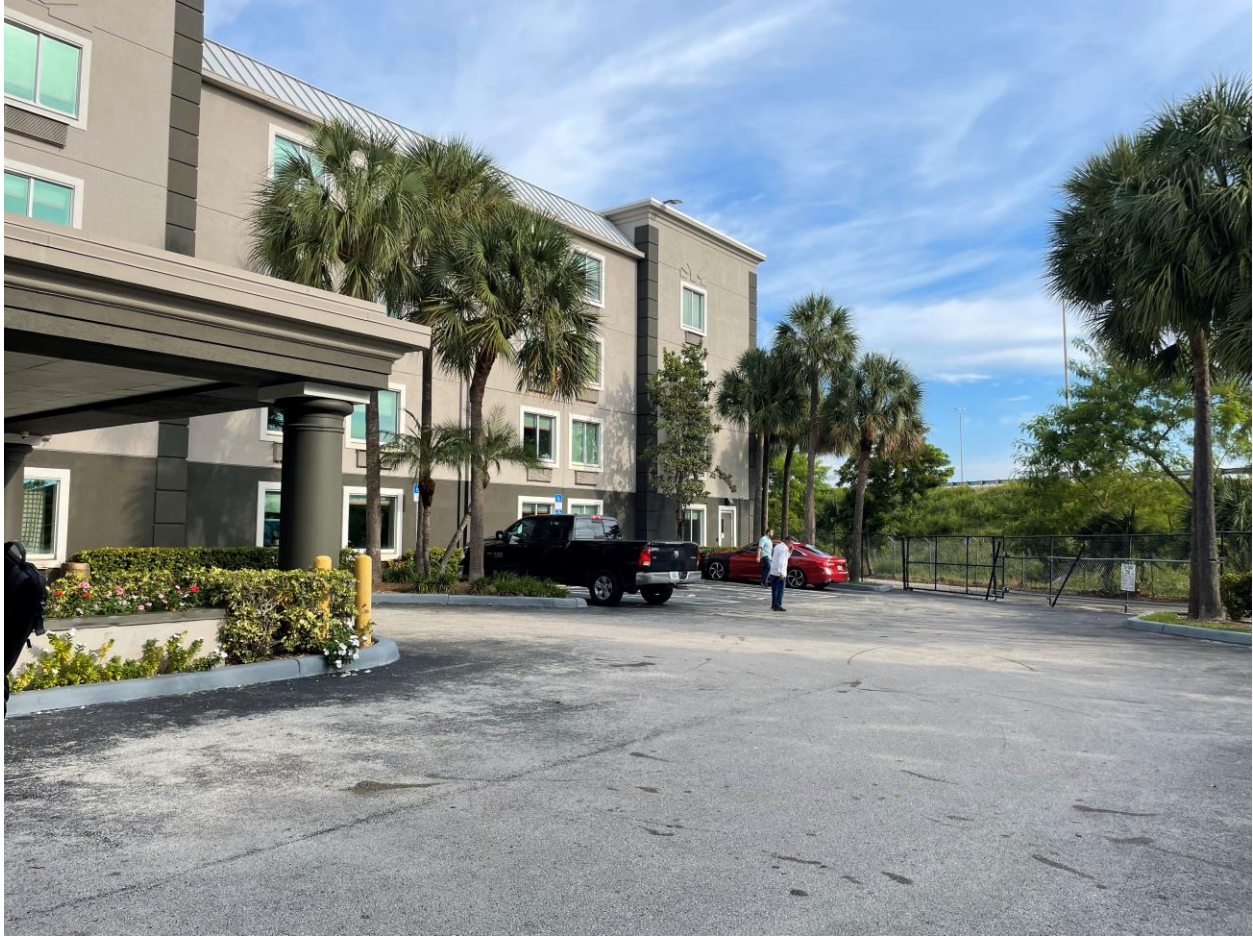
18.5.4 BUILDING ENTRANCE

The building features a covered drop-off area with a minimum height of 9'2". During the site visit, damage to the structure was observed, likely resulting from a collision. To mitigate the risk of further incidents, we recommend implementing warning signalization that clearly communicates the maximum allowable height within the drop-off area. This precautionary measure aims to enhance safety by providing clear information to drivers and minimizing the risk of potential structural damage.

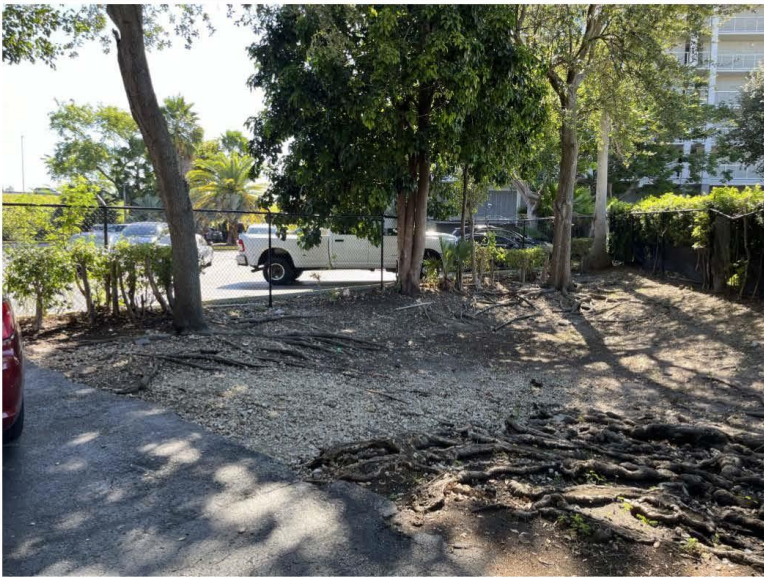
Direction Photo Taken: South		
Description: Swale 1 condition		
Photo No. 2	Date: [Date]

- Restore swales to original condition.
- Root Pruning
- Tree Removal and Replacement
- Swale Grading
- Sodding
- Construct new Exfiltration trench section.
- Furnish and Install New Catch basin with Pollution Retardant baffle.
- Furnish and install a Section of 5' of solid 24" Pipe followed by 20' of 24" perforated pipe.

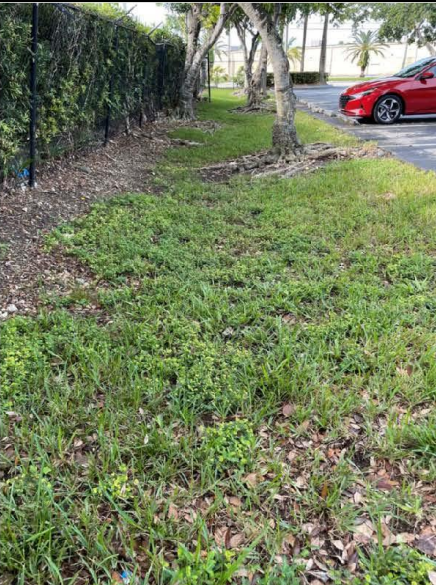
Direction Photo Taken: South-West		
Description: Swale 2 condition

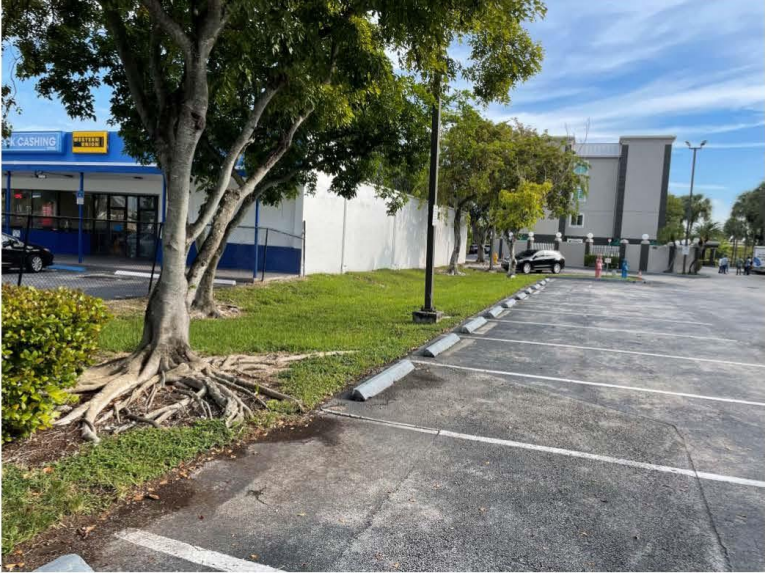
Direction Photo Taken: North East			
Description: Swale 3 condition			
Photo No. 4	Date: [Date]

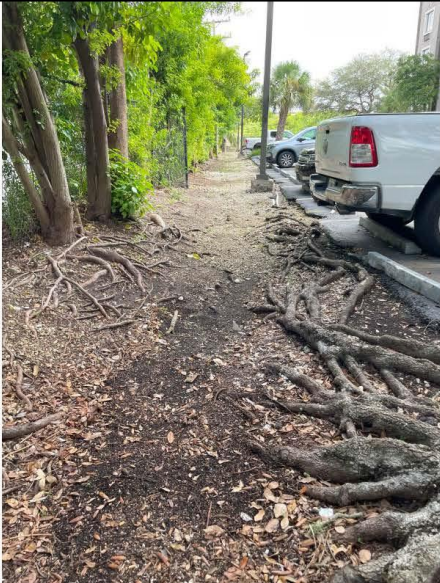
Direction Photo Taken: North East			
Description: [Swale 4 condition

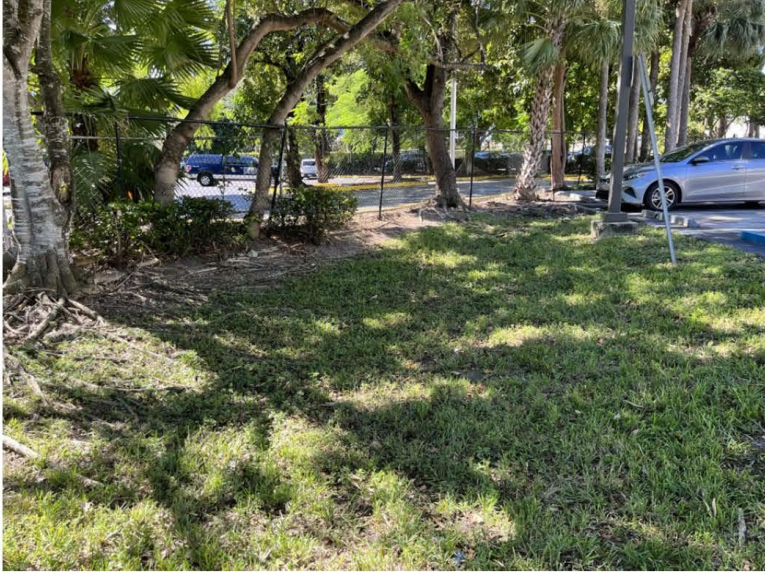
Direction Photo Taken: South-West		
Description: Swale 5 condition		
Photo No. 6	Date: [Date]

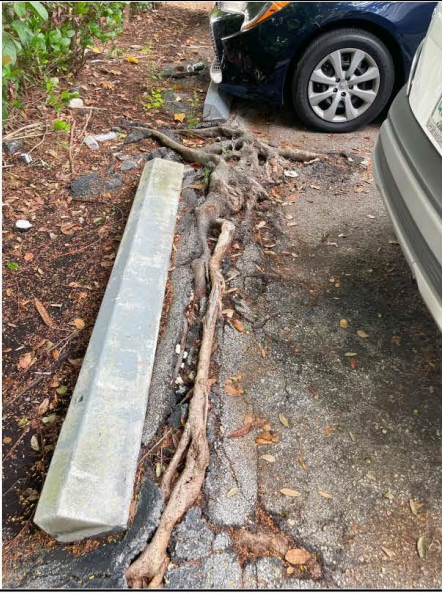
Direction Photo Taken: South West			
Description: Pavement Edge and Wheel stops			
Photo No. 20	Date: [Date]

Various locations of broken concrete curb at parking islands noted on plans	visual inspection estimates 300 ft
Various location of pavement damage along edge of parking lot were it meets the swales, noted on plans	visual inspection estimates 800 ft

- Repair 300 LF of damaged Type D curb
- Furnish and Install 20 new concrete wheel stops.
- Repair 800 LF of asphalt edge
- Install new flushed concrete curbing to repair edges near existing trees.
- Repair 7,000 SF of damaged pavement by removing asphalt and excavating base, install new 8" thick limerock base compacted to 98% of proctor density and install new 2" thick hot asphalt patch.

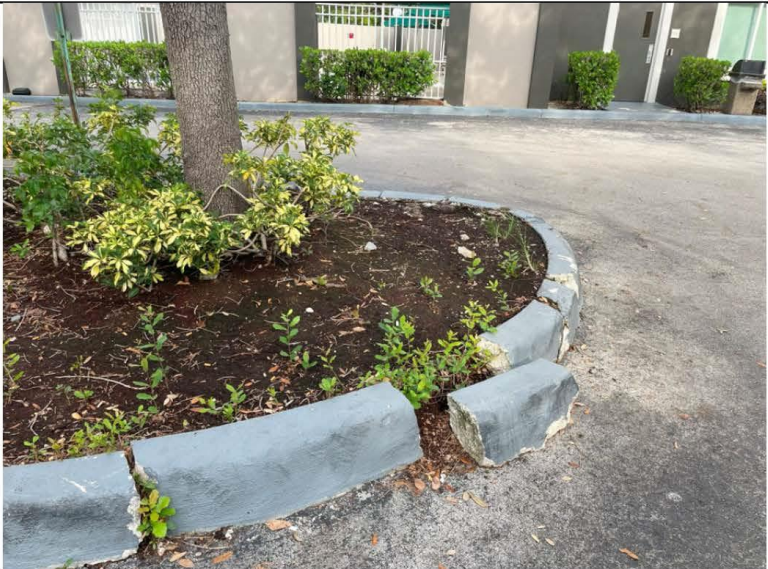
Direction Photo Taken: North			
Description: Curbs

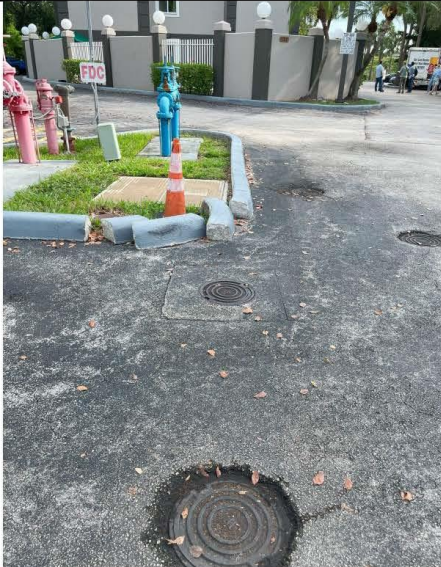
Direction Photo Taken: North East			
Description: Curbs

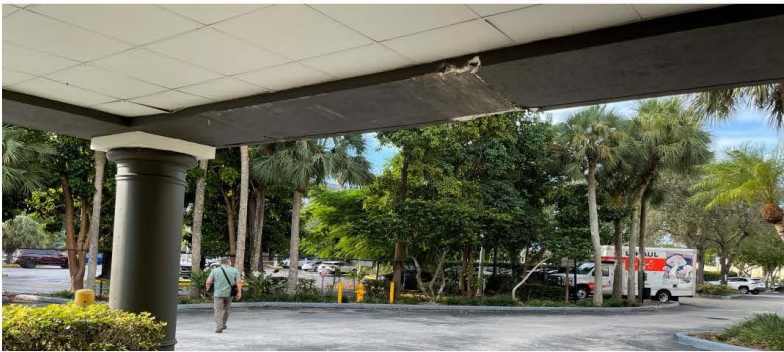
Direction Photo Taken: South West			
Description: Covered drop off

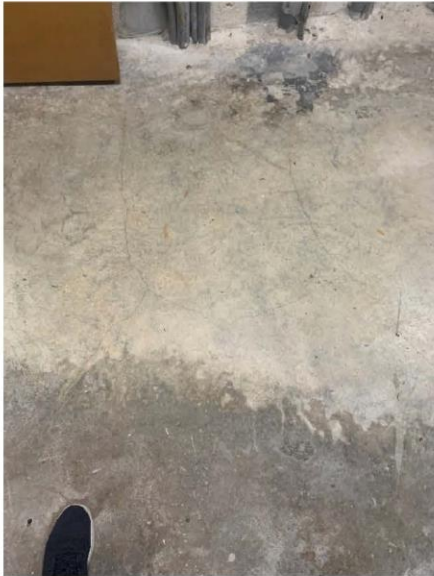
BNI identified minor structural issues, such as slab cracking exceeding 2mm in width around the pool deck (Photo #1) and 1-2mm wide cracks in room 1B Electrical room (Photo #2). Additionally, after removing ceiling tiles on level 4 hallway, several areas were spotted with spalled concrete that had exposed reinforcement in areas where tapcons were used (photo #4).

Direction Photo Taken: Interior Room 1B Electrical Room Floor		
Description: Hairline Slab Cracks Tier III Estimated Life Expectancy: More than 10 years.
