MIAMI-DADE COUNTY INTERNAL SERVICES DEPARTMENT

La Quinta Inn Physical Condition Assessment

10821 Caribbean Blvd, Miami, FL 33189

ISD PROJECT No. W220057

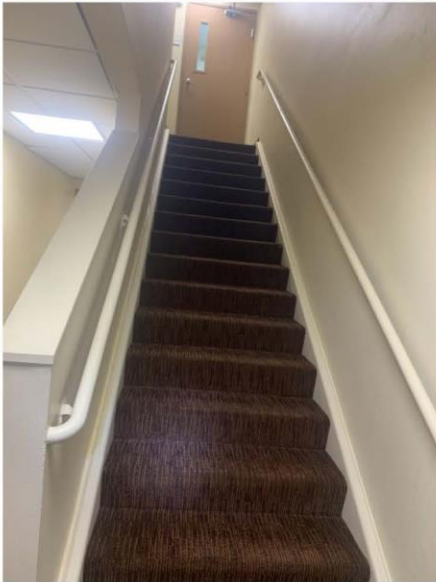
Direction Photo Taken: Stairwell			
Description: Stairwell with ceiling tiles and drywall Fair Condition. Estimated Life Expectancy: More than 20 years with proper maintenance.			
Photo No. 10	Date: 10/19/23

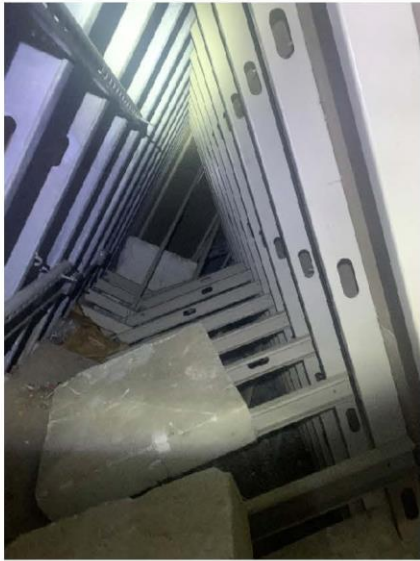
Direction Photo Taken: Roof Parapet interior			
Description: Roof parapet constructed of light gauge framing with loose construction materials laying around. Fair Condition. Estimated Life Expectancy: More than 20 years with proper maintenance.

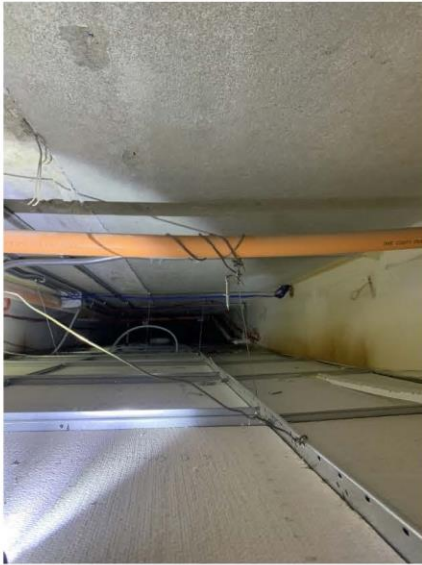
Direction Photo Taken:			
Description:			
<p>Interior hallway at Level 3 above ceiling panel looking up</p>			
<p>Bottom of hollow core slab in good condition with no visible reinforcement exposed. Fair Condition.</p>			
<p>Estimated Life Expectancy:</p> <p>More than 20 years with proper maintenance.</p>

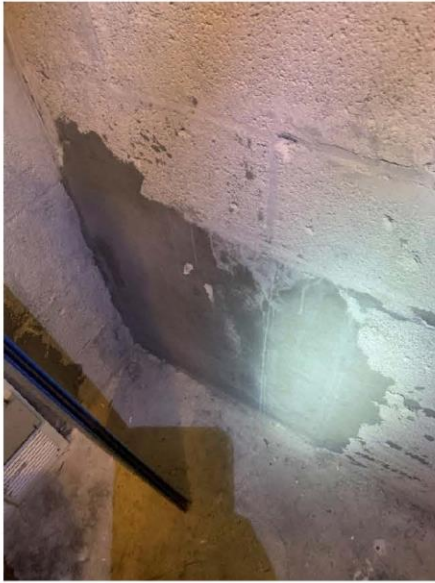
Direction Photo Taken: Ground Floor mechanical room looking at wall			
Description: Load bearing wall with signs of patch work done. Fair Condition. Estimated Life Expectancy: More than 10 years with proper maintenance.			
Photo No. 16	Date: 10/19/23	 	
Direction Photo Taken: Elevator Certificate of Operation			
Description: Elevator Inspection good until July 2024. Fair Condition. Estimated Life Expectancy: N/A to Structural

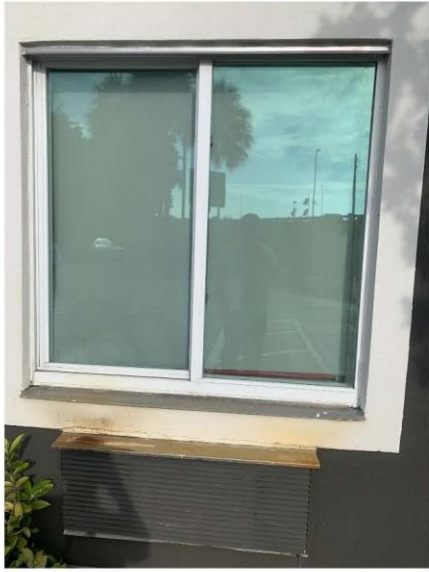
Direction Photo Taken: Exterior ground floor window		
Description: Window and sealant in acceptable condition, no large holes, broken windows or air infiltration found. Fair Condition.		
Estimated Life Expectancy: More than 10 years with proper maintenance.		
Photo No. 20	Date: 10/19/23

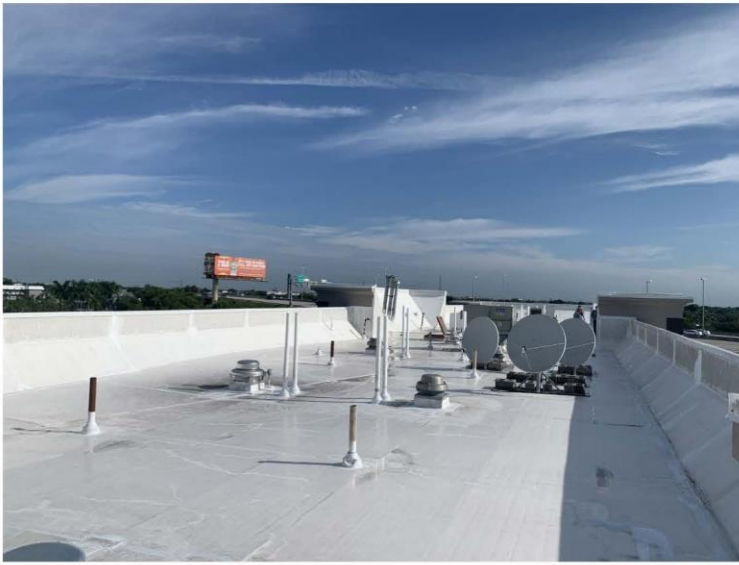
Direction Photo Taken: Roof Overview		
Description: No leaks found. Minor puddling of water. Fair Condition.		
Estimated Life Expectancy: More than 10 years with proper maintenance.

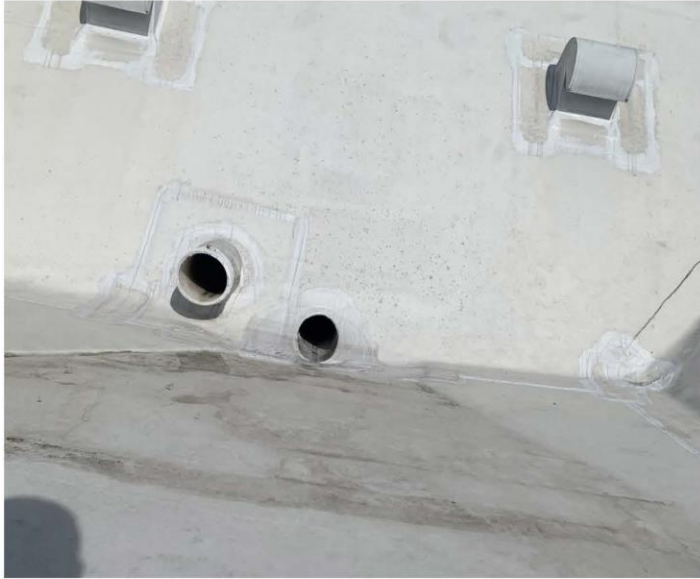
Direction Photo Taken: Roof Drains looking down		
Description: Roof drain is clear of any debris. Fair Condition. Estimated Life Expectancy: More than 10 years with proper maintenance.		
Photo No. 22	Date: 10/19/23

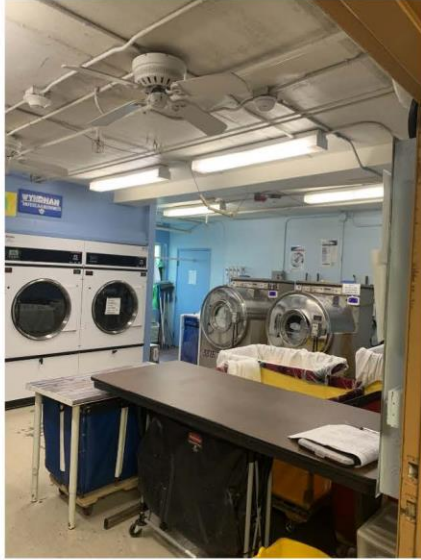
Client: Miami Dade County - ISD Consultant: Bliss & Nyitray, Inc.		
Site Location: La Quinta Inn 10821 Caribbean Blvd, Miami, FL 33189		Project: 21-9007 / W220057
Photo No. 27	Date: 10/19/23

Direction Photo Taken: Ground Floor Laundry Room entrance looking inwards		
Description: Exposed slab and hollow core ceiling with no visible defects such as cracking or spalling. Fair Condition.		
Estimated Life Expectancy: More than 20 years with proper maintenance.

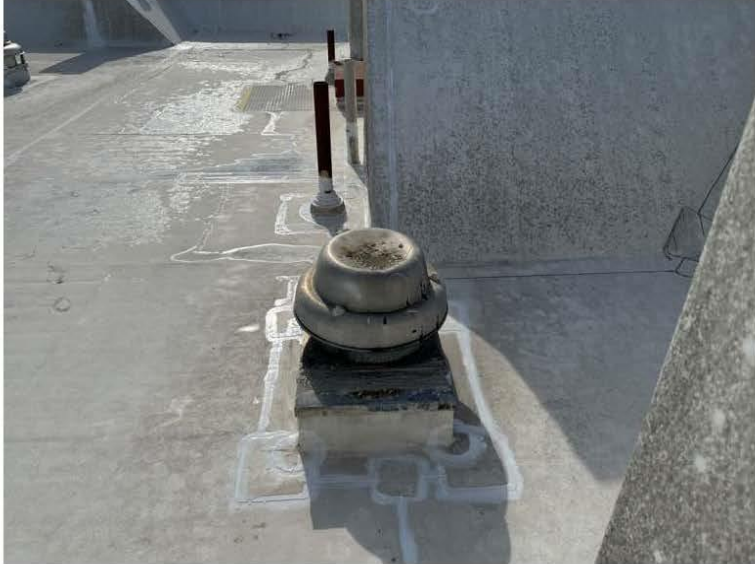
Client: Miami Dade County - ISD Consultant: [Company Name Here]		Site Location: La Quinta Inn 10821 Caribbean Blvd, Miami, FL 33189
Project: 21-9007 / W220057		
Photo No. 3	Date: 10/10/23

Direction Photo Taken:		
Description: Typical exhaust fan due for replacement		
Photo No. 4	Date: 10/10/23

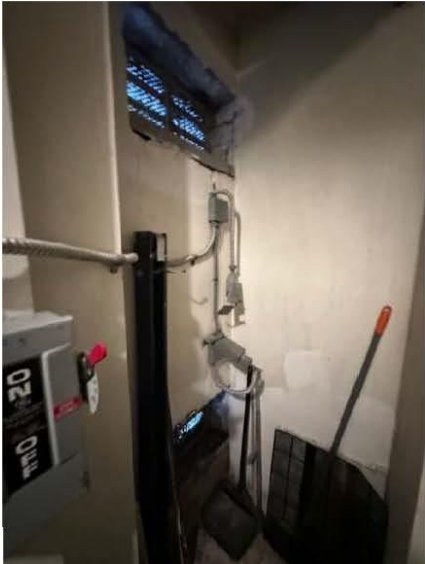
Client: Miami Dade County - ISD Consultant: [Company Name Here]		Site Location: La Quinta Inn 10821 Caribbean Blvd, Miami, FL 33189	
Project: 21-9007 / W220057			
Photo No. 5	Date: 10/10/23

Direction Photo Taken:			
Description: Ventilation provisions for dryers exhaust room not working properly			
Photo No. 6	Date: 10/10/23

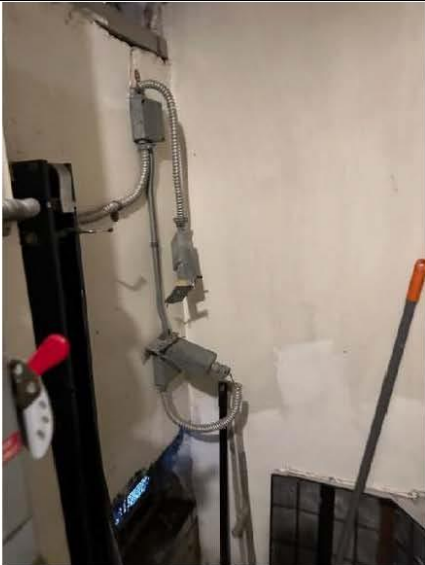
Direction Photo Taken:			
Description: Ventilation provisions for dryers exhaust room not working properly

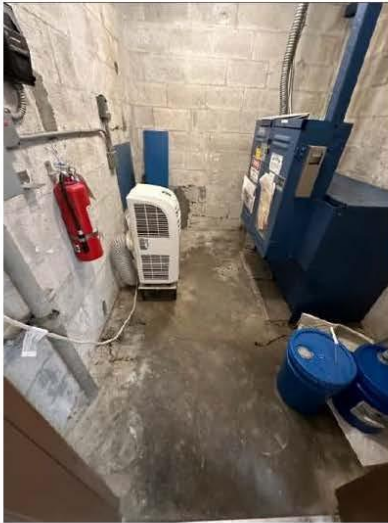
Photo No. 8	Date: 10/10/23

Direction Photo Taken:		
Description: Elevator machine room ventilation is deficient

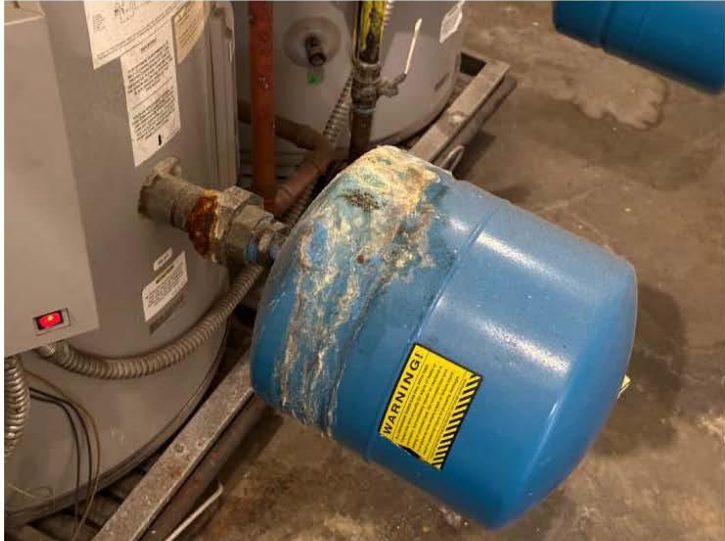
Client: Miami Dade County - ISD		Site Location: La Quinta Inn	
Consultant: [Company Name Here]		10821 Caribbean Blvd, Miami, FL 33189	
Project:		21-9007 / W220057	
Photo No. 9	Date: 10/10/23

Direction Photo Taken:			
Description: Boiler room Corrosion Damage

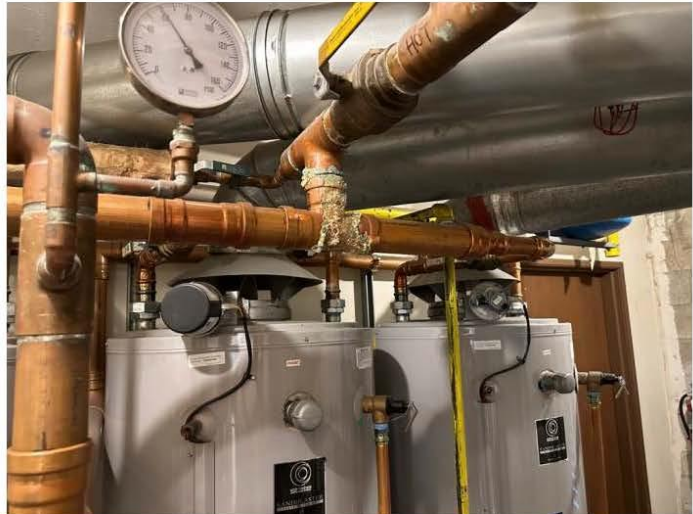
Photo No. 10	Date: 10/10/23

Direction Photo Taken:		
Description: Boiler room leaking valve

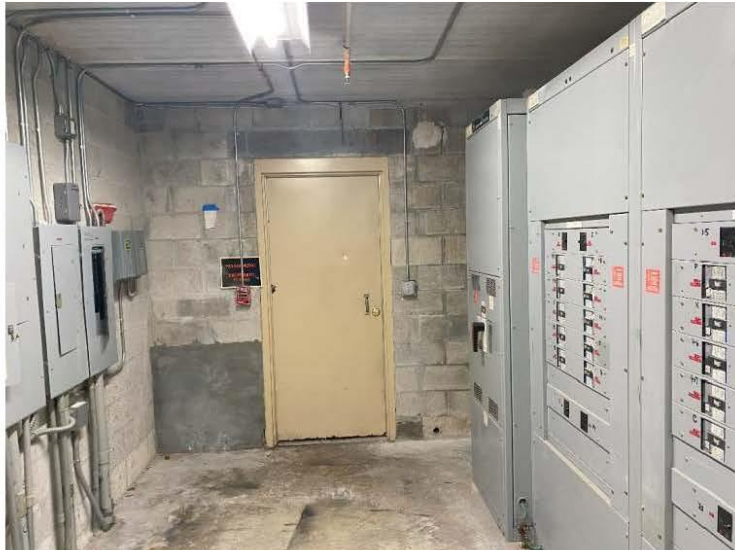
Client: Miami Dade County - ISD Consultant: [Company Name Here]		Site Location: La Quinta Inn 10821 Caribbean Blvd, Miami, FL 33189
		Project: 21-9007 / W220057
Photo No. 16	Date: 10/10/23

Direction Photo Taken:		
Description: Main electrical room exterior door missing panic hardware and exit sign as required by National Electrical Code.		
Photo No. 17	Date: 10/10/23

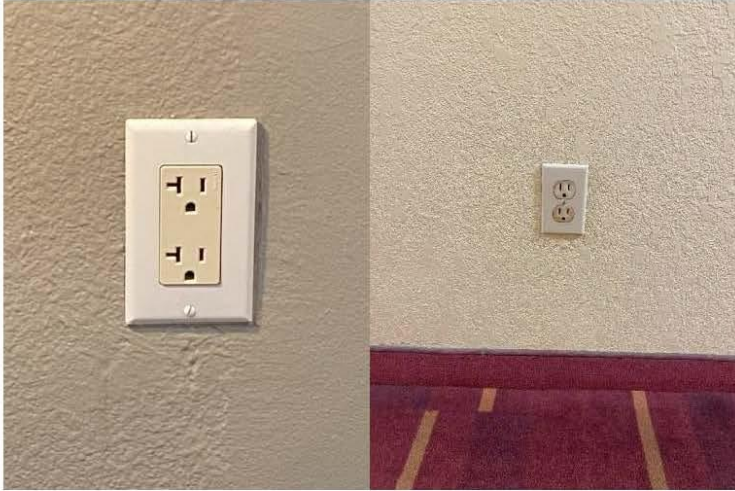
Site Progress Report			
Client: Miami Dade County - ISD		Site Location: La Quinta Inn	
Consultant: [Company Name Here]		10821 Caribbean Blvd, Miami, FL 33189	
Project:		21-9007 / W220057	
Photo No. 24	Date: 10/10/23

Direction Photo Taken:			
Description: Typical duplex receptacles can be found in common areas and guest rooms. These receptacles need to be replaced with new tamper-resistance type where required by National Electrical Code.			
Photo No. 25	Date: 10/10/23
